LHC POWERING ISSUES – REVIEW OF BEAM DUMPS*

S. Rowan[#], University of Glasgow, Glasgow, United Kingdom
S. Gunther, University of Stuttgart, Stuttgart, Germany
I. R. Ramirez, M. Zerlauth, CERN, Geneva, Switzerland

Abstract

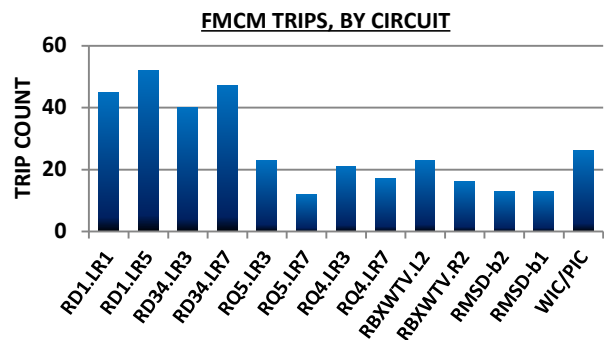
In reviewing the FMCM the most significant results presented themselves when looking at all trips of specific individual circuits. Fig. 5 shows all FMCM trips since stable LHC operation began in 2009. Notably, the RD1 and RD34 circuits stand out as clear outliers.

Note: The graph shown includes all FMCM trips; when a beam dump is triggered due to electrical network issues, several monitors may trip simultaneously, resulting in large trip count. To quantify, the total beam dumps triggered by FMCM recorded was 78.

Figure 5: All FMCM Trips by specific circuit since 2009

Further investigation found that this is likely due to the fact that the RD1 and RD34 circuits are powered directly from the 18 kV grid instead of the more stable 400 V line like the RQ4 and RQ5 [5]. This drastically increases the circuit sensitivity to electrical network perturbations (Fig. 6). There are plans to design and implement an improved regulation characteristic for the thyristors of PCs that are connected directly to the 18 kV grid in attempt to reduce sensitivity [6].

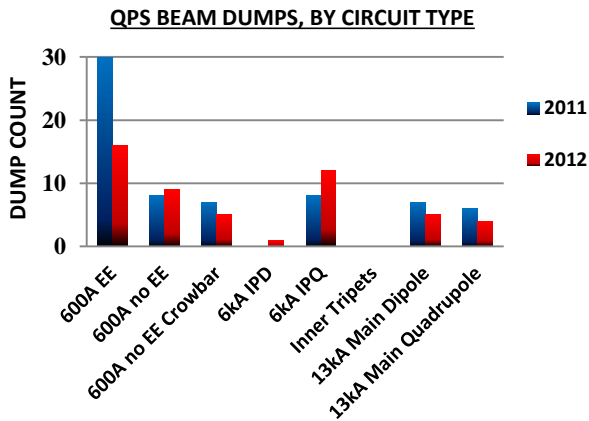
Looking at beam dumps triggered by the QPS, by circuit type, showed quite drastic changes in beam dump triggers when comparing 2011 to 2012 (Fig. 7). The most significant being a reduction in dumps due to particularly problematic 600 A Energy Extraction (EE) circuits. This reduction was due to the continuous improvement of thresholds for the RQTD-F circuits both during and since the Christmas shutdown in January 2012; RQTD-F circuits are particularly sensitive to action of the tune feedback system [8]. There are also plans for R2E mitigation via radiation hardening of protection electronics of 600 A circuits in several sectors (all UJ underground regions) during LS1 which is likely to

further reduce the number of spurious triggers [9]. In contrast, however, an important increase in beam dumps caused by the 6 kA IPQs is also seen. This may be due to a scaling effect of SEUs with the increase of beam energy from 3.5 to 4 TeV, though this is not likely to be the sole cause of the increase. Further study into the matter is called for.

Figure 7: Comparison of beam dumps triggered by QPS by circuit type, 2011 to 2012
