Construction of and first experience with a 2.2 x 1 m² micromegas chamber

Givi Sekhniadze
On behalf of the Micromegas community

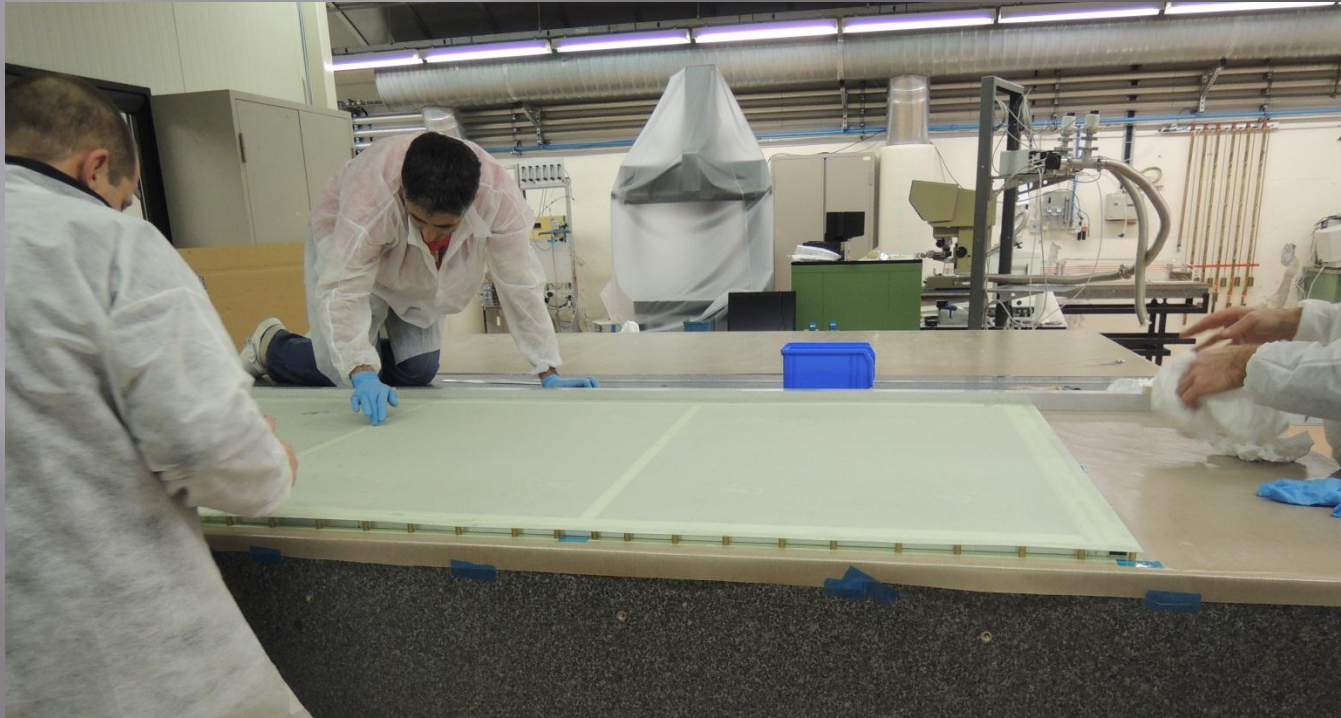
Mechanical issues – Drift panel (2)

Panel was closed with 0.5 mm thick FR4 skin

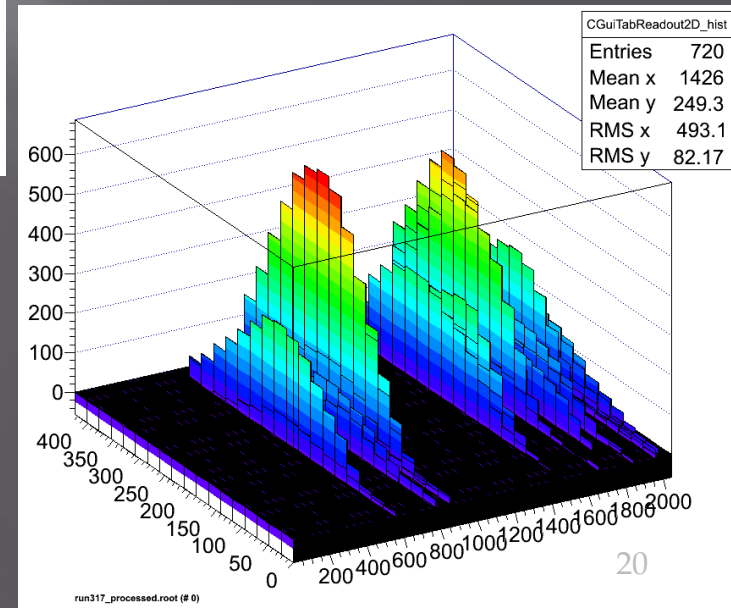
Cosmic shower detected by L2
