IBL Project Overview

9th Trento Workshop

D. Ferrère on behalf of the ATLAS Pixel community

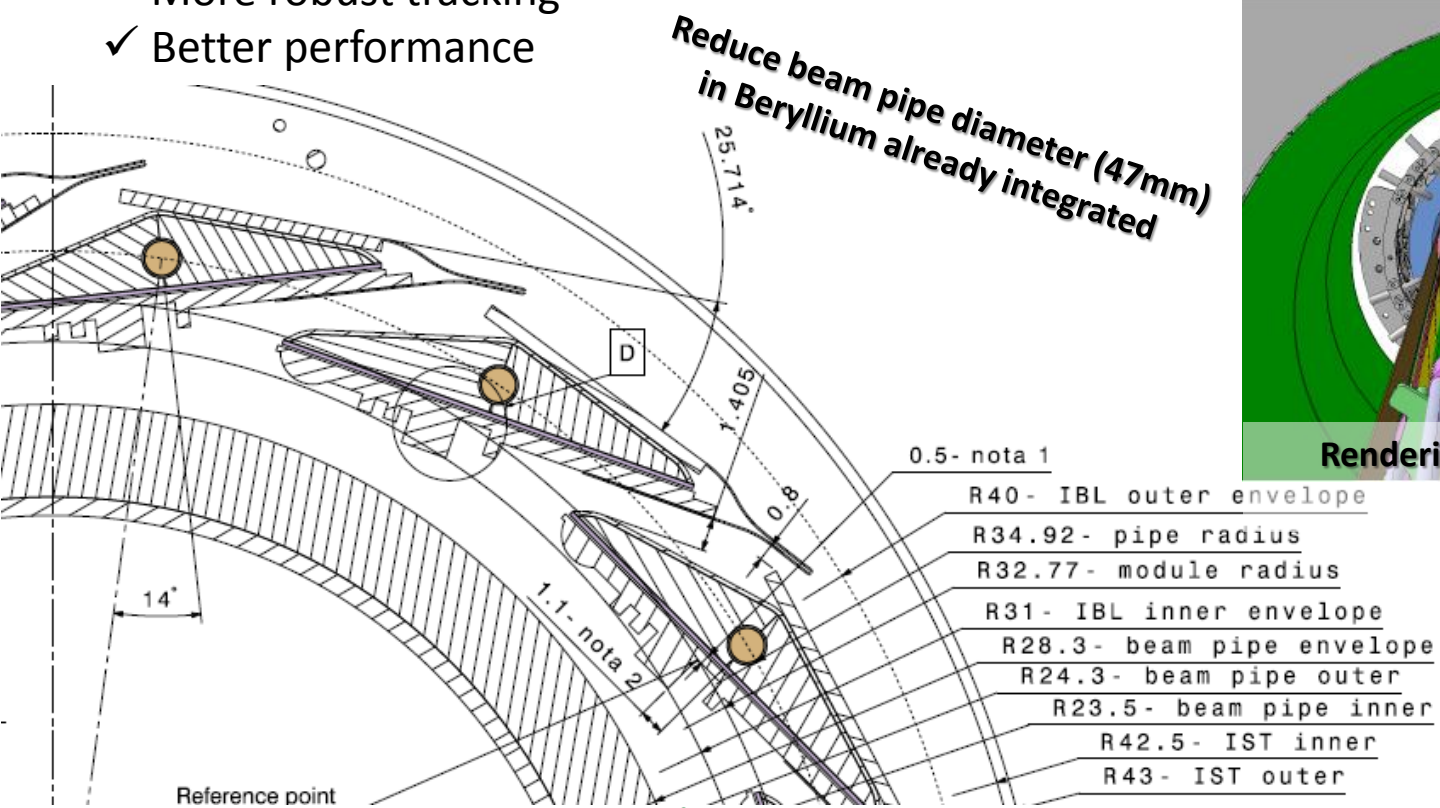
Rendering view with IBL and smaller beam pipe

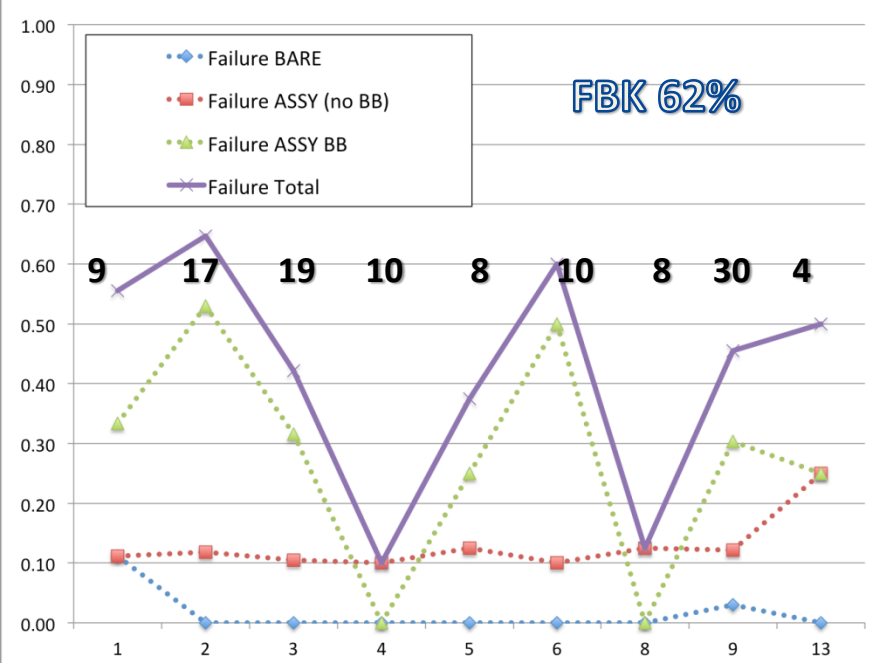
Amount per batch

28 52 51 11 42 42 24 41 58 36 5 34

Bump Bonding (BB) failures were monitored all along the production since this was the major concern during the 1st 3 batches

electrical failure rate dominated by sensor failures

BB failure rate better than for FBK ~10% on average

reduced electrical failure rate
~10%
→ single chips

higher BB failure rate
~20% for all batches

constant electrical failure rate of 15 – 20%

BB failure rate of ~5% if not counting batch 1-3 and first Gö

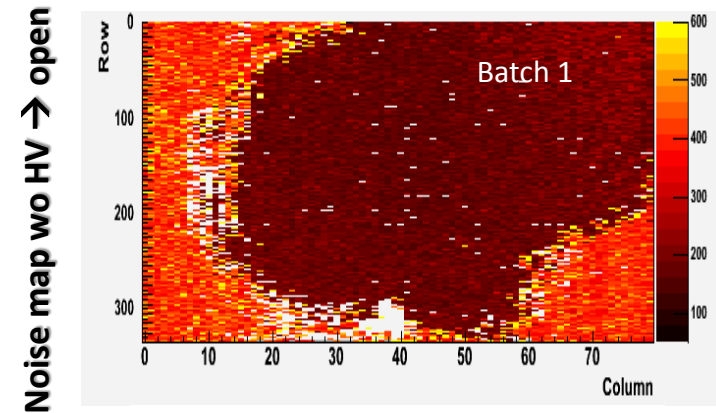
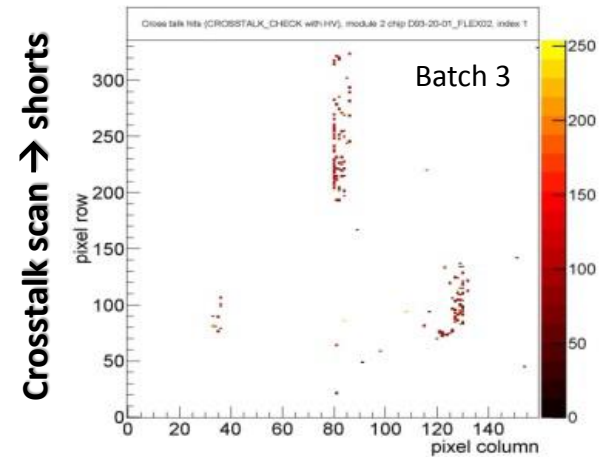
It was observed high failure rate mainly because of two types of defects:

- Open: large fraction of the pixel are not properly connected to the FE pads (seen in the noise map without HV and confirm with the source scan)
- “Shorts”: On some region of the FE it was observed coupling between surrounding pixels like shorted pixels or merge bumps (seen on the crosstalk scan)

- Open bumps traced back to be excessive flux in Flip Chip process.
- Still lack a convincing explanation of the origin of shorts but problem got vanished with flux-free flip chip.

1. **Bump bonding defects:** Likely to be due to the FC machine together with the tacking method for reflow. When both were changed the problem disappeared!
2. **Corrosion issue:** DI water tests allowed to observe an extreme sensitivity of wet flex surface which with the galvanic coupling and the presence halogen explained the chemical attack of the Al-wire.
 - White persistent residue $\text{Al}(\text{OH})_3$
 - Detected halogen in samples taken from production staves after corrosion spotted

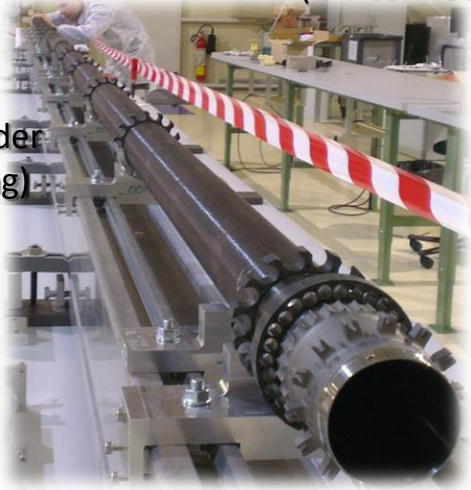
Beam pipe integration into the IPT structure

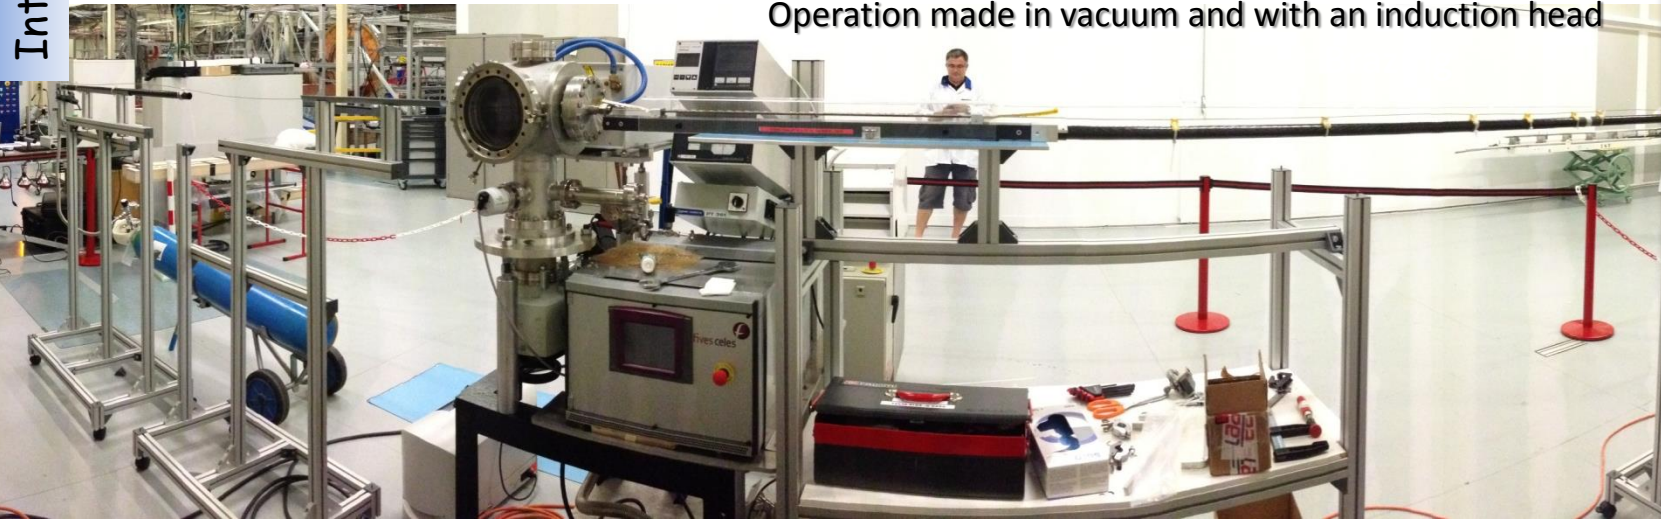
Next step before integration is the cooling pipe extension for each stave to 7m long by brazing

Operation made in vacuum and with an induction head

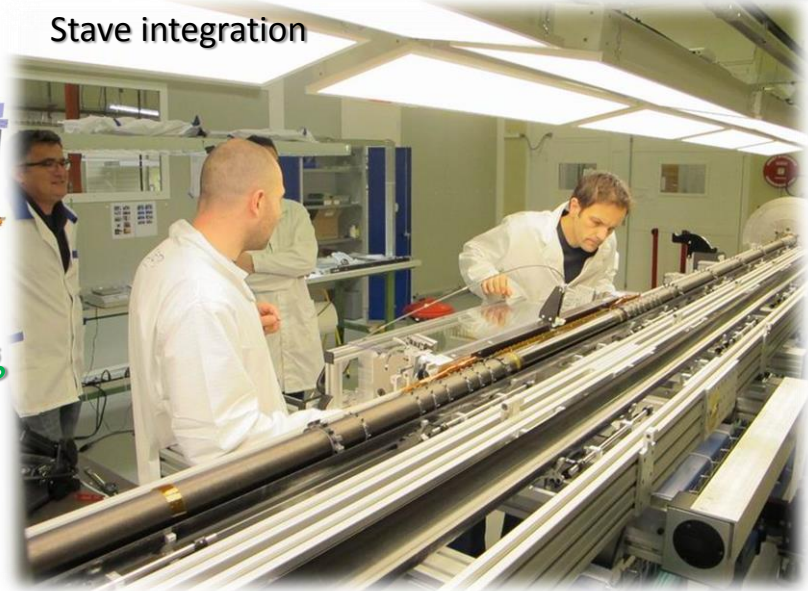
Stave integration

1st 2 real staves (rejected at QA) were integrated with success for practicing

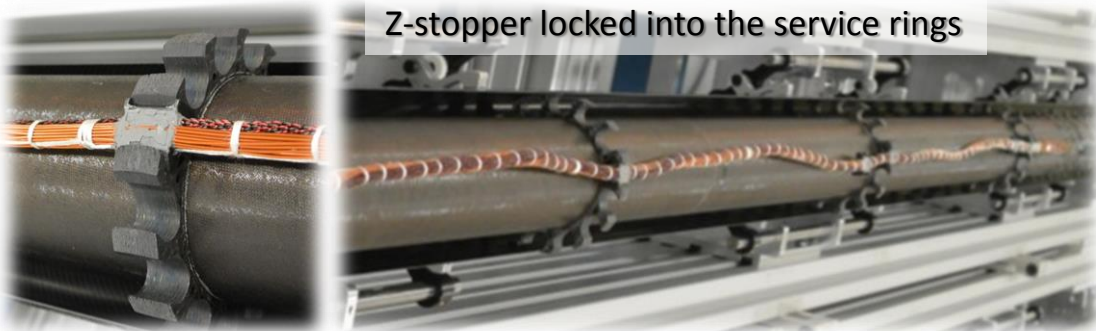
- CTE mismatch of the copper type-1 bundles will be absorbed by the controlled waves
- Intermediate flex joining the stave to the Type-1 is corrugated and allows to compensate for small inaccuracy and CTE

Z-stopper locked into the service rings

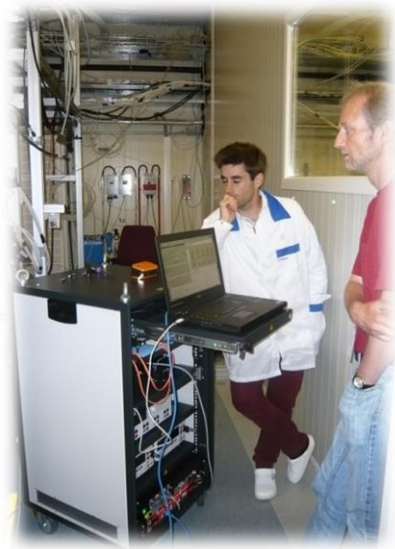
Qualification of the stave and service integration thanks to the connectivity set-up

- Can test that all the FE functionalities is working
- No cooling required & test is performed in less than 5s
- Interlock is always active based on temperature survey
- Setup is mobile and can be also used in the pit
- Two set-ups built to work in // on the two sides

System was extremely useful for the stave rework and for the validation of the stave07 and 08 integration practicing

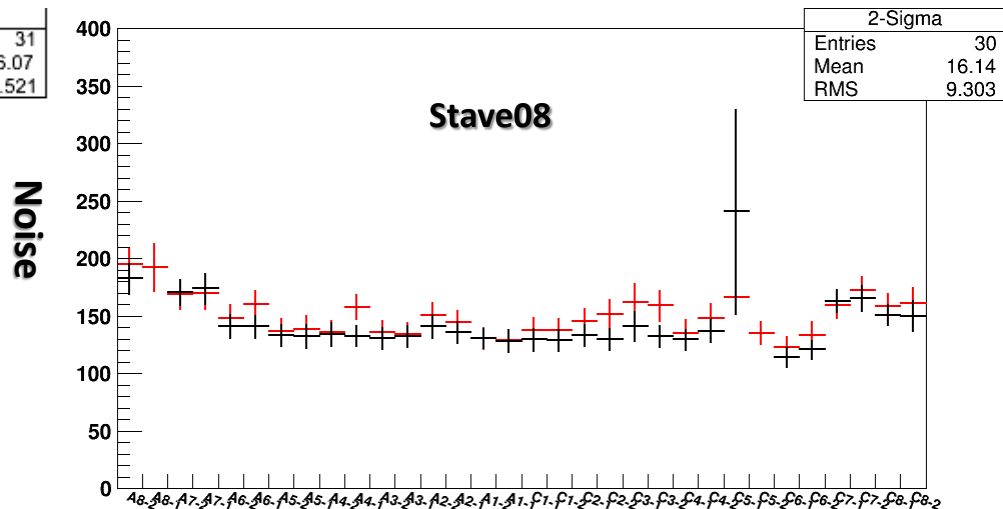
Stave 8

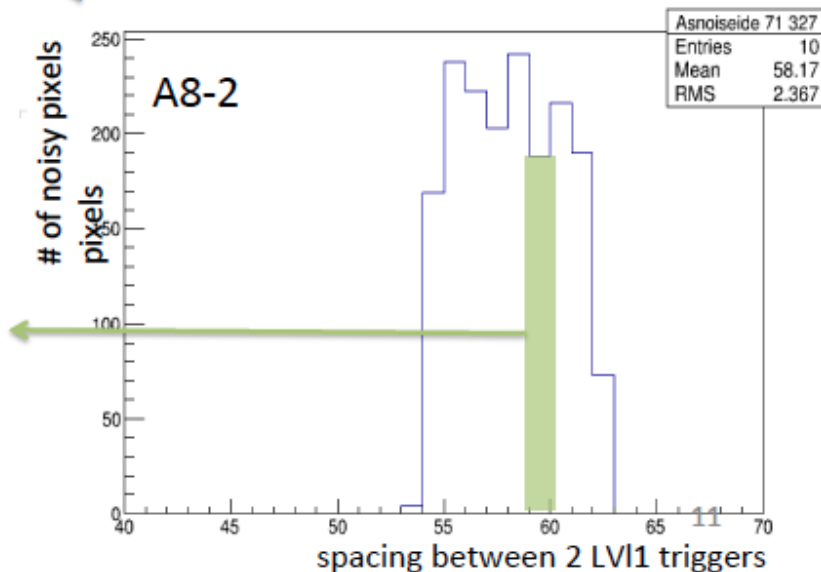
Stave08 Double trigger noise tests

Latency 210
8 slices read

Noise found on FBK modules

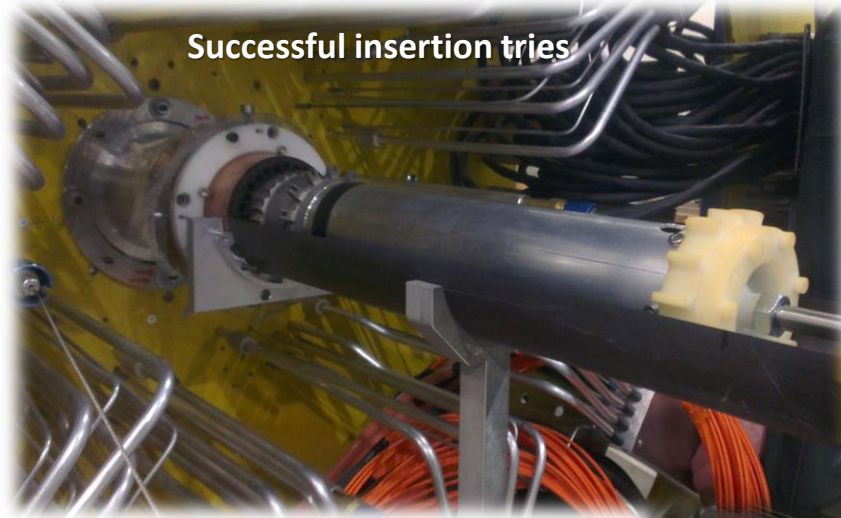
Successful insertion tries

- Tests made first by insertion by hands ✓
- Second stage of test with linear motor and torque limit ✓
- Repeat the above operations with services loaded into the sealing rings and test also the leak rate
- Practice the Z positioning pin insertion (IPT wrt IST)
- Practice the insertion with wrapped services at IPT extremities
- Practice the service unwrapping → procedure

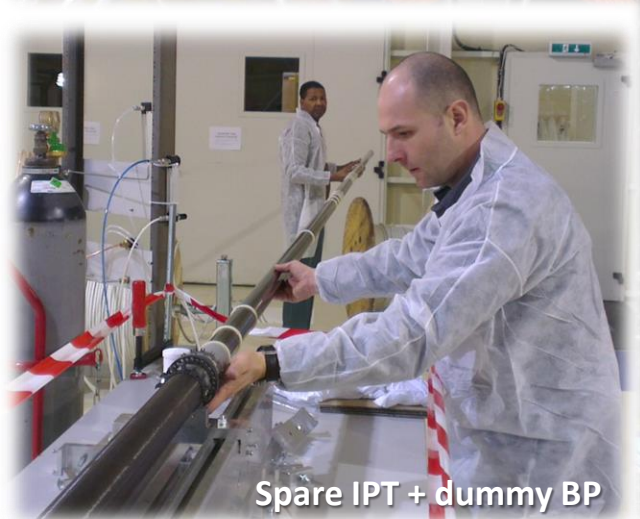
ID Mockup for installation tries

A mock-up exists in bldg 180 to practice (originally to minimize the time of intervention in the cavern and review the procedures)

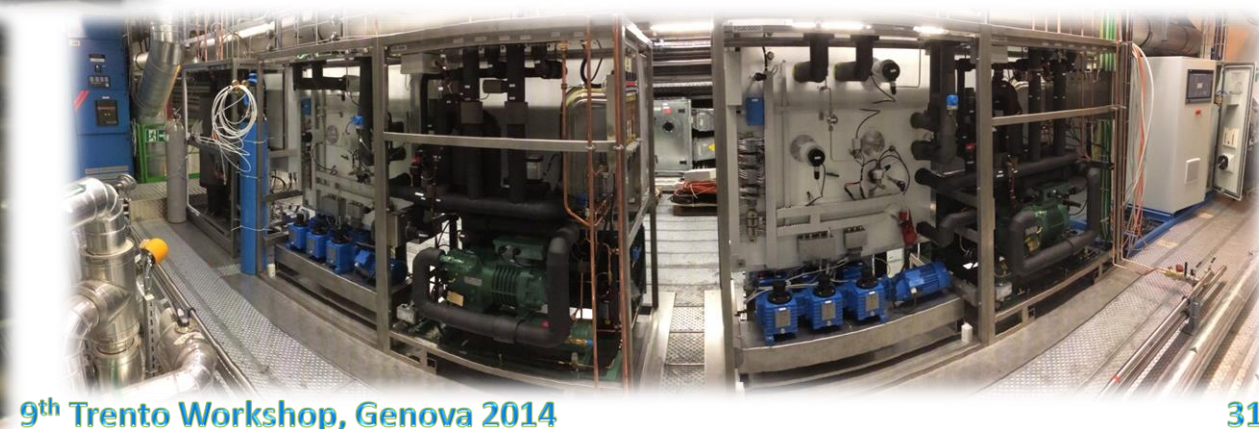
CO₂ cooling system

- CO₂ cooling is new for ATLAS
- Cooling capacity is for 3kW
- Two cooling plants running in parallel
- Increase the safety during bake-out in addition to the blow-off system
- Plant & 100m vacuum transfer lines already installed with distribution system close the detector
- Commissioning and 1st circulation of liquid CO₂ started last week success fully
- Electrical break at the junction of the Ti and SS pipe was a technological challenge
