Radiation damage of monolithic pixel detectors

M. Menichelli, G.M. Bilei, L. Bissi, L. Servoli
INFN Sez. di Perugia

INFN Perugia plans for AIDA

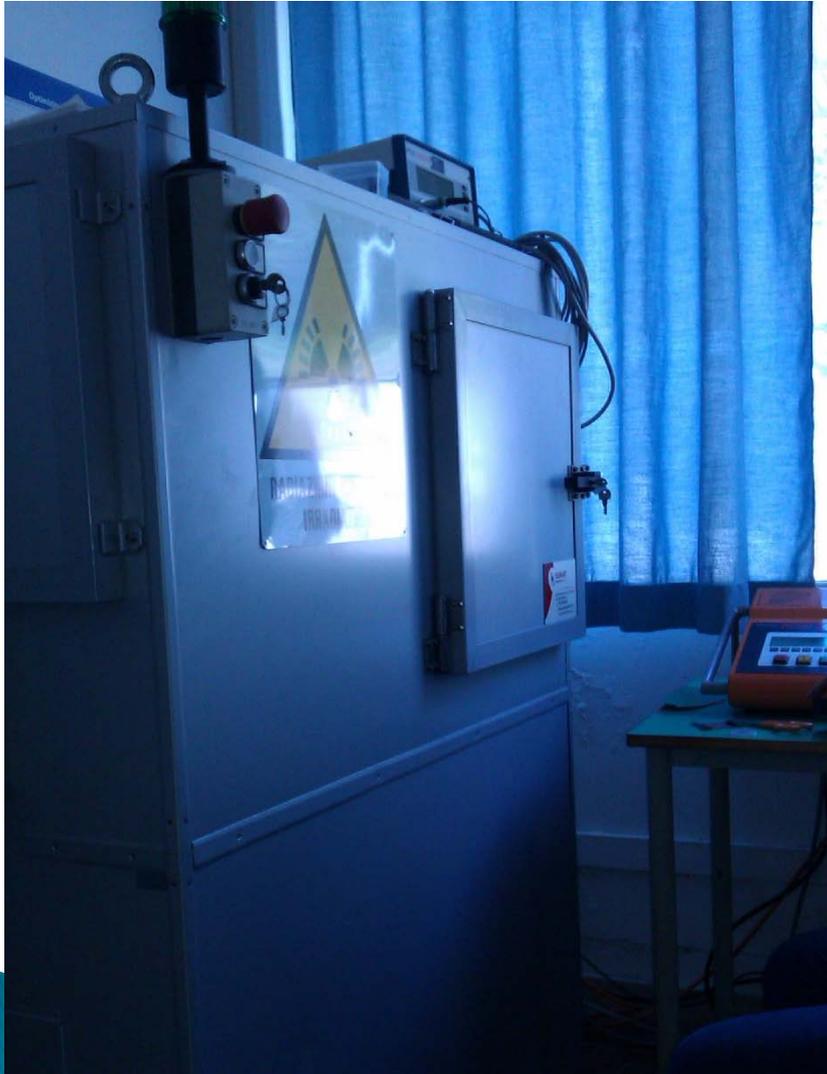
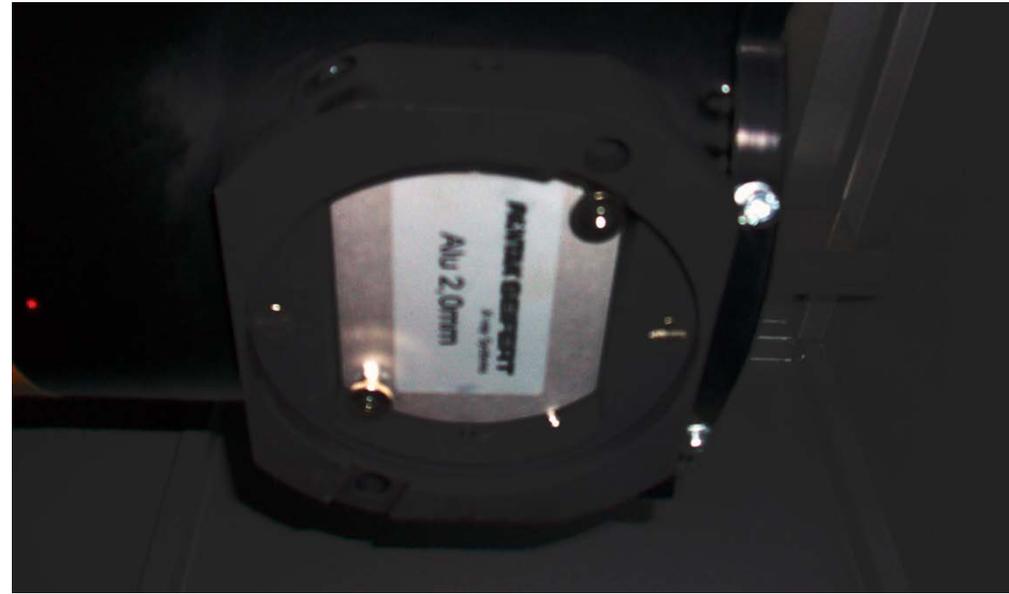
X-ray machine

- 900 W (200 kV max) tube taken from AMS (designed for radiation damage for space studies)
- Under calibration for dose rate characterization
- Dose rate maximum about 10 rad/s unsuitable for very high doses but reasonable for test at reduced rate up to 10 Mrad
