PIC configuration (maskable/unmaskable circuits)

MPP meeting – 07.03.2014

Powering and Beam Interlocks

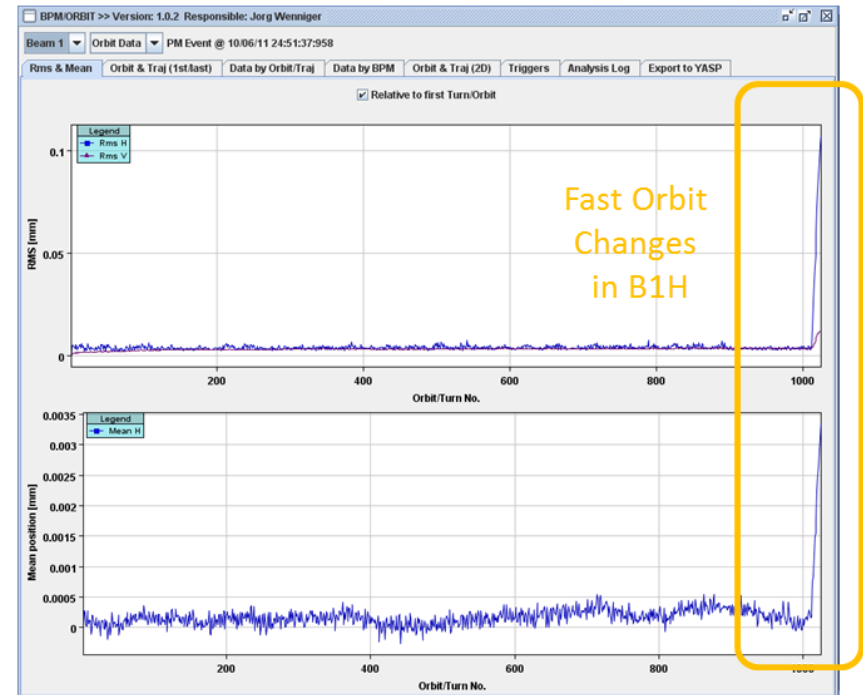
Modifications during Run1

- **RQSX3**: Included in **Maskable** PIC configuration after trip provoking fast orbit changes and beam losses in SR7 (event on June 2011 – ECR 1203408)
