Pierpaolo Valerio

# **DESIGN CONSIDERATIONS FOR CLICPIX2 AND STATUS REPORT ON THE TSV PROJECT**

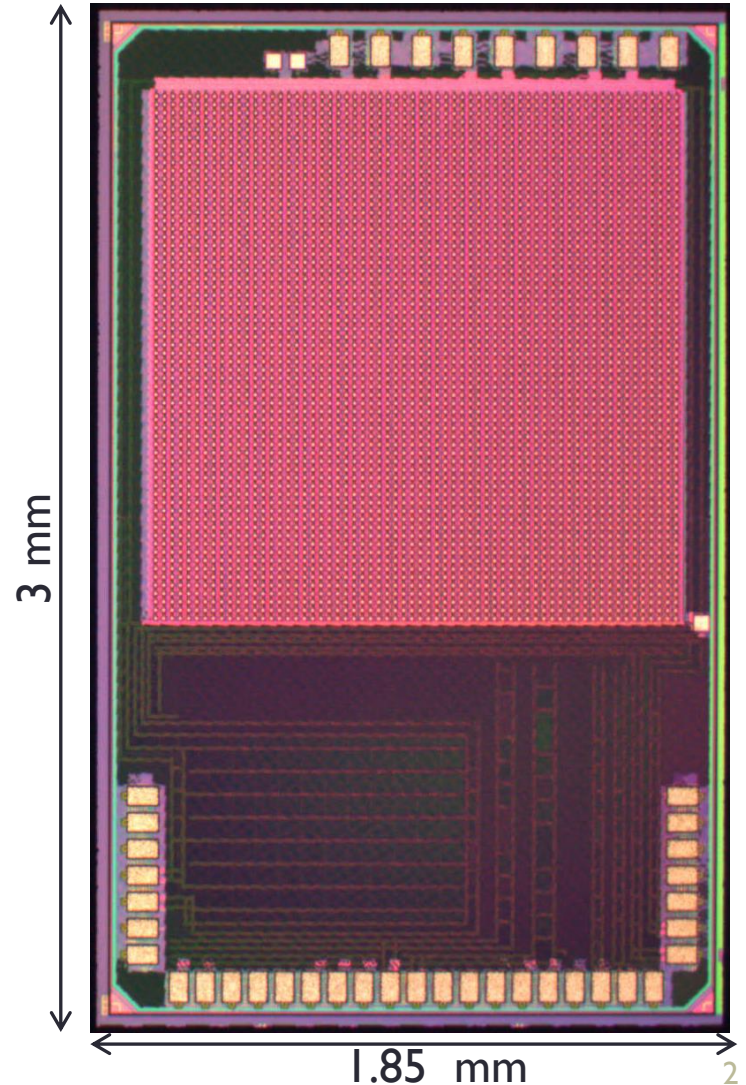
- CLICpix is a **hybrid** pixel detector to be used as the CLIC vertex detector
- Main features:
  - small pixel pitch ( $25\ \mu\text{m}$ ),
  - Simultaneous TOA and TOT measurements
  - Power pulsing
  - Data compression
- A demonstrator of the CLICpix architecture with an array of  $64 \times 64$  pixels has been submitted and tested

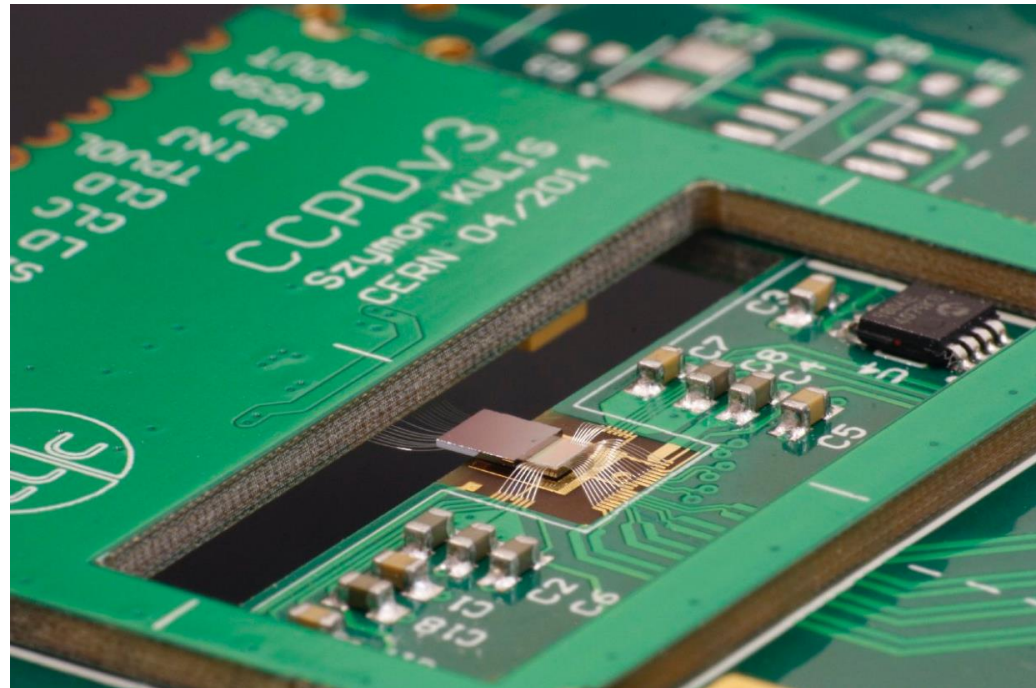
- Latest results on CLICpix were presented by Daniel Hynds before
- The chip works well and it provides a good proof-of-concept for a CLIC vertex detector built with current technology
- CLICpix has been tested in a test-beam scenario using an HV-CMOS sensor. Tests with a Si sensor are planned for the future

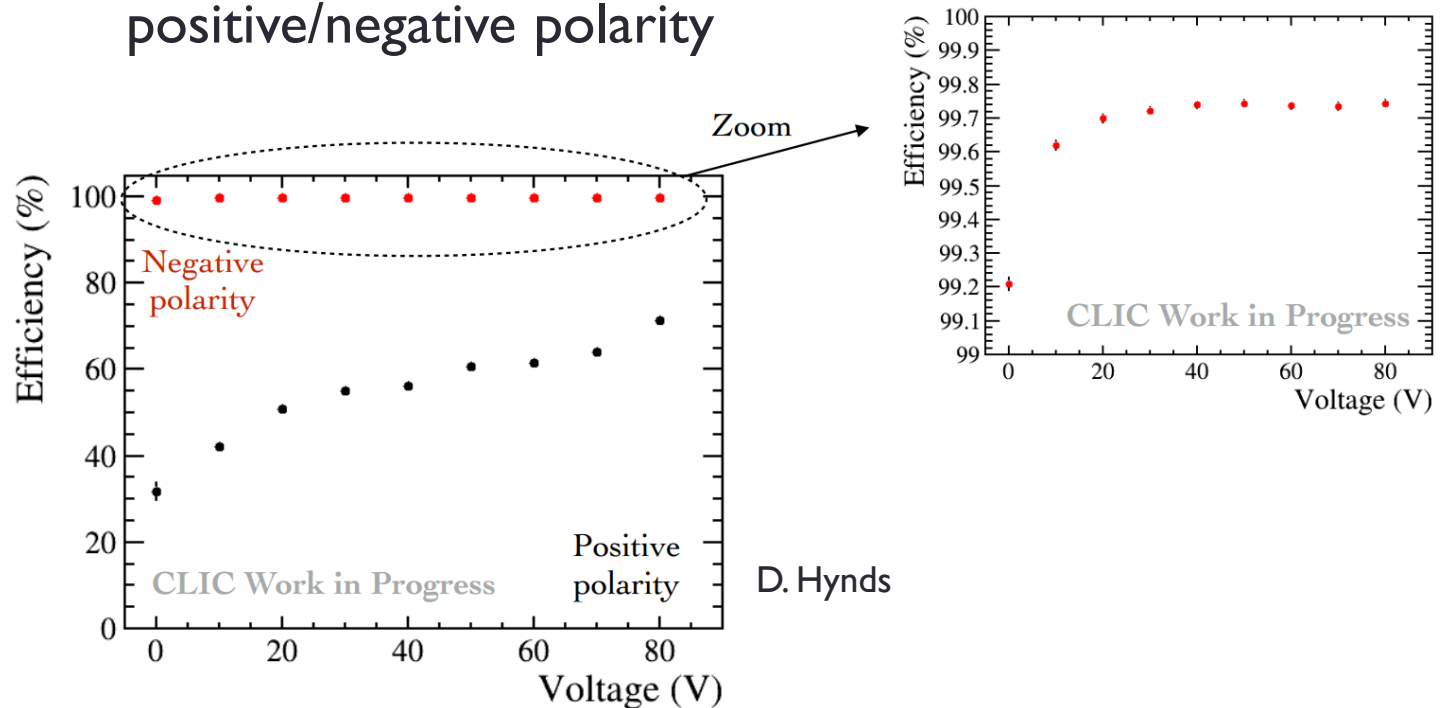
- However, the current chip has a few issues...
- **Charge injection** from discriminator output to the input pad.
  - This is the most serious issue. It changes the minimum threshold significantly and creates a difference between left/right pixels in a double column and between positive/negative polarity

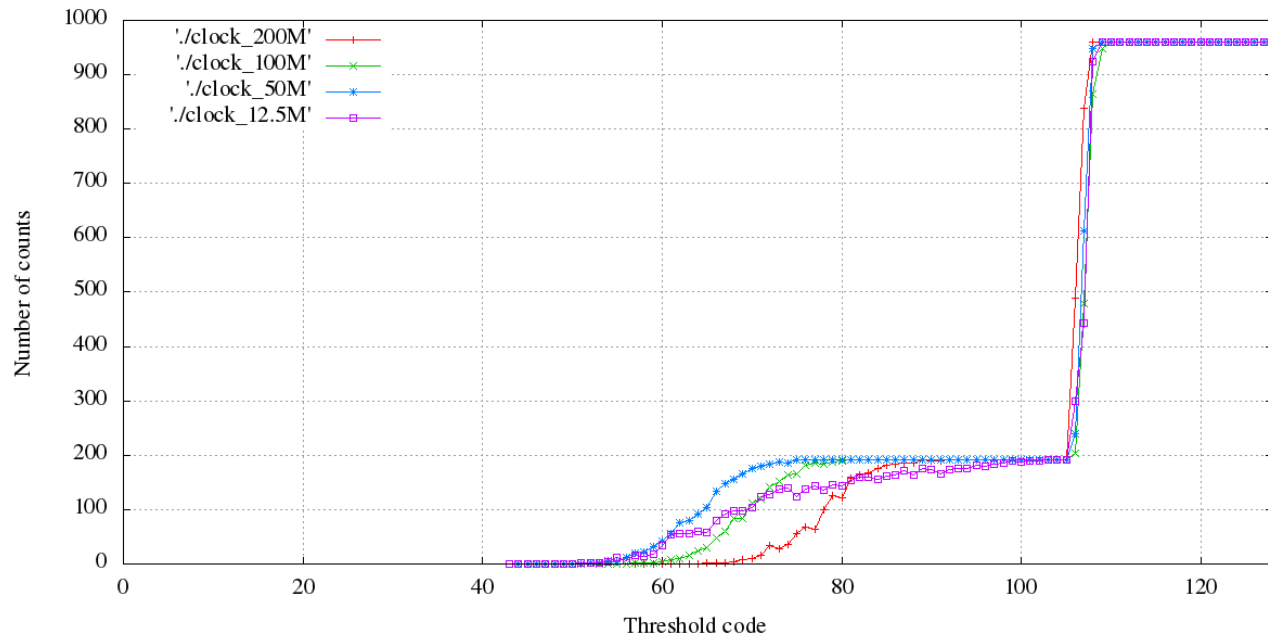
- Other smaller issues are also present:
- Charge injection from digital side
  - This issue is more limited and it causes increased noise for a certain range of clock frequencies.
- Compression bug
  - Very simple logic bug that slows down the readout when using cluster/column compression

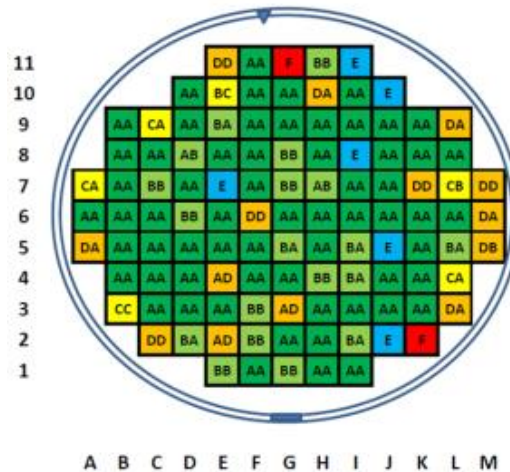
W128\_AZPGBPH\_before\_TSV

\* Original wafer probing results  
(Foundry yield)

AA	62	57%
BB, BA or AB	19	17%
CC, CA, AC, BC or CB	6	6%
D	14	13%
E	6	6%
F	2	2%
Total	109	100%

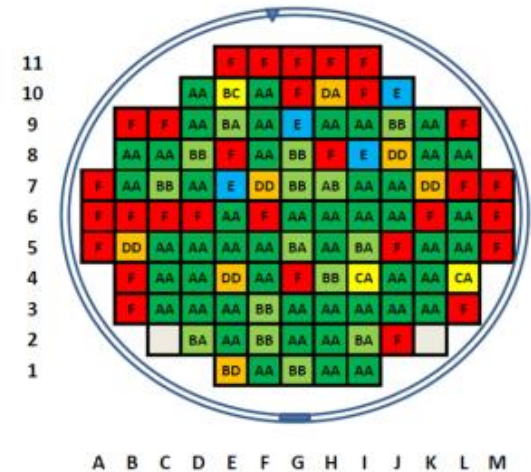
W128\_AZPGBPH\_after TSV

After foundry production and TSV added process the final yield is 45% of fully functional chips

AA	48	45%
BB, BA or AB	15	14%
CC, CA, AC, BC or CB	3	3%
D	7	7%
E	4	4%
F	30	28%
Total	107	100%
