Module Construction at Pusan

Bong-Hwi Lim*, KyungEon Choi, In-Kwon Yoo

Pusan National University (PNU)

ALICE ITS upgrade, MFT and O2 Asian Meeting 2014@Pusan
2014.12.15.

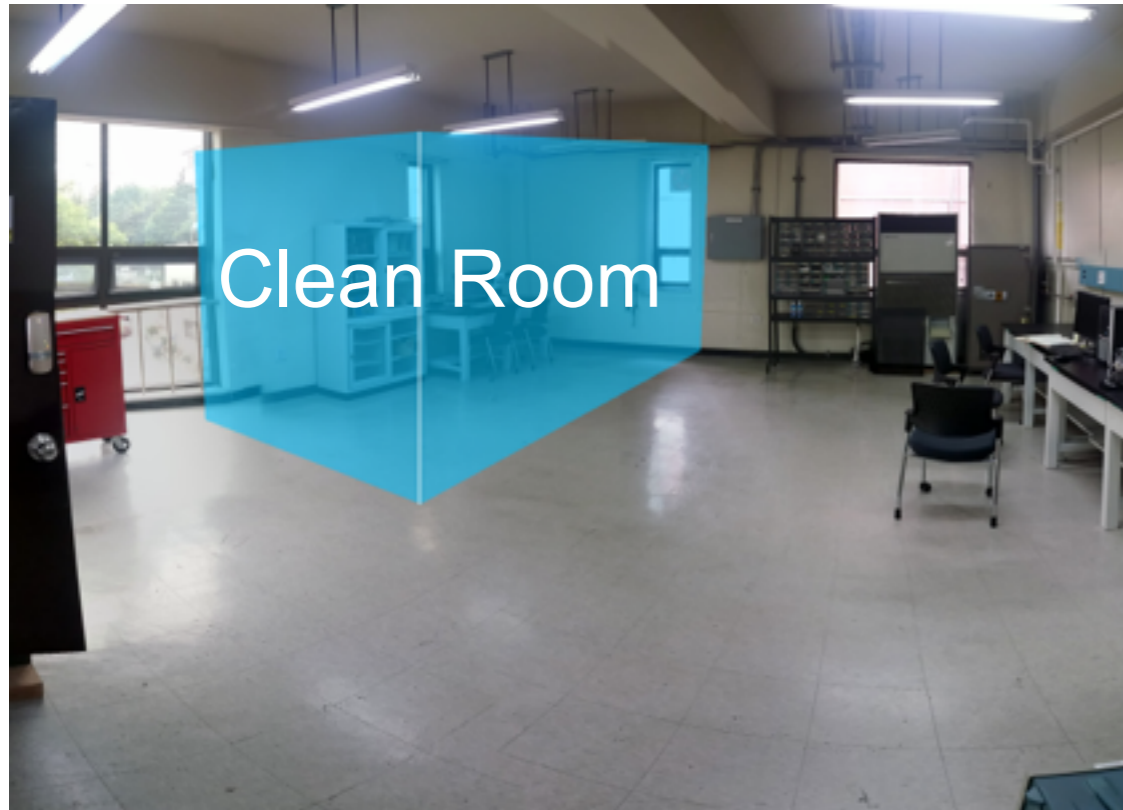
New room & Clean booth(Planned)

- **Infrastructure**
 - 20m² of **Clean booth** (100,000 Level)(Planned)
- **Equipments**
 - Microscope(SZX7)
 - Further will be informed by WP4 Group
(**Desiccator** for Silicon Chips, **Storage** for modules)
- **Misc.**
 - Further will be informed by WP4 Group
(Gloves, Air spray, Alcohol so on..)
- **Will be delivered**
 - **Baseline System for HIC Assembly**
 - contains mass test system & HIC Assembly System

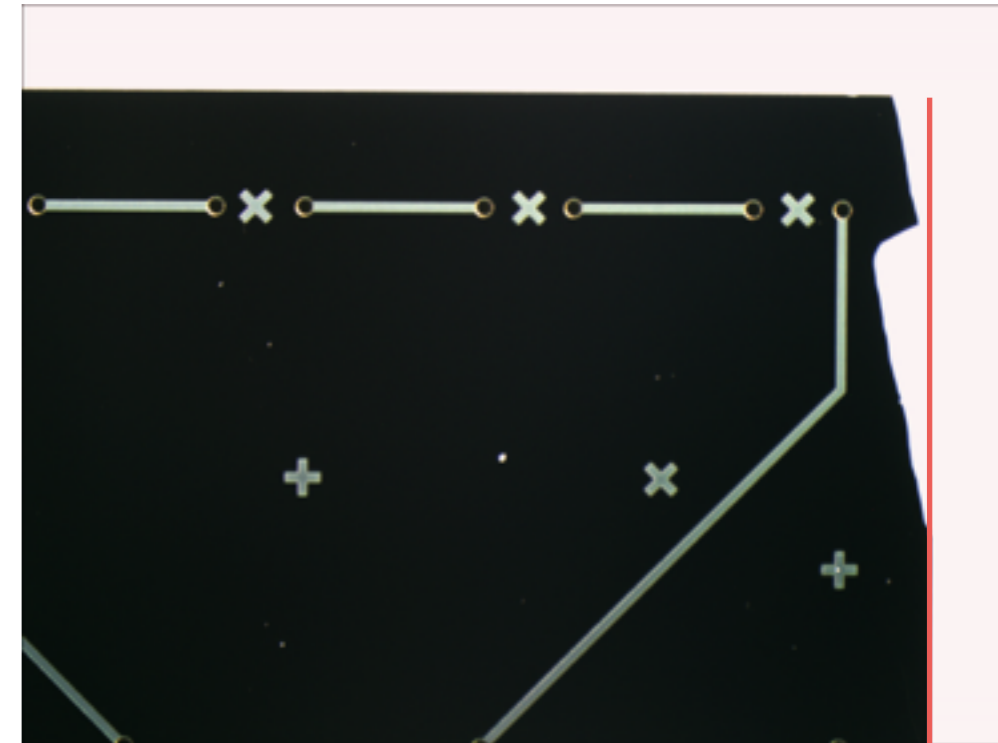
Chip Edge

- **Result:**
 - No damage on the box
 - 1 Small fragment of chip is found
 - but, don't know where it comes from.
 - Size of fragment is different with broken edge of same chip.
 - Some chips are damaged.
 - This problem is reported to WP4 group.
- **Waiting for next Transportation Test.**

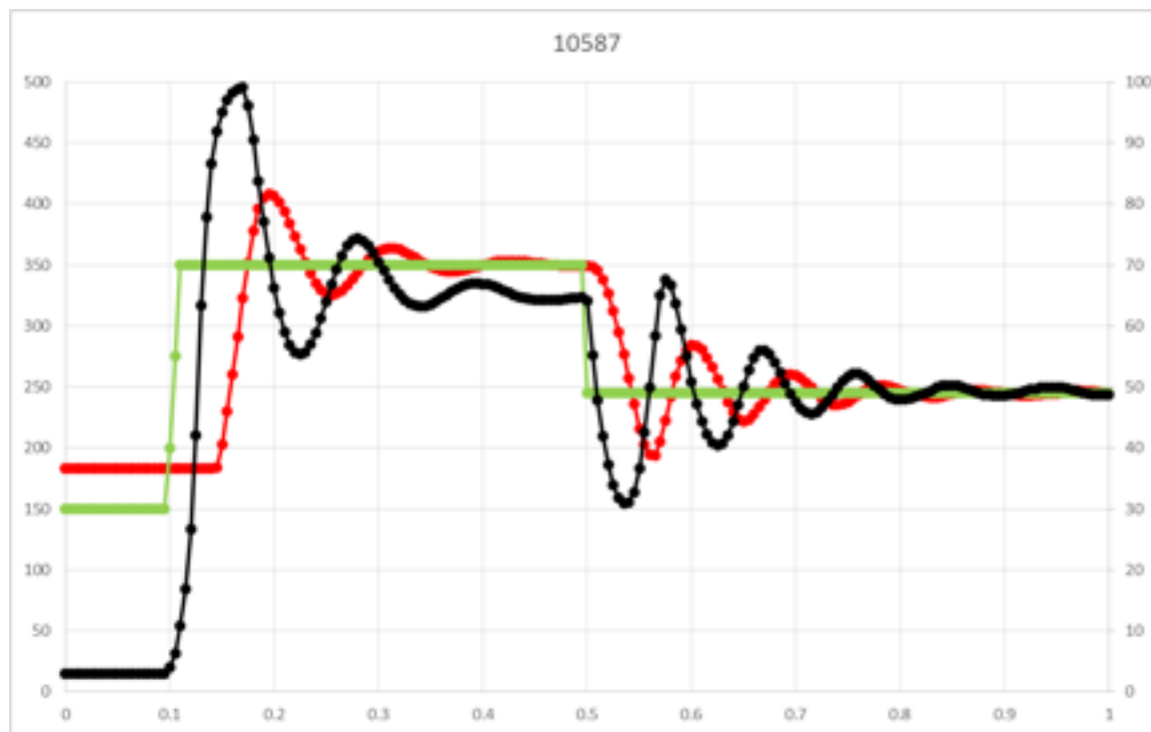
Worst Case

- Checked the Surface Temp. and Laser Power curve.
- The Worst Case, they show almost perfectly similar curve shape.

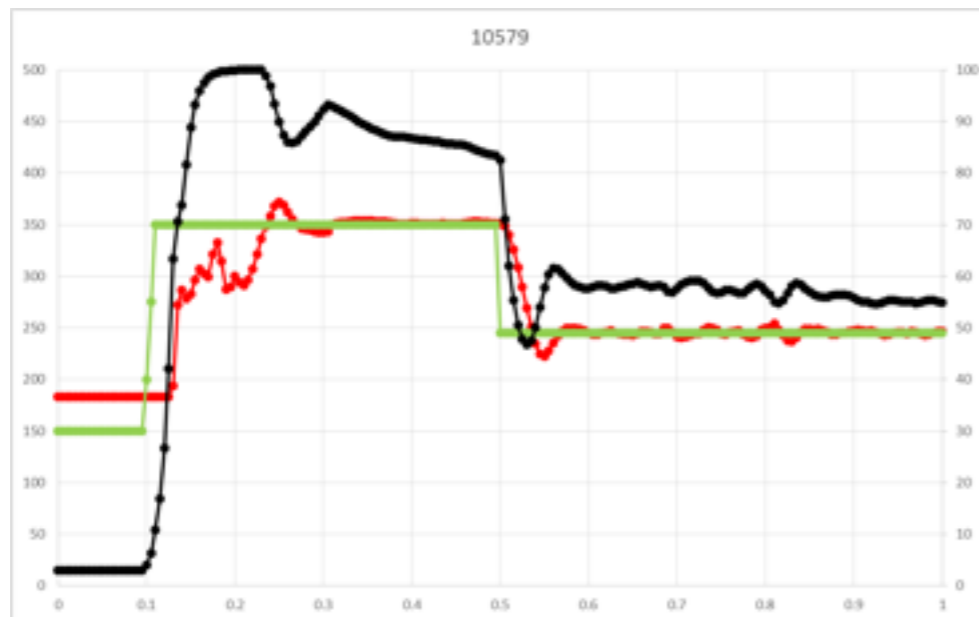
Good case(10579)

Black line(Laser power) is decreased in Bad case.

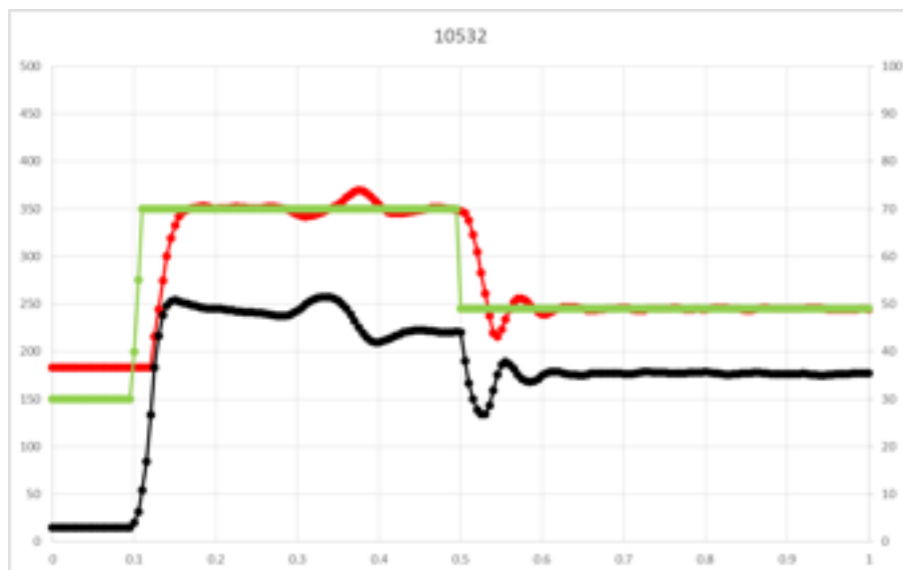
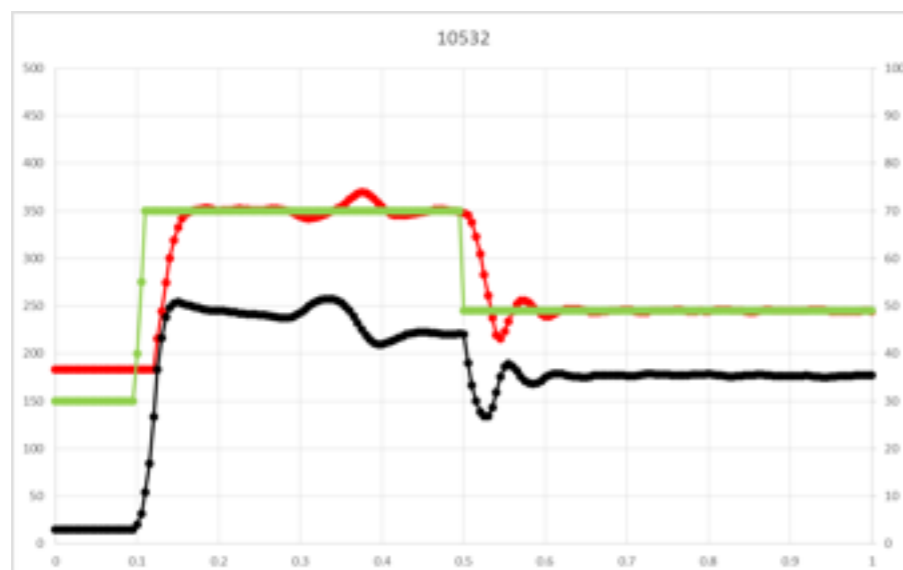
- Check with measured value
 - Below is some soldering data in same sample.
 - There is no cross-section picture yet.
but, we can assume the cross-section image with previous data.

This Soldering data should be **'Bad' case**

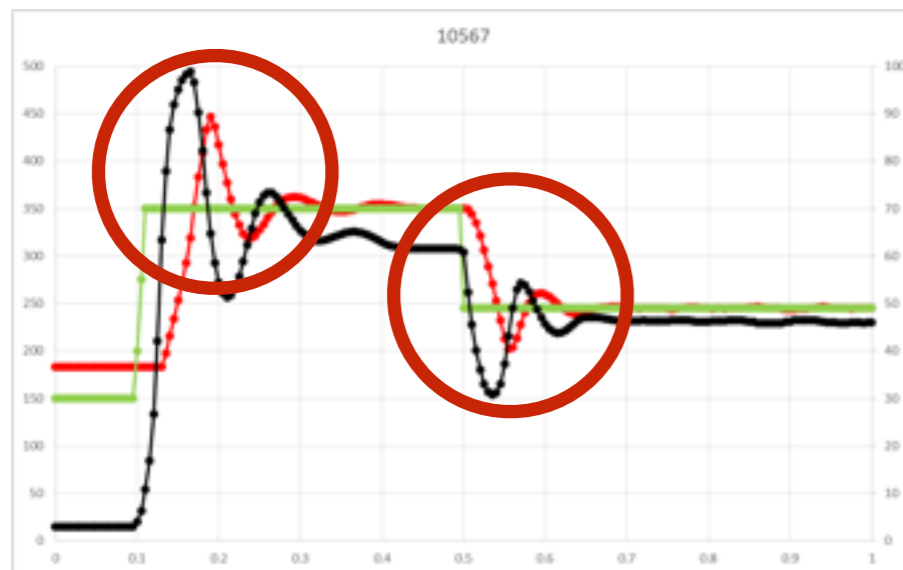
This Soldering data should be **'Worst' case**

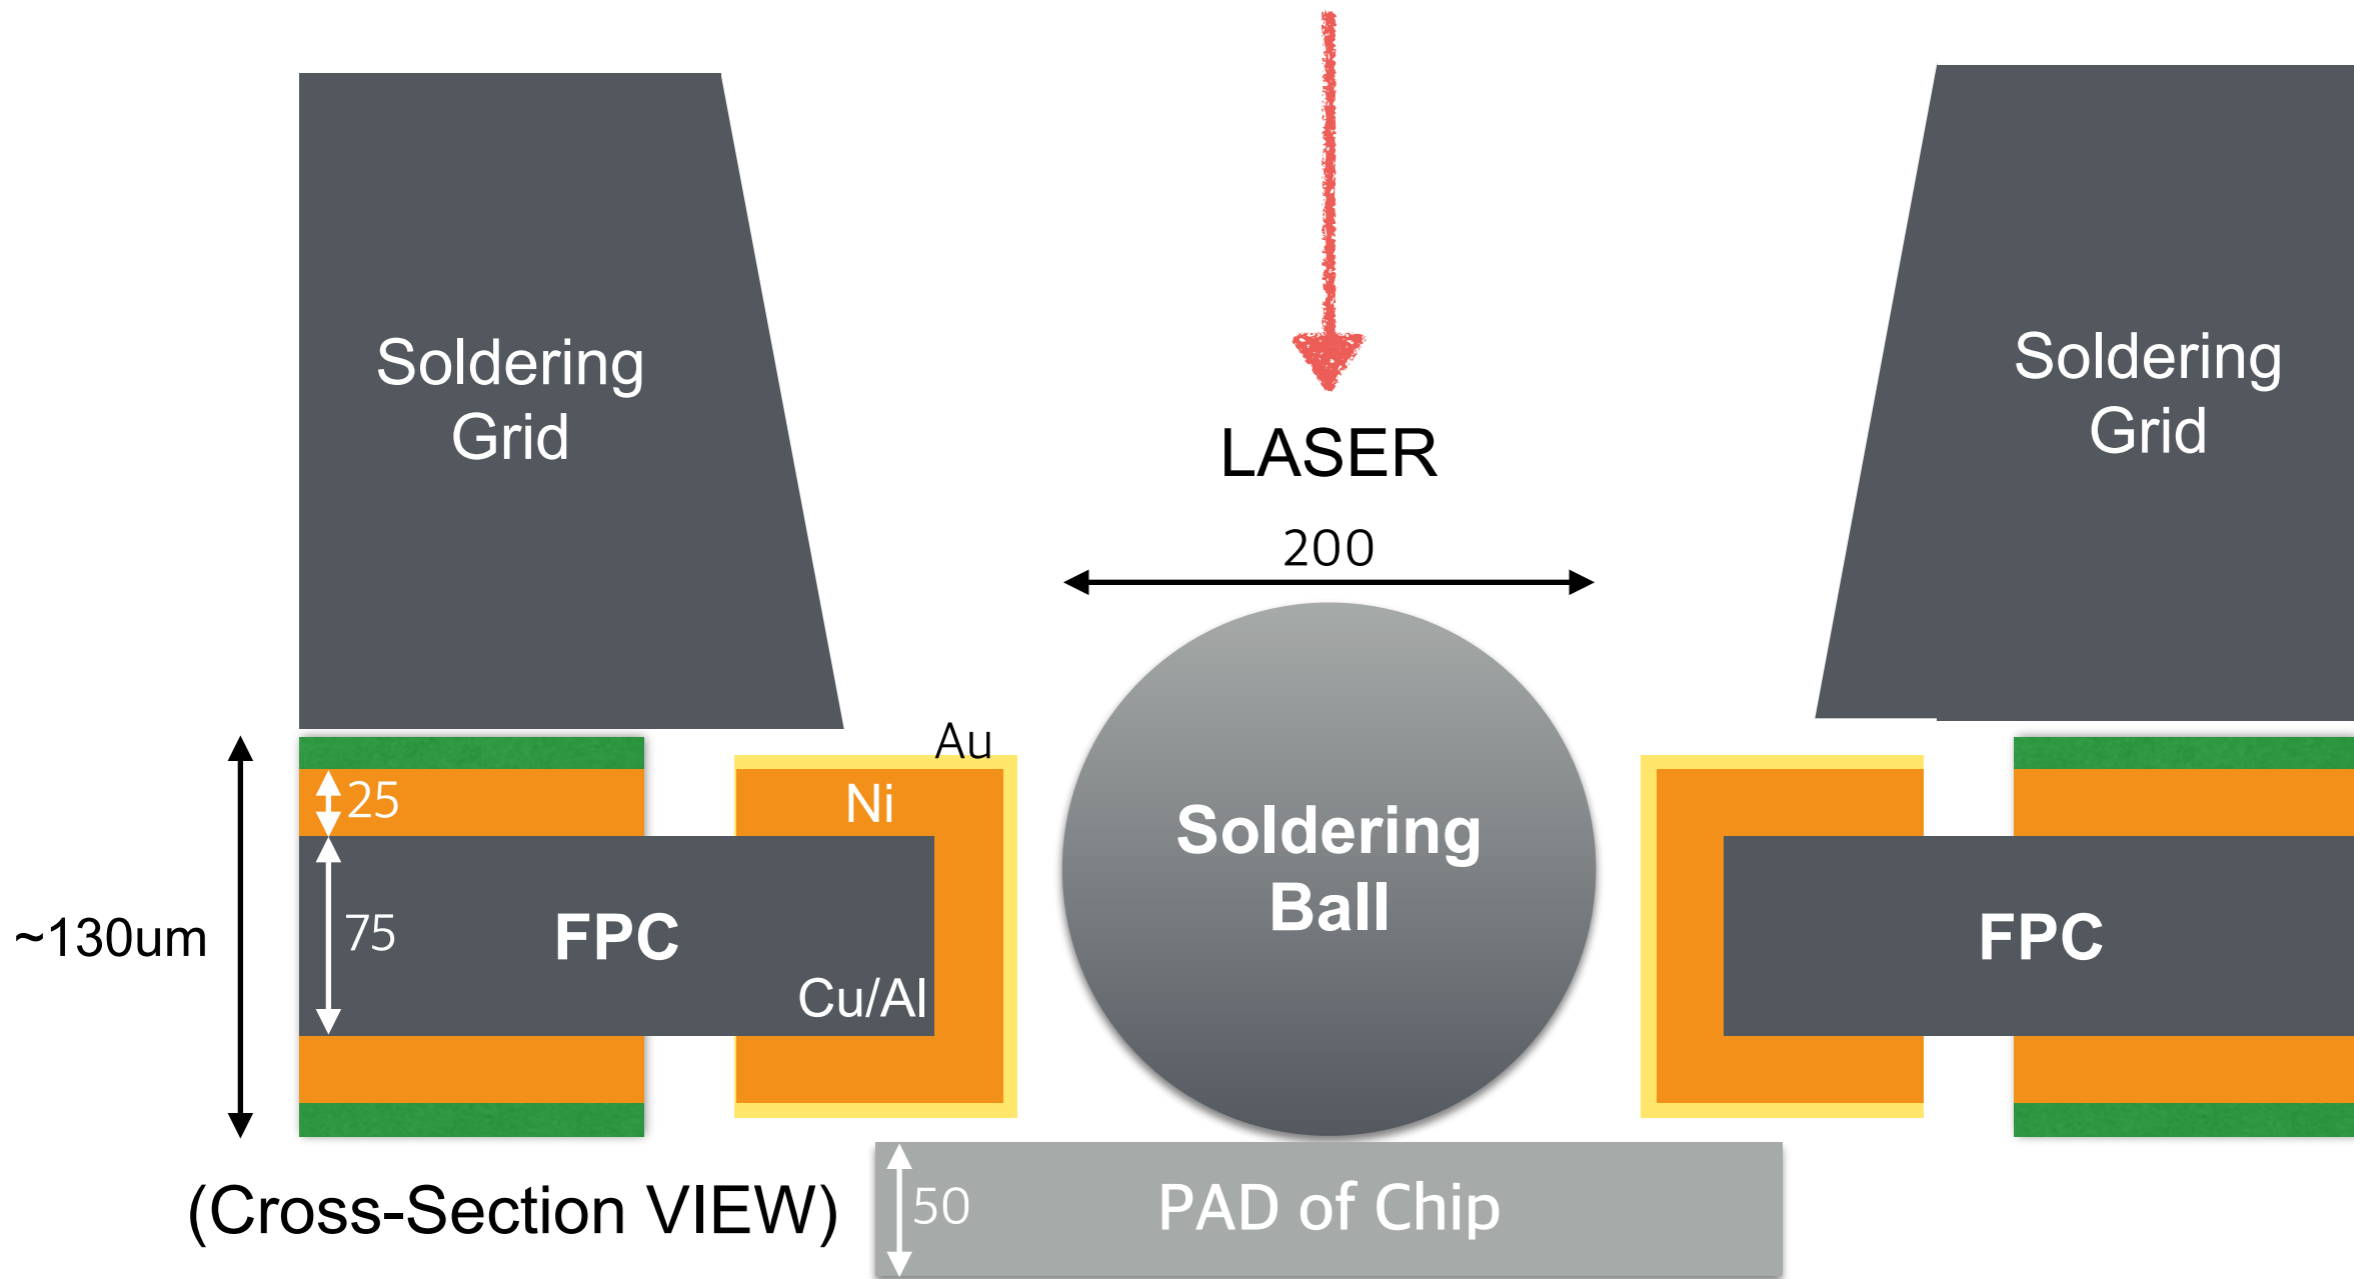
Cartoon of Cross-Section view

- Pixel chips are soldered to FPC by Laser soldering technique
- It can avoid thermal stress on the full HIC Structure
 - The hit is only generated in the small local area of the size of connection pad
