First Performance Results of the ALICE TPC RCU2

Chengxin Zhao

The ALICE TPC Readout electronics

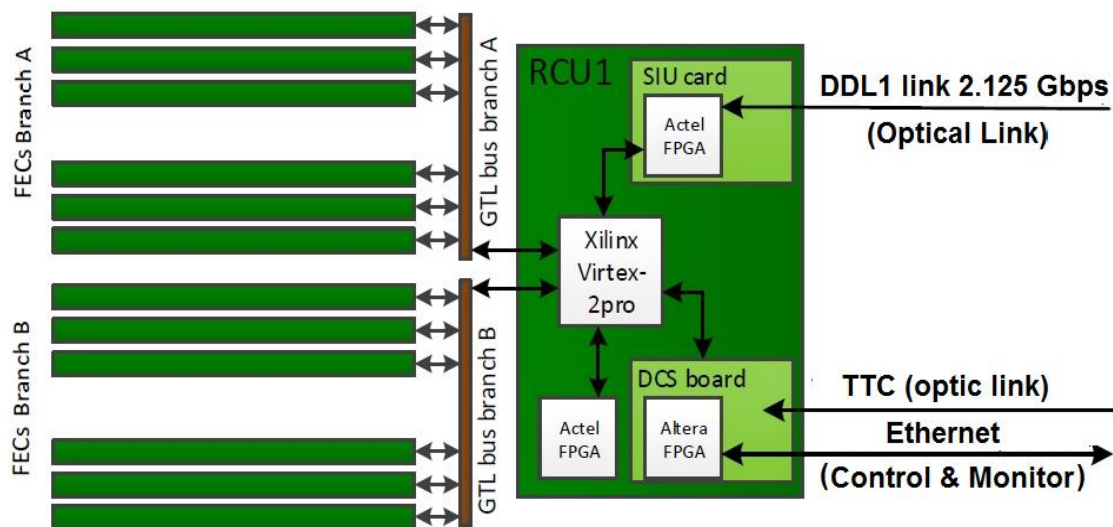
RUC1 readout electronics sketch

- Two branches → Four branches
- Detector Data Link (DDL) with higher bandwidth:
 - DDL1@2.125Gbps → DDL2@4.25Gbps
- 3 PCB boards → 1 PCB board
- Four FPGAs → One FPGA:
 - Two Flash based FPGAs and two SRAM based FPGAs in RCU1
 - Microsemi Smartfusion2 Flash based FPGA in RCU2
- Detector pad row based readout scheme
 - Utilize the parallelism of RCU2 hardware structure

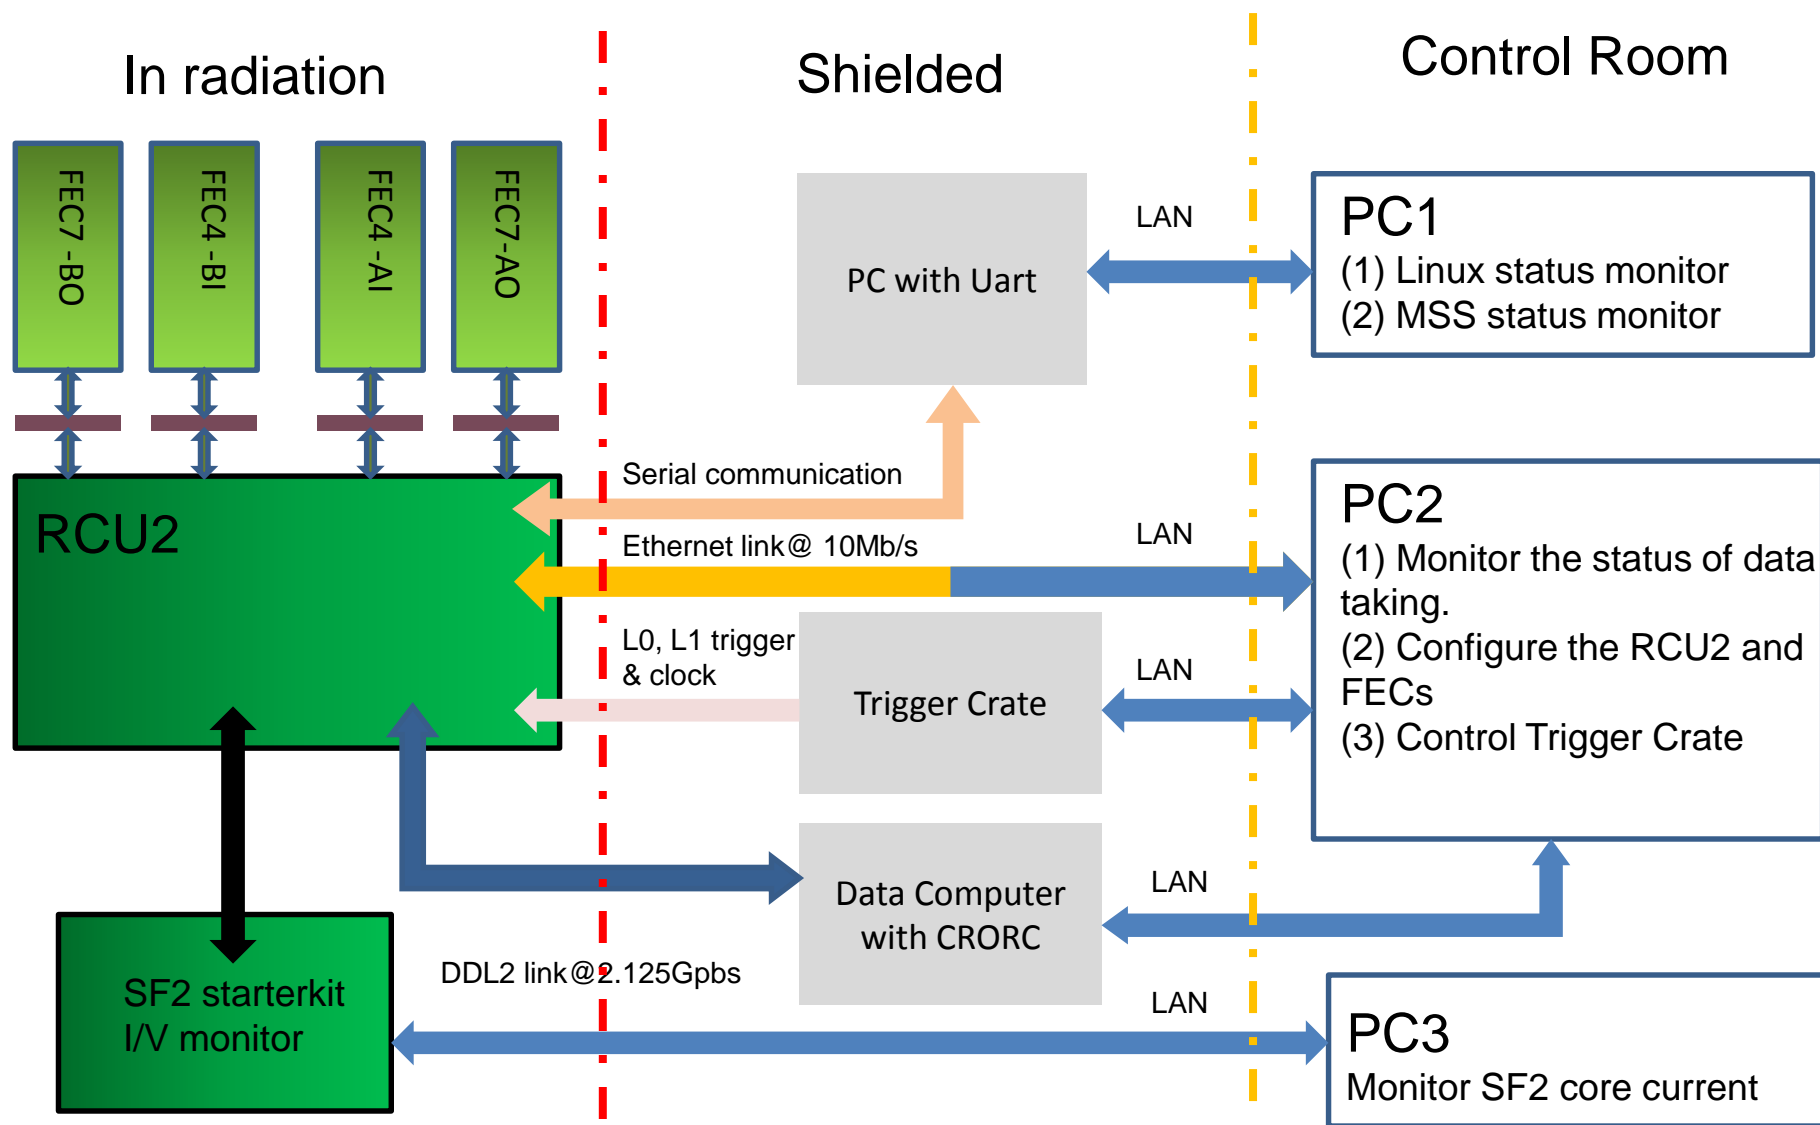
Irradiation Test Setup I

- System Irradiation Campaign @ TSL Uppsala
 - 170 MeV Protons
 - 28 – 29 April 2015
 - Irradiation test of the RCU2 with all surrounding systems (Trigger, DCS & DAQ) in place.
- The focus in this presentation are:
 - Readout stability
 - Linux system Stability
 - Trigger Interface stability
 - Ethernet stability
- The test results are presented as follows:
 - Cross Section for the different tests have been calculated
 - **Mean Time Between Failure (MTBF)** for LHC RUN2 has been calculated, assuming (**Worst Case**):
 - >20MeV Hadrons: 3.0 kHz/cm² *
 - 216 RCUs
 - 4356 FECs

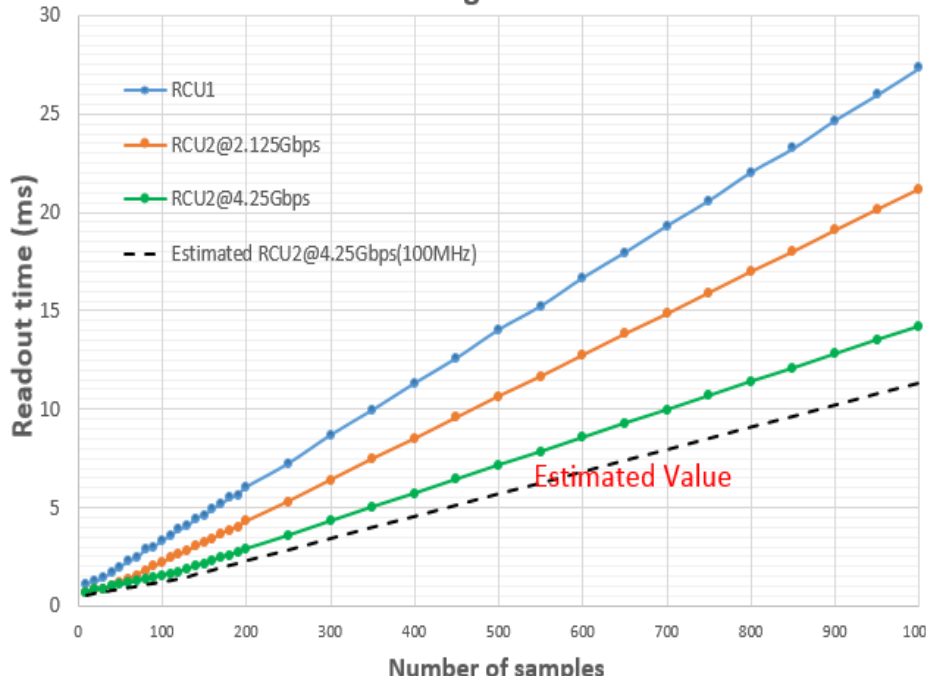
Readout time of single event RCU1 vs RCU2

- One full readout partition with 25 FECs used for test
- DDL link@2.125Gbps
 - DDL link saturated from number of samples set to be ~ 50
- DDL link@4.25Gbps
 - Readout Unit@80MHz \rightarrow Speed improved with a factor of ~ 2
 - Readout Unit@100MHz \rightarrow Speed will be improved with a factor of ~ 2.6

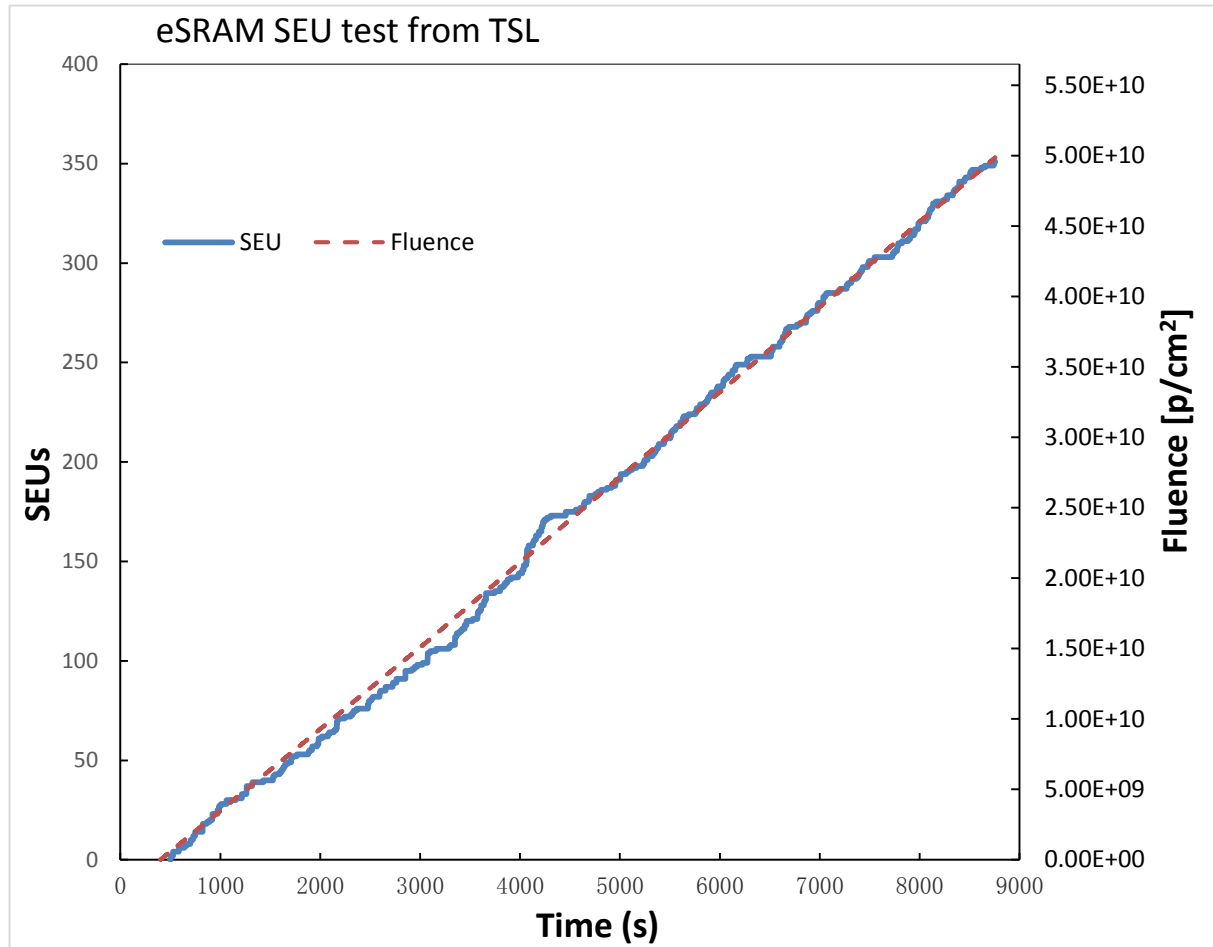
- **Smartfusion2 MSS has two eSRAM memories**

- size of each of is 256 Kbits
- SECDDED can be enabled/disabled manually

- **Test were performed on eSRAM_1:**

- Write a pattern to all eSRAM_1 locations.
- SECDDED mechanism stores the number of 1-bit and 2-bit errors into the error counter registers.
- Read the register of error counter every second.

SF2 eSRAM (single eSRAM per RCU2)
Cross section [cm ² /bit]	2.70E-14 ± 5% (352 errors)
Mean Time Between SEUs in RUN2	219 ± 11 seconds
