LS1 start-up experience

B.Mikulec and J.L. Sanchez Alvarez

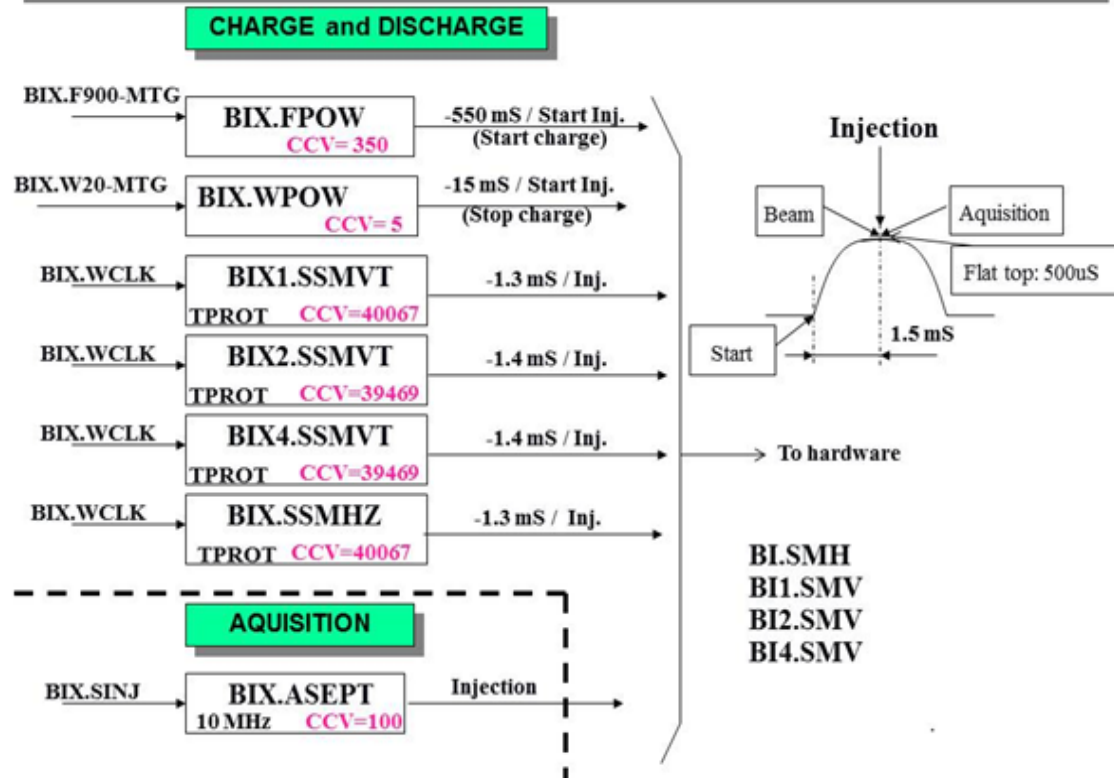
TIMING INJECTION SEPTA: BI1,2,4.SMV & BI.SMH

Trig-Acquisition	BIX.ASEPT	c:275
Trig-Warning	BIX.WPOW	C:260
Trig-Forwarning	BIX.FPOW	C:-275

Devices	Min	Max	Ref	Knobs	PPM	Trig-Start	Timing	Laser	OASIS	Signal
BI.SMH	2000	3500	3118			BIX.SSMHZ	C:273.7		BI.SMH1L1-AS	
BI1.SMV	10000	20000	17790			BIX1.SSMVT	C:273.7		BI1.SMV-AS	
BI2.SMV	10000	17000	14220			BIX2.SSMVT	C:273.6		BI2.SMV-AS	
BI4.SMV	10000	17000	14140			BIX4.SSMVT	C:273.6		BI4.SMV-AS
