BCT's for beam protection

L. Søby

Outline

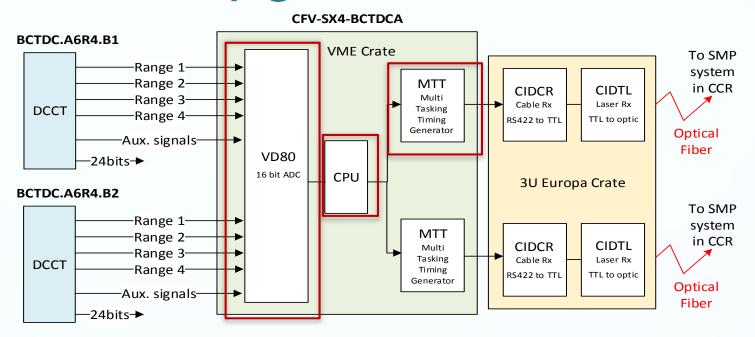
DCCT upgrades and status

- New CPU and FESA class
- New ADC: VD80
- MTT module driver update by BE-CO

- Fibers to CCR modified
- MPS changes on receiving end as well
- Good collaboration between, CO, MP, and BI to solve all issues.

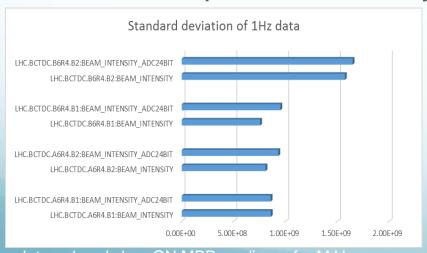
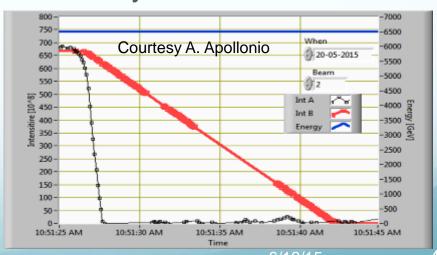
DCCT upgrades and status

- System B Beam 2 is twice more noisy than 3 other DCCTs. But still within 1% of one nominal bunch.
- P. Odier will try to improve during TS1.
- But only hysteresis can cure the problem of flickering of the SBF.
- M. Ludwig increased averaging from 1s to e.g.16s from 500GeV, implemented. Only active on system B B2.

- System B2, 2 times more noisy, P. Odier will try to reduce.
- SBF: Not clear to BI why it goes unsafe at low intensity.
- Need diagnostics: SBF, mode, received intensity.
- SBF SIL level is low: Scaling factors, offsets
- For new system: specifications are needed.

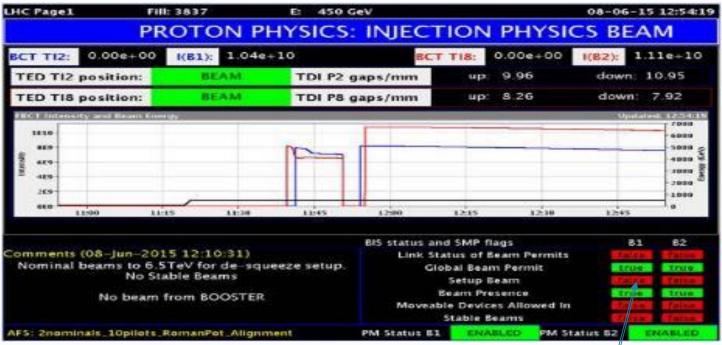
DCCT SBF

- System operational
- SBF "false" has on some occasions created beam dumps, even though intensity was safe.
- Status on VISTAR "False" with low intensity, not clear to BI why.
- To diagnostic SBF errors, logging in Timber (SBF, mode (e.g. forced), intensity.) is a must. This is a request ©

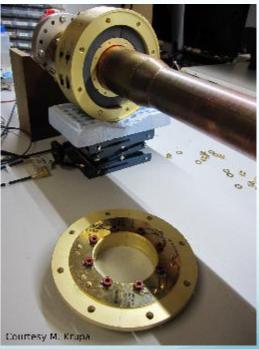
- 4 units installed during LS1
- Bunch and orbit clock, energy from BST fiber
- CIBU links commissioned
- Operational system (A)
- Development system (B)
 - ICT, Beam1 and BCTW, Beam2
- New stable firmware
- Realistic thresholds set to since 8/6-2015
- New FESA class, still not 100% operational
 - Data analysis and logging in Timber
 - QT based Python scripts used to evaluate performance
