TOTEM Interlock Revalidation

MPP Meeting 19 June 2015

Movement System Architecture (strongly simplified)

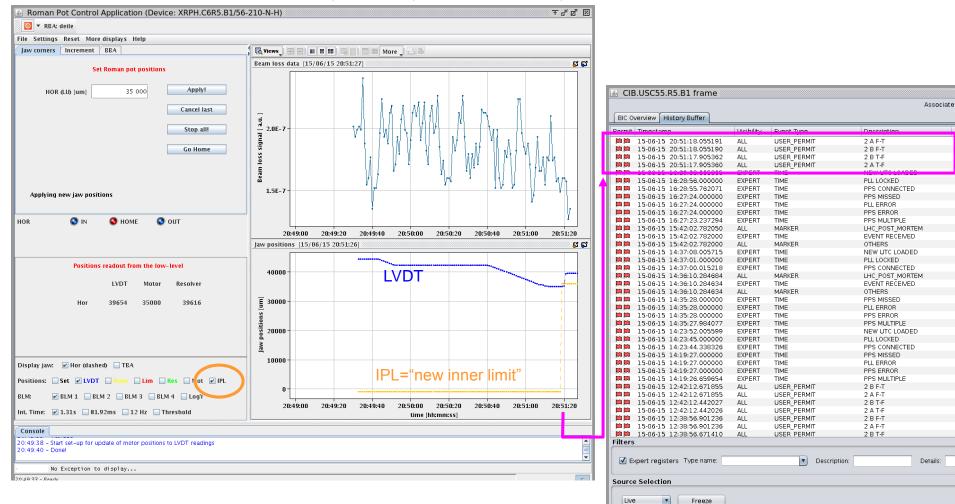
Illustration

- Beam-mode dependent tests not redone (They concern the logic in the hardware "interlock box"; not touched)
- Retested:
 - Correct transmission of all position limits to the interlock PXI and read-back to the CCC collimator application
 - Correct system reaction to violations of the limits (RP retraction for violation of warning limits, RP retraction + dump for violation of dump limits)

Done for all 26 RPs and for all inner limits:

- old inner warning
- old inner dump
- new inner dump

Outer limits: no operational meaning \rightarrow tested transmission for all pots, retraction and dump for a subset of pots

• Test of the automated operational sequence (reset, set limits, drive pots)
