# P-spray implant optimization for p-type microstrip detectors -Status of the RD50 calibration run-

#### <u>C. Fleta</u>, M. Lozano, G. Pellegrini, K. Vatter, F. Campabadal, J. M. Rafí and M. Ullán

Instituto de Microelectrónica de Barcelona IMB-CNM (CSIC) Spain

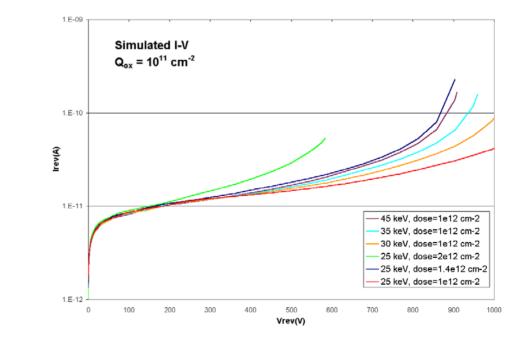
## Simulations: I-V

P-spray	B peak (cm <sup>-3</sup> )	B total (cm <sup>-2</sup> )	V <sub>BD</sub> (V)
Wafer 1	25 kev, 10 <sup>12</sup> cm <sup>-2</sup>	3.80×10 <sup>15</sup>	3.01×10 <sup>11</sup>	> 1000
Wafer 2	25 kev, 1.4×10 <sup>12</sup> cm <sup>-2</sup>	5.32×10 <sup>15</sup>	4.22×10 <sup>11</sup>	900
Wafer 3	25 kev, 2×10 <sup>12</sup> cm <sup>-2</sup>	7.59×10 <sup>15</sup>	6.02×10 <sup>11</sup>	580
Wafer 4	30 kev, 10 <sup>12</sup> cm <sup>-2</sup>	4.13×10 <sup>15</sup>	3.56×10 <sup>11</sup>	> 1000
Wafer 5	35 kev, 10 <sup>12</sup> cm <sup>-2</sup>	4.30×10 <sup>15</sup>	3.85×10 <sup>11</sup>	960
Wafer 6	45 kev, 10 <sup>12</sup> cm <sup>-2</sup>	4.44×10 <sup>15</sup>	4.09×10 <sup>11</sup>	910

V<sub>BD</sub> decreases as implanted dose increases

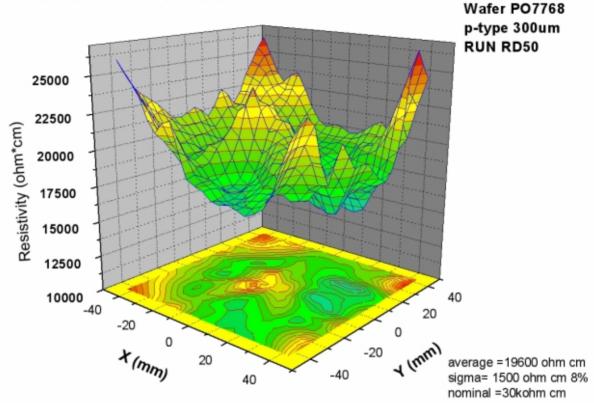
#### Wafer characteristics

- New wafers from Siltronic
- <100>, p-type, 300 ± 15 μm
- **D**  $\rho$  (nominal) = 30 kΩ.cm,  $\rho$  (measured) = 20 kΩ.cm

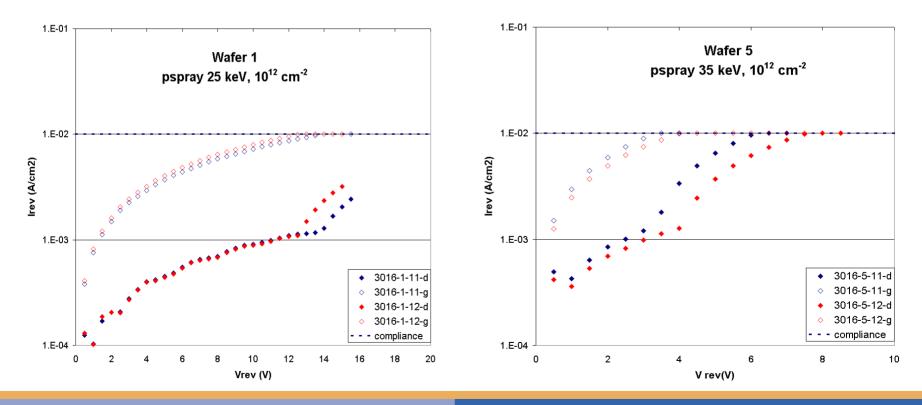
#### **Electrical characterization**

- Microstrips of wafers 1 to 5:
  - Very high leakage currents (mA/cm<sup>2</sup> @ 10 V)
  - Do not fulfill the requirements for radiation detectors

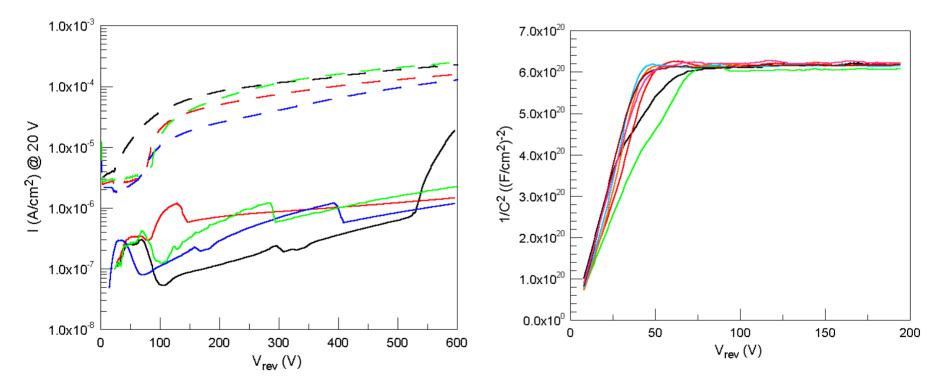
## **Electrical characterization**

- Wafer 6
  - Leakage current ~ μA/cm<sup>2</sup>
  - V<sub>BD</sub> > 600 V
  - $V_{FD} = 46 \pm 5 \text{ V} \rightarrow \rho = 17 \pm 2 \text{ k}\Omega.cm$

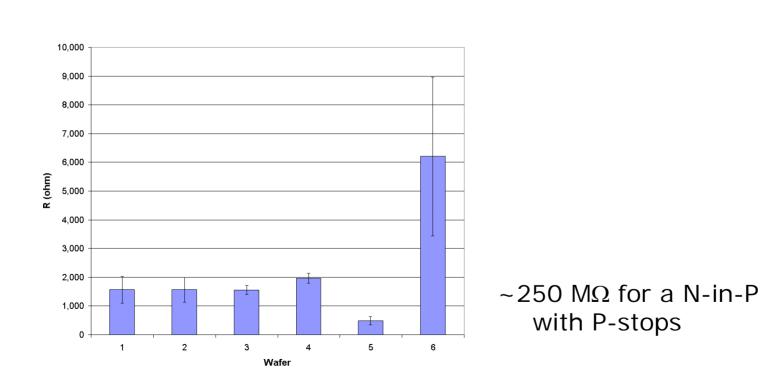
### **Electrical characterization**

- Verify strip insulation
  - Measurement of the resistance between two consecutive microstrips

Surface is clearly inverted

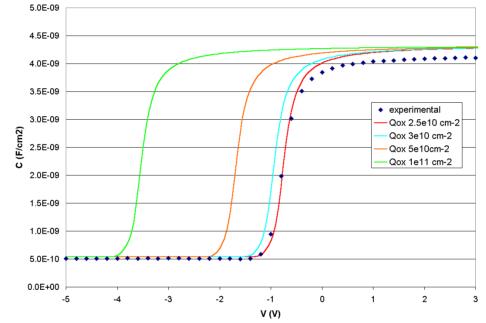
#### Oxide charge measurement

Simulated devices:  $Q_{ox} = 10^{11} \text{ cm}^{-2}$ . Overestimated oxide quality?

- C-V measured in test structure (MOS capacitor)
  - Agreement with the simulated curve for Q<sub>ox</sub> = 2.5x10<sup>10</sup> cm<sup>-2</sup>
  - Another reason for the bad electrical performance

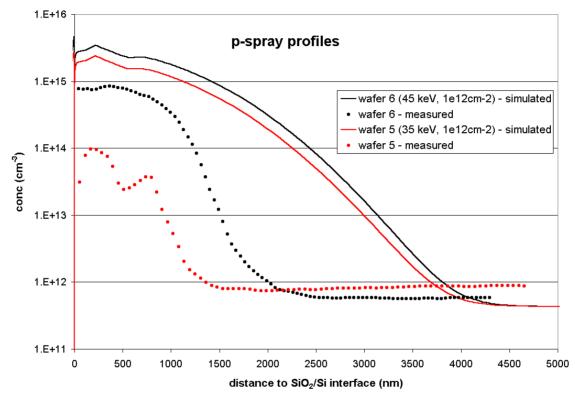
## Spreading resistance measurements

Total implanted dose lower than the predicted by simulations

- Wafer 6: 70% of the expected dose
- Wafer 5: 9%

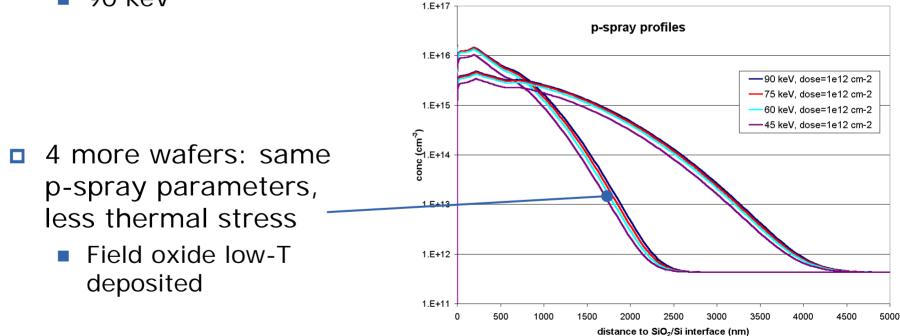
### Second calibration run

Higher implant energies with the lowest dose (10<sup>12</sup> cm<sup>-2</sup>)

- 45 keV (= wafer 6)
- 60 keV
- 75 keV
- 90 keV

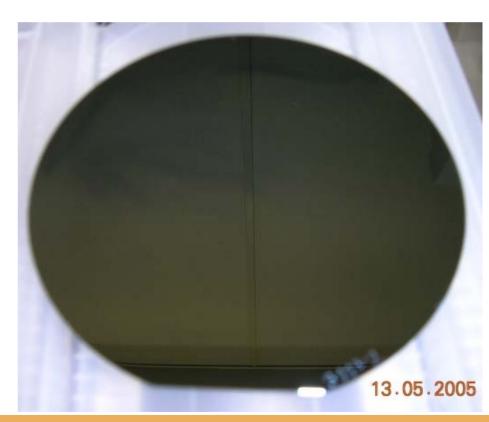
## Second calibration run

- Defective wafers from Siltronic
  - P-spray implant oxide thicker in some areas (irregular wafer surface)
  - Will affect the implant profile
- Could this be the reason for the bad results of the previous run?
  - Wafers from the same provider but a different batch
  - Did not detect anything unusual during the first process
