Have we been operating safely in 2015?

D. Wollmann, CERN/TE

6th Evian Workshop, 16.12.2015

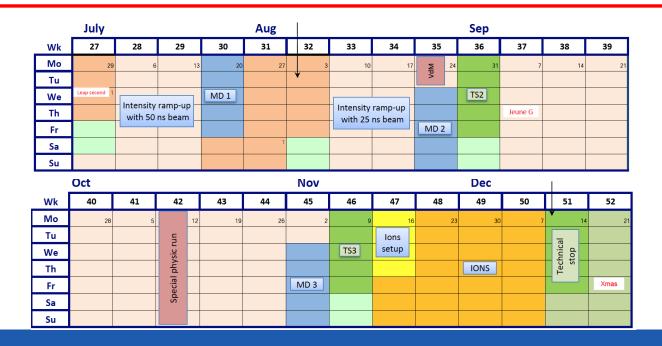
- 50ns up to 500b dominated by hardware and software issues in Machine Protection systems → debugging phase
- 25ns dominated by intensity and beam related issues.
- Careful check of each high energy beam dump and documentation in 17 intensity ramp-up check lists (<u>EDMS</u>).

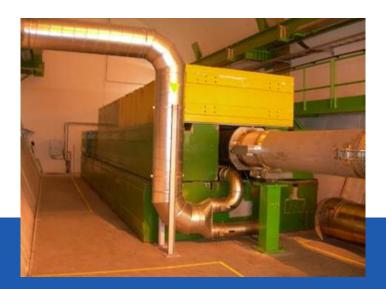
TDE N2 Leak

- TDE normally runs at 1.2 bar Nitrogen overpressure.
- Nitrogen leak on TDE B2. Fixed by tightening the flange after some days.
- Manometer on the **bottle was found closed**, causing initial pressure drop.
- The **only** 'interlock' is presently in the **XPOC**.
- The only **gauge is far away from the dump block**, on a long line. Gives the correct pressure in stable conditions...
 - To consider
 - Separate TDE N2 overpressure more clearly from other signals in XPOC.
 - Install a second, hardware interlock on the TDE pressure.
 - Consider a **second pressure gauge** on the TDE for complementary information.
 - Derive operational procedure and intensity limits in case of a leak in the TDE

- MKD compensation power converter trip during rampdown \rightarrow replaced.
- MKB(HA.B2) self trigger \rightarrow generator replaced.
- Leak in B2 TDE \rightarrow temporarily limiting intensity \rightarrow solved by tightening bolt in collor flange.
