Beam Loading Dog-leg experiment status

Frank Tecker (BE-OP)
on behalf of the dogleg team

- Introduction
- 2014 Data Analysis
- 2015 Spring Run
- 2015 Autumn Run
- Conclusion

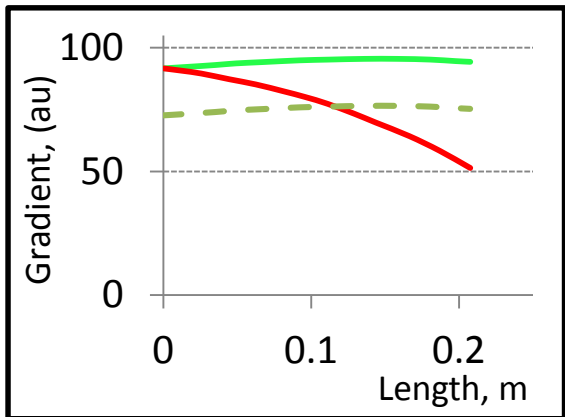
Constant input power

- Alternative: measure BDR for constant input power (when power limited)
=> BDR decreases?

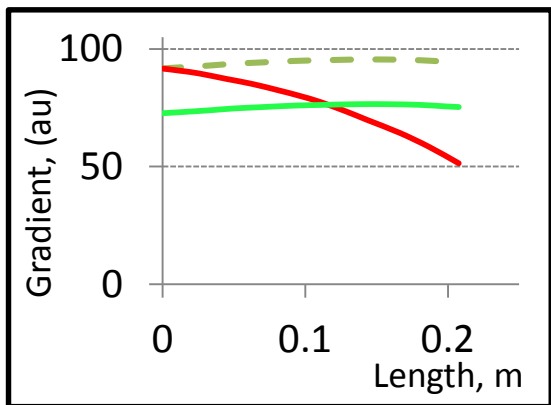
Constant average gradient

for the **same average gradient**

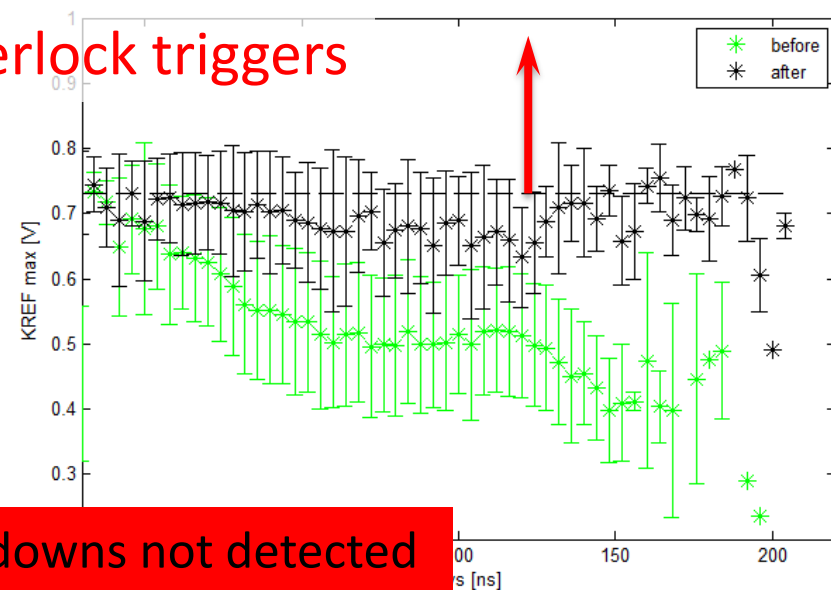
Interlock triggers

many Downstream Breakdowns not detected

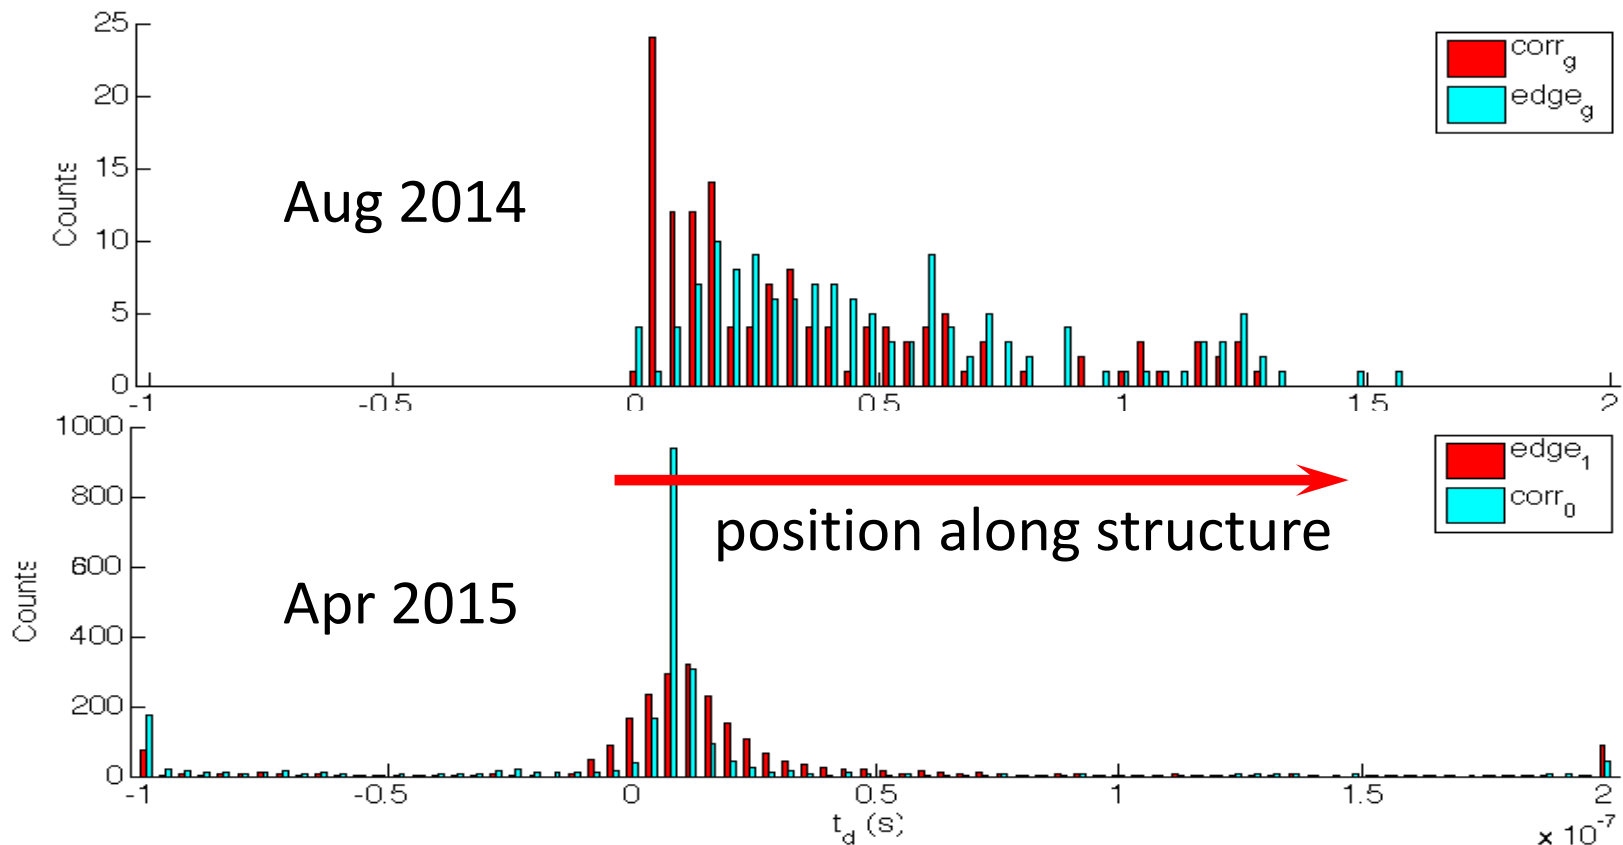
- Initially: breakdown distribution inside structure as expected 😊
- Later: breakdowns mostly detected at beginning of structure 😞
- => **hot spot** for breakdowns had developed there
- **structure unusable** for beam-loading experiment => changed

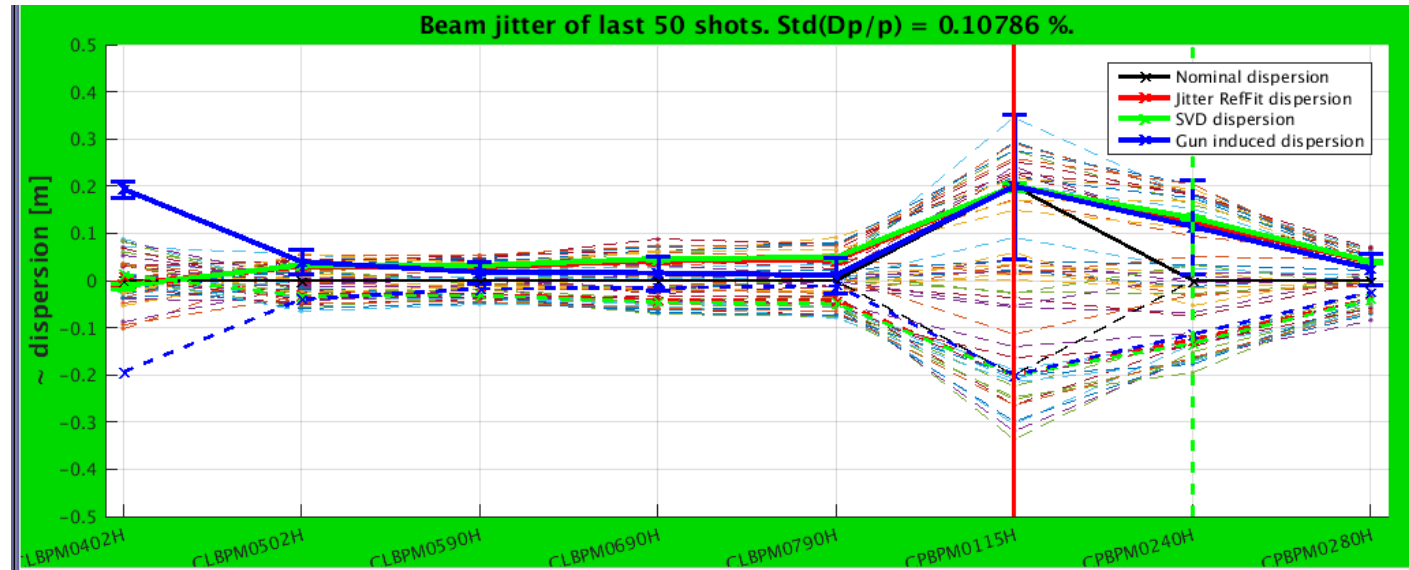
horizontal dispersion not fully closed

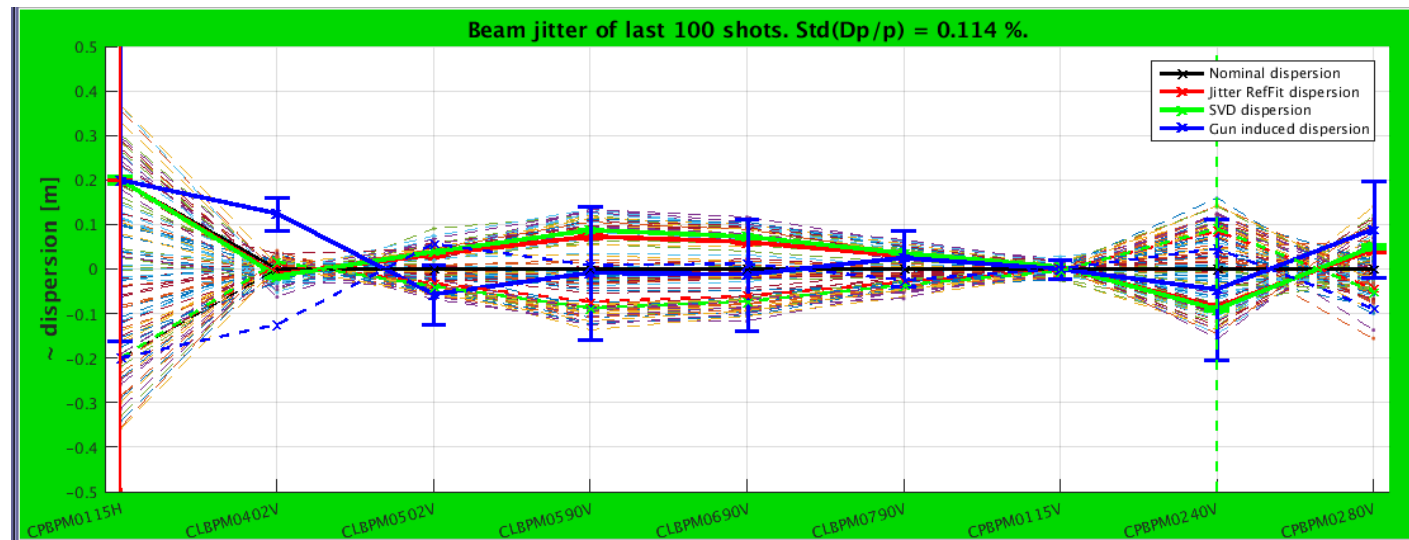
vertical dispersion can still be improved

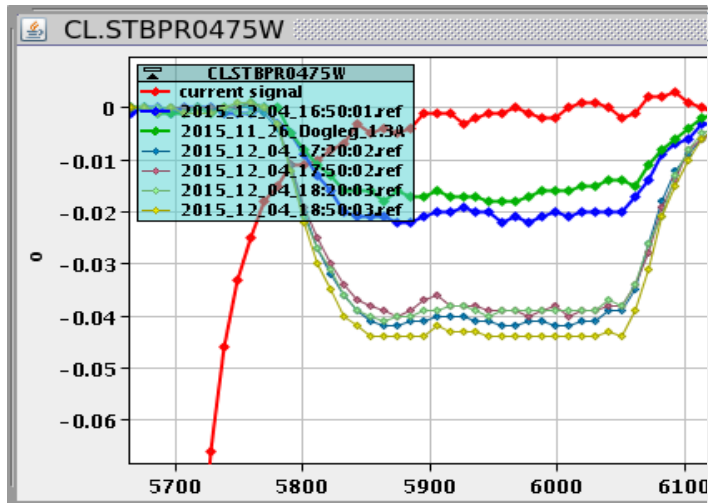
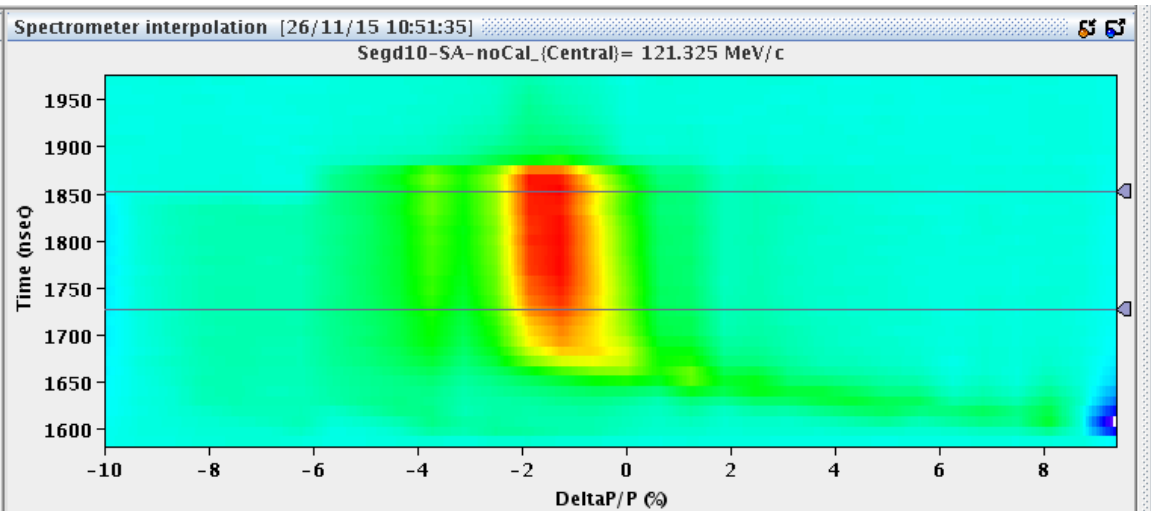
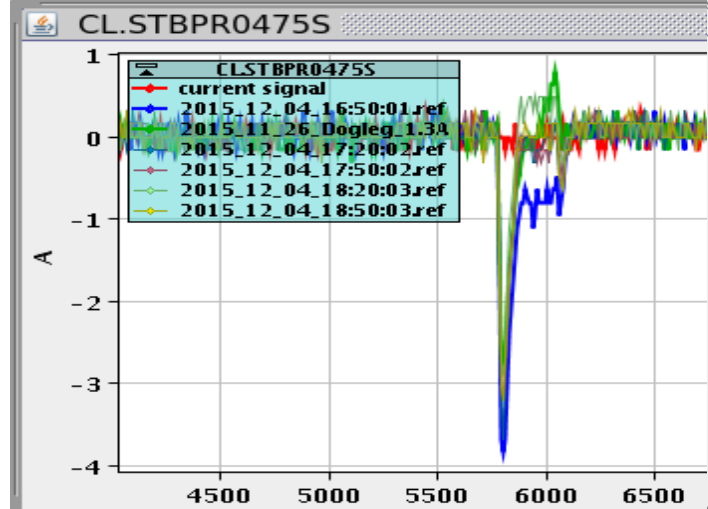
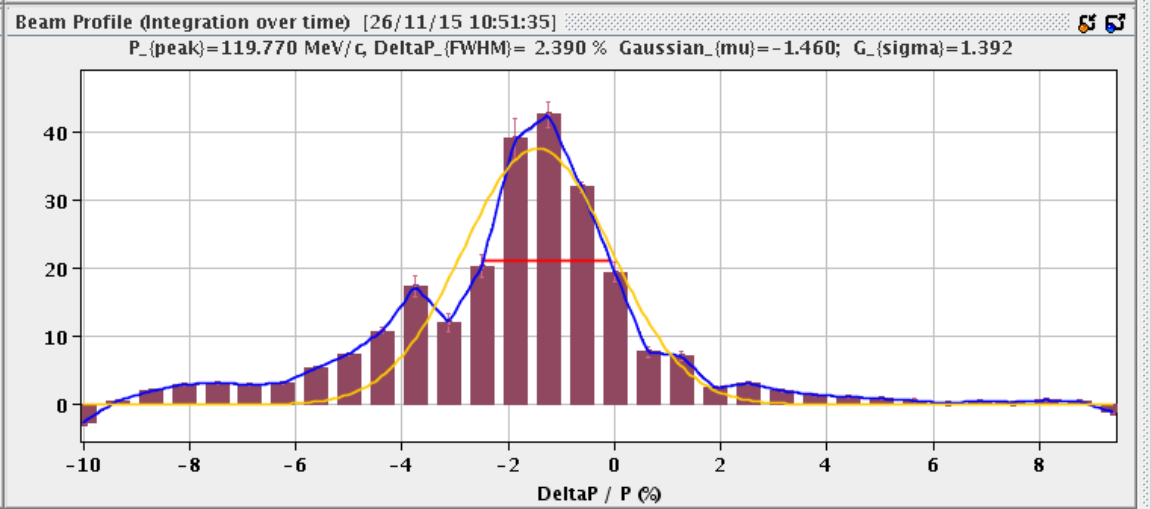
- BPR0475W (bunch length) + energy nicely flat along the pulse
- beam phase constant after transient

- Beam phase and RF phase have to match to assure constant loading along the pulse
- Beam and RF setup OK and output power matches expectations

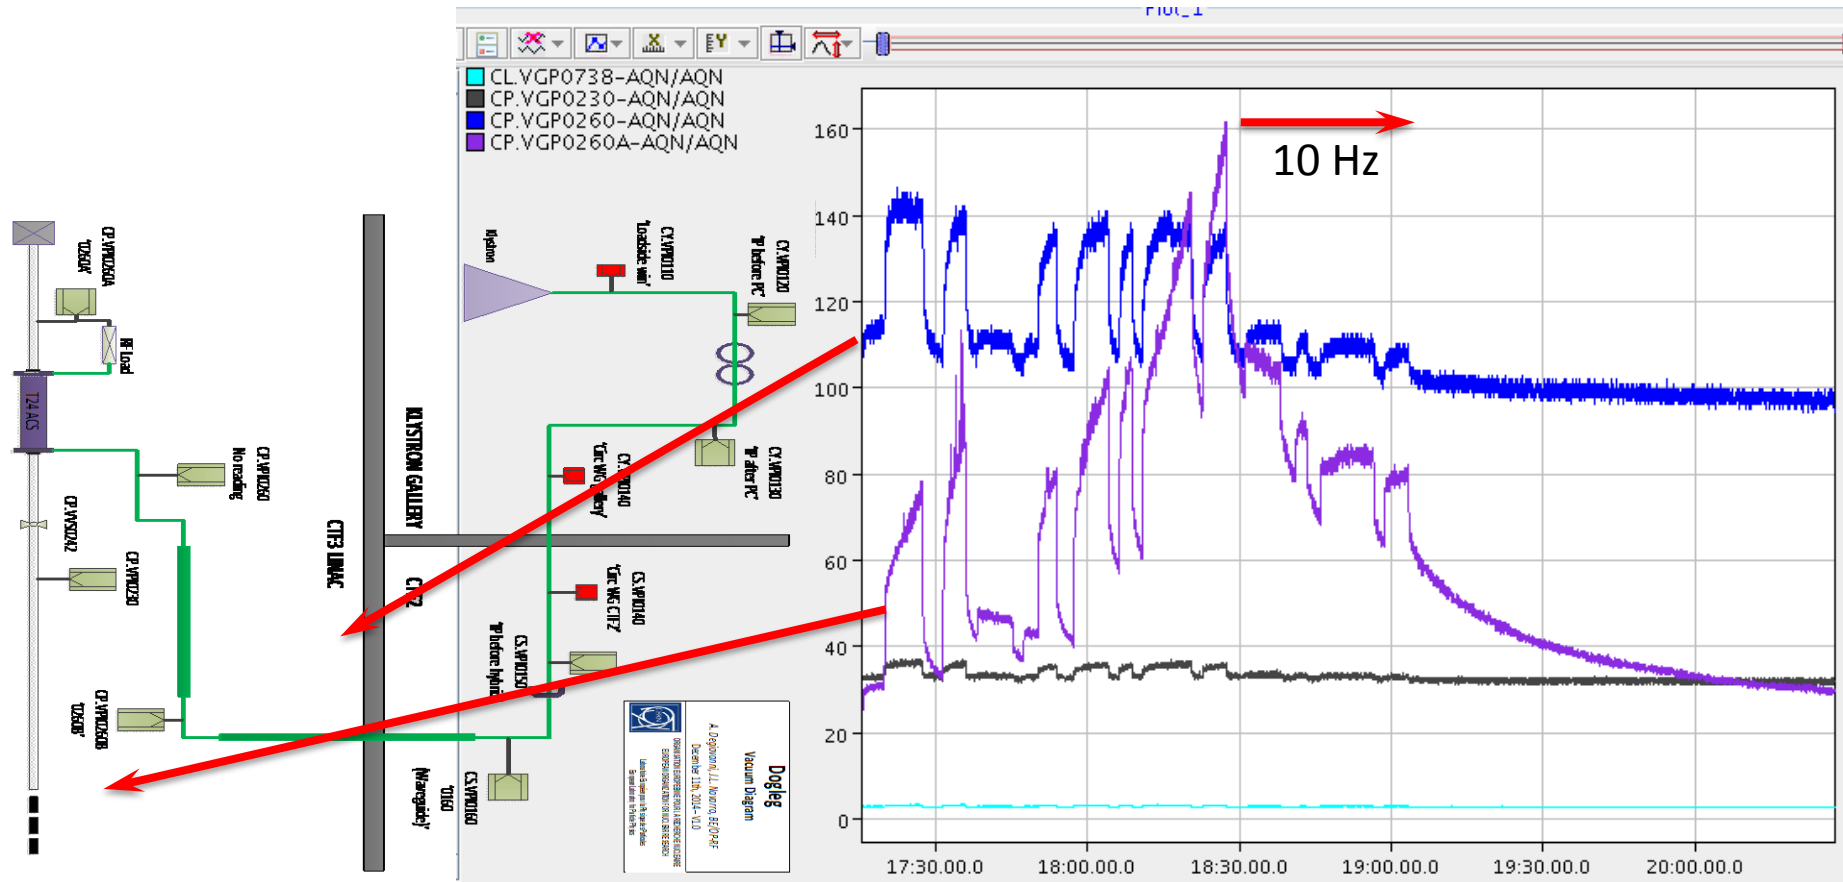
- Vacuum on dump side increased when going to 25 Hz beam frequency
- Stabilized at 10 Hz
- Losses limiting operation?

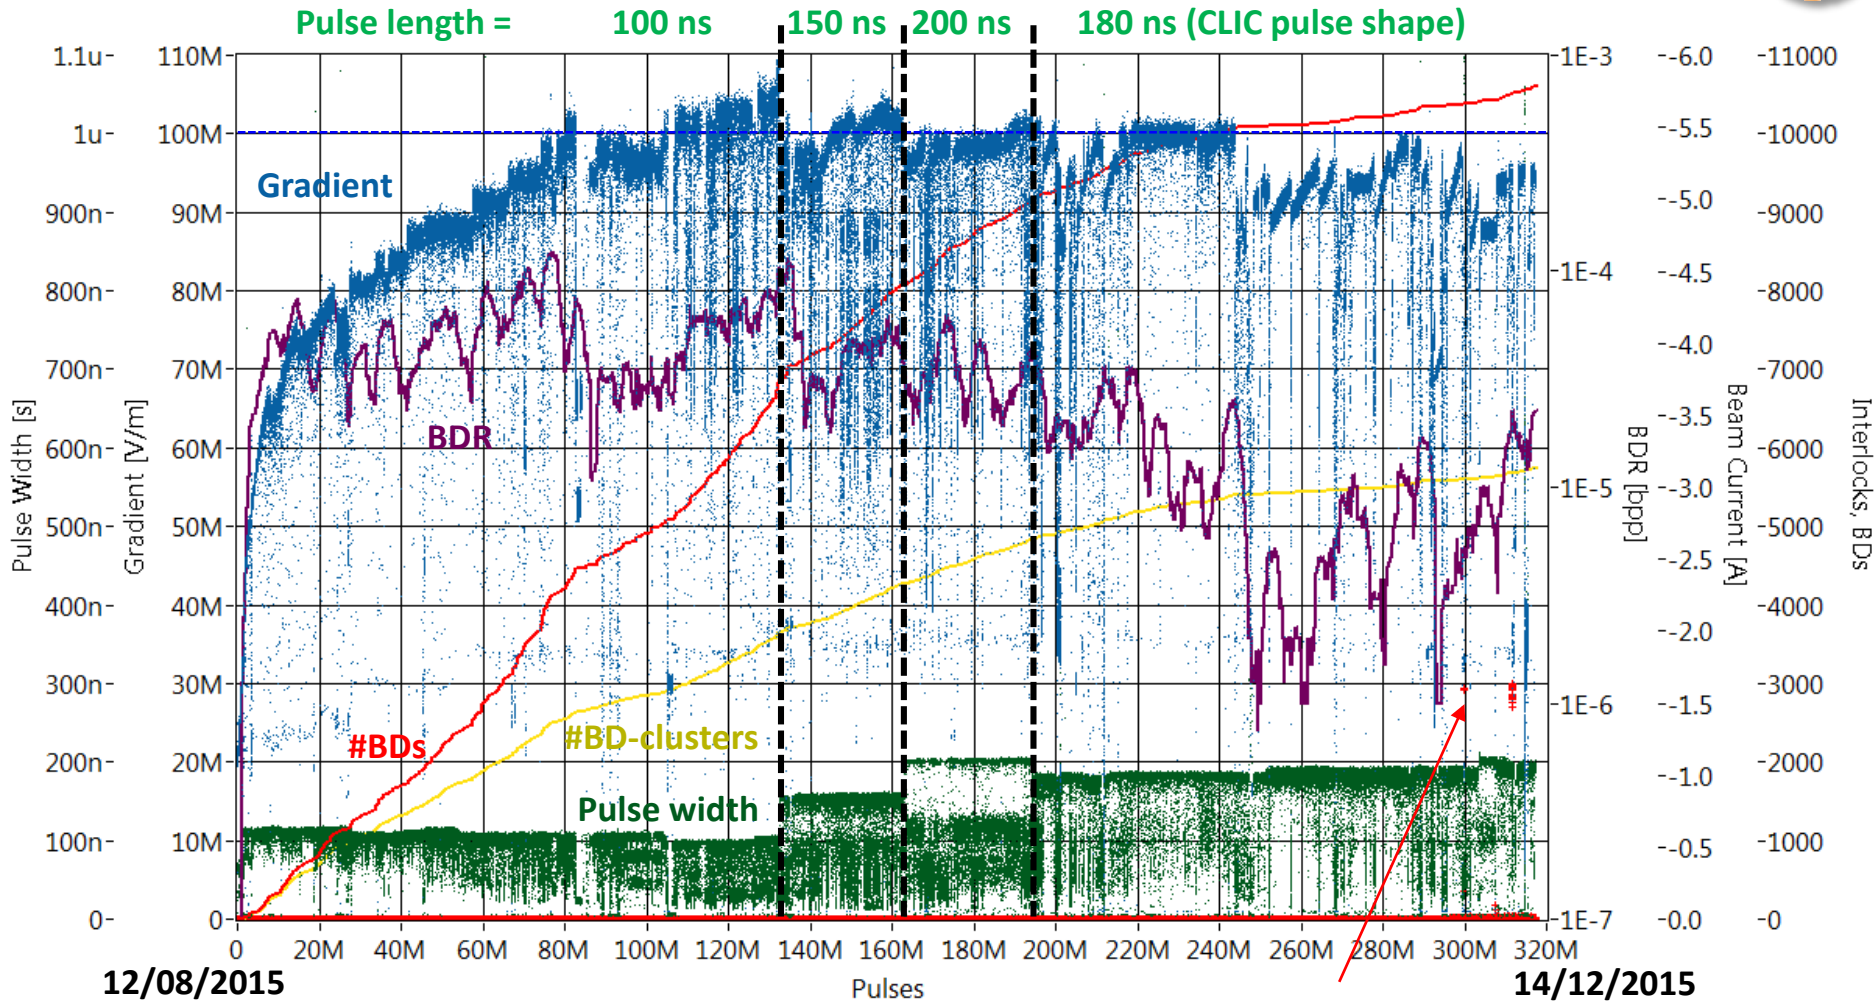
Full history of the TD26CC-N1 structure

# Pulses	317.2M	Equip hours	1762	Up-time	59.4 %
# BDs	10610	Cluster BDs	5743	Mean BDR	3.35E-5

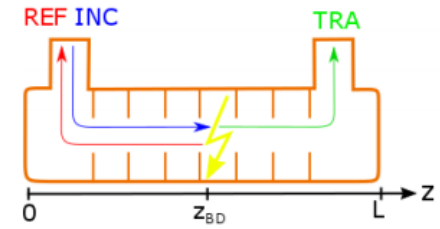
- Initially BD more at downstream end
- Later at the beginning
- Now uniformly distributed

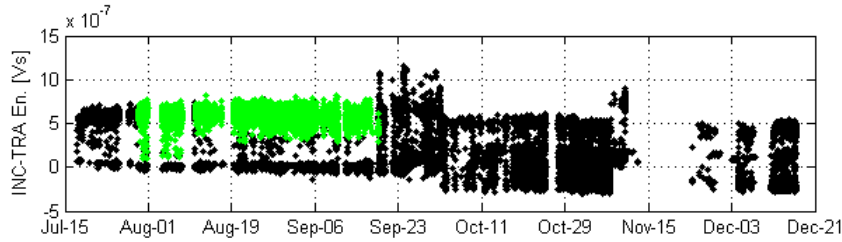
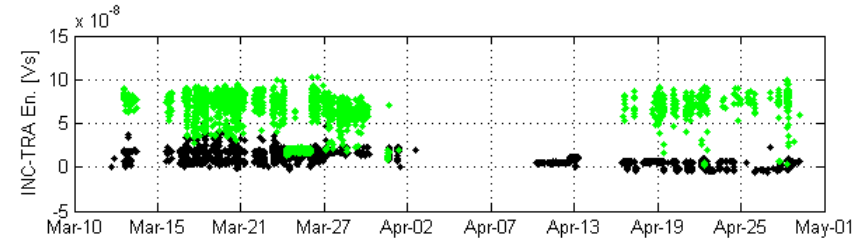
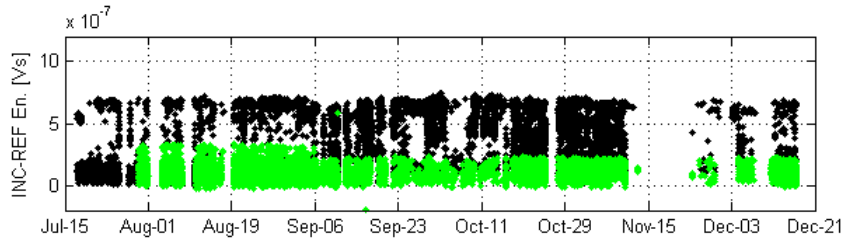
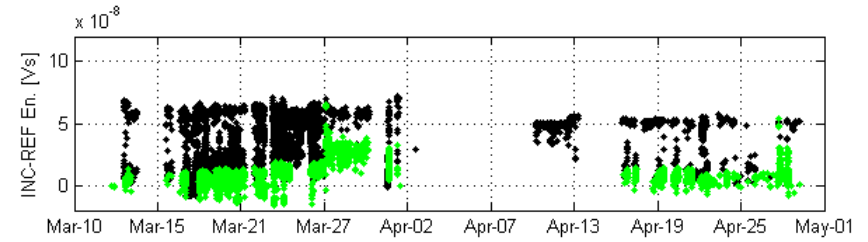
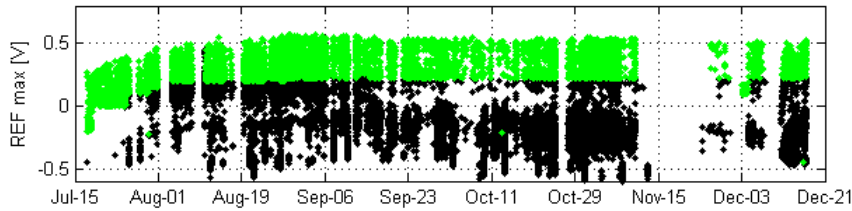
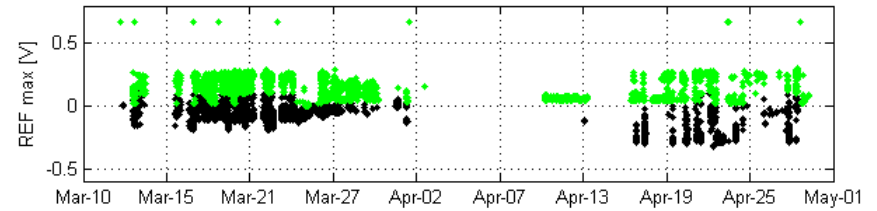
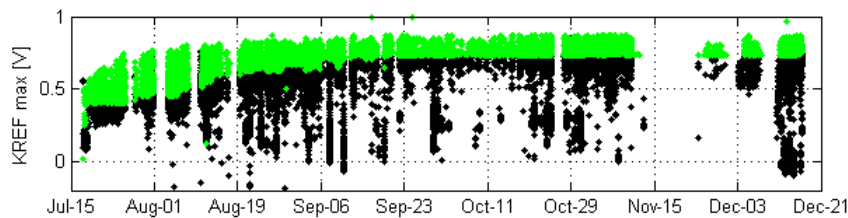
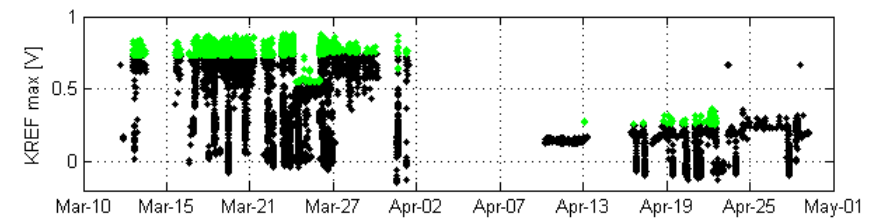
We did not observe an increase of breakdown rate with the beam but...

... the beam could have develop a hot-cell.

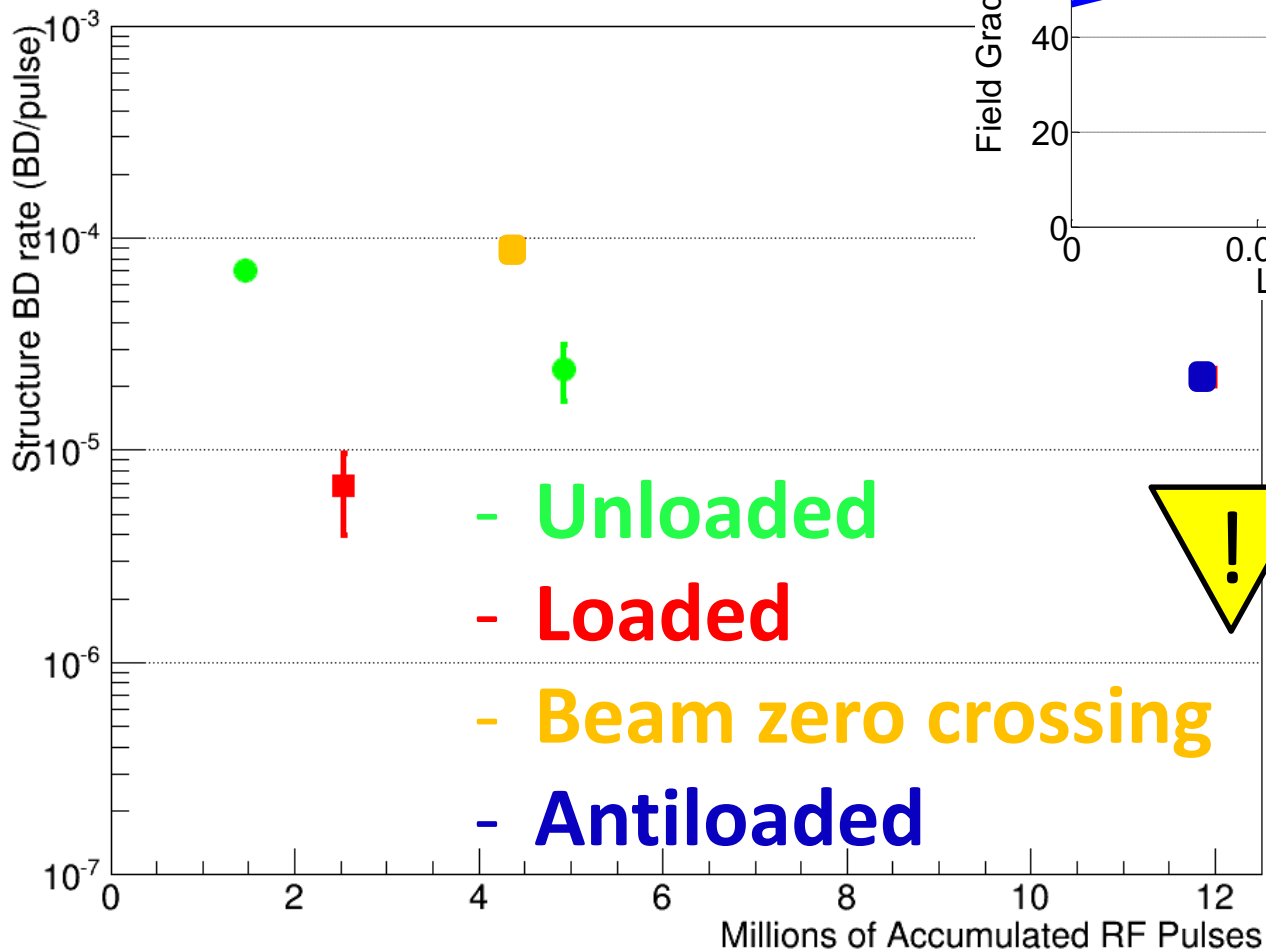
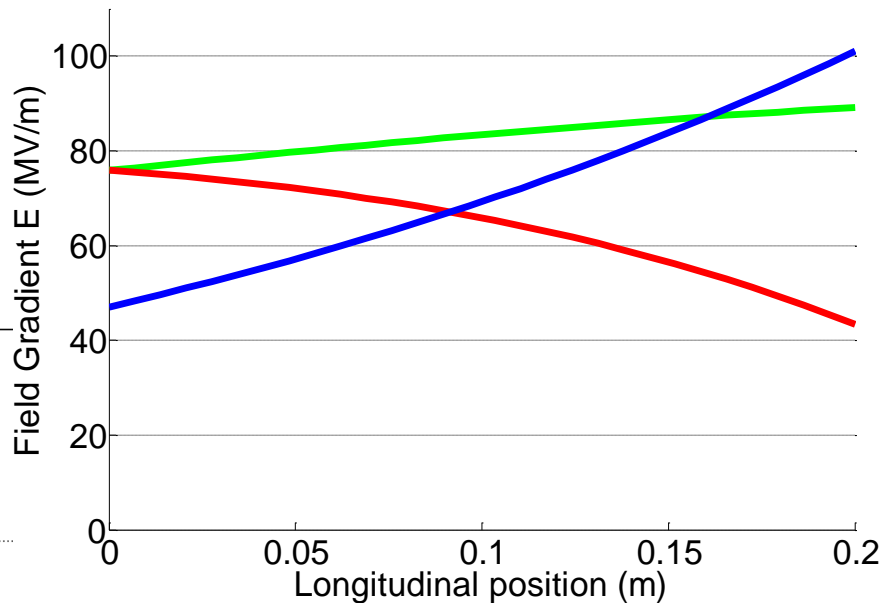
Only March and April data.

Error bars account only for statistical errors.
