Chamonix'09 - Session 8: What will we do for beam preparation in 2009

Magnet Circuits

Powering Tests of a S.C. Circuit

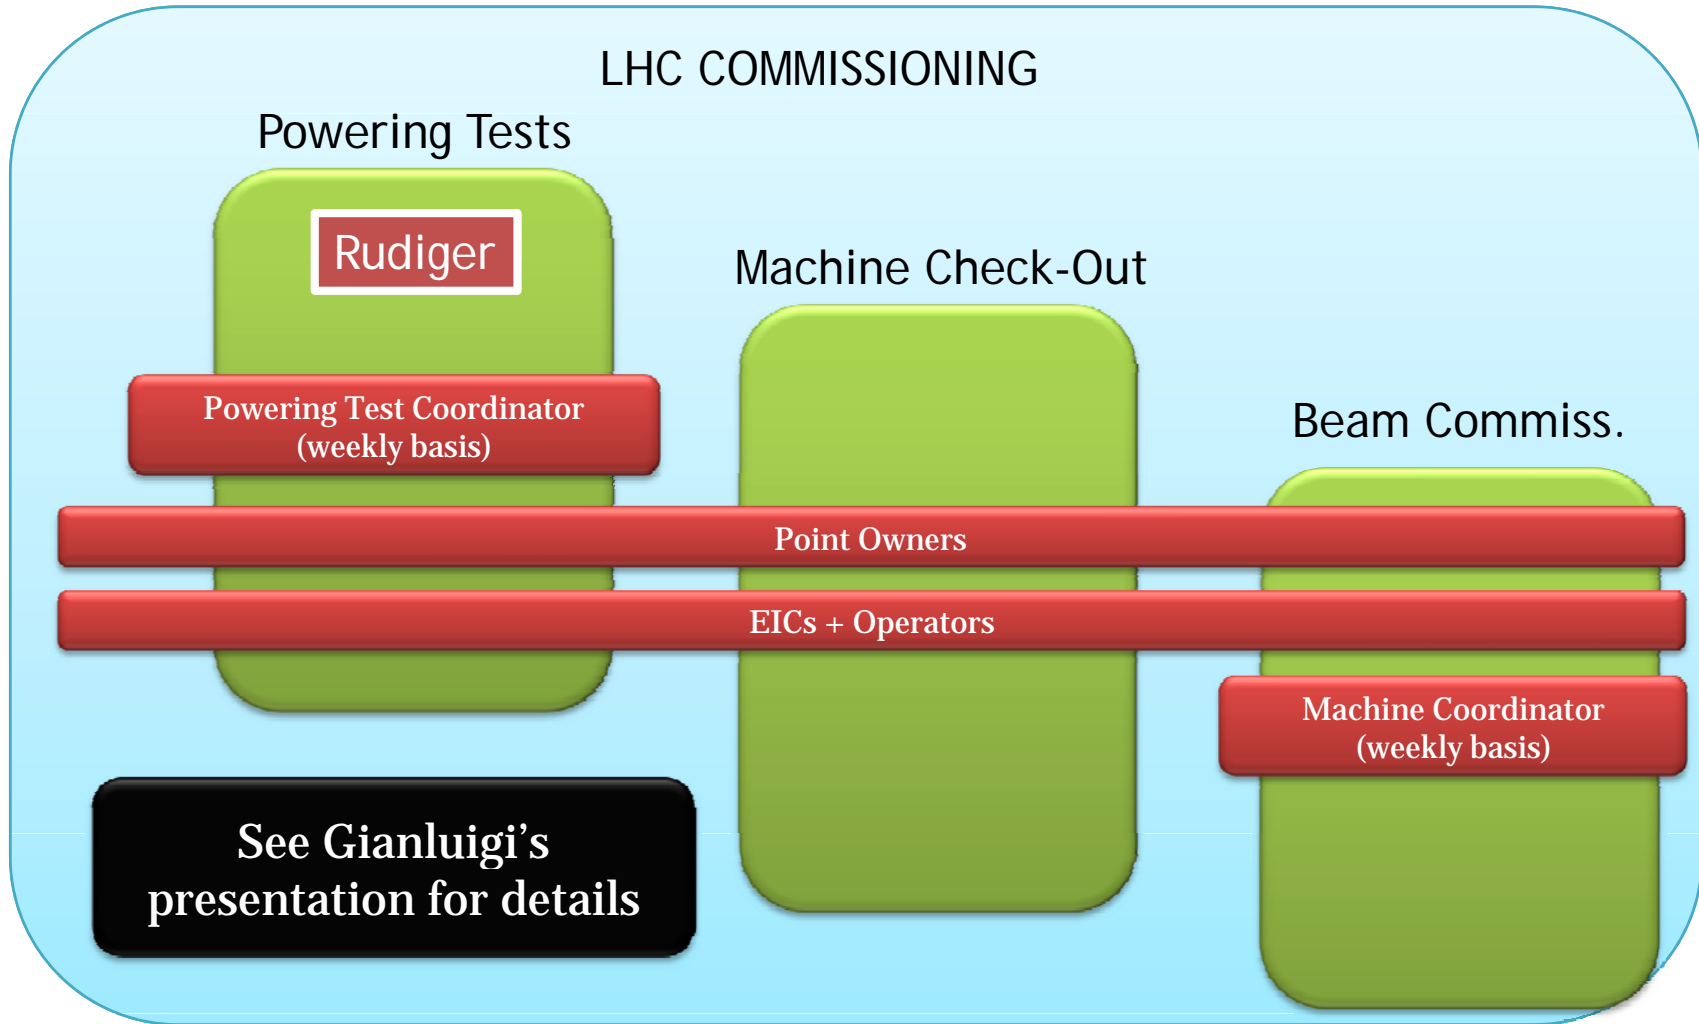
LHC Commissioning Integration

- Main differences:
 - Starting point is not the same
 - 2007: All sectors were warm, no circuit had been powered. 8 machines to commission from scratch.
 - 2009: Boundary conditions change between sectors
 - Most of the hardware has been already debugged
 - More restrictive access conditions
 - New hardware has been implemented (e.g. QPS upgrade)
 - Many people involved in the HC have left CERN
 - The HCC unit doesn't exist anymore. However, the team (Boris, Matteo, Mirko, & Antonio) is now within the OP group. This will allow us to keep the acquired know-how and at the same time integrate better the powering tests with the machine check-out and beam commissioning
