Readout board upgrade for the Pixel Detectors: reasons, status and results in ATLAS

EPS Conference on High Energy Physics
Venice, Italy 5-12 July 2017

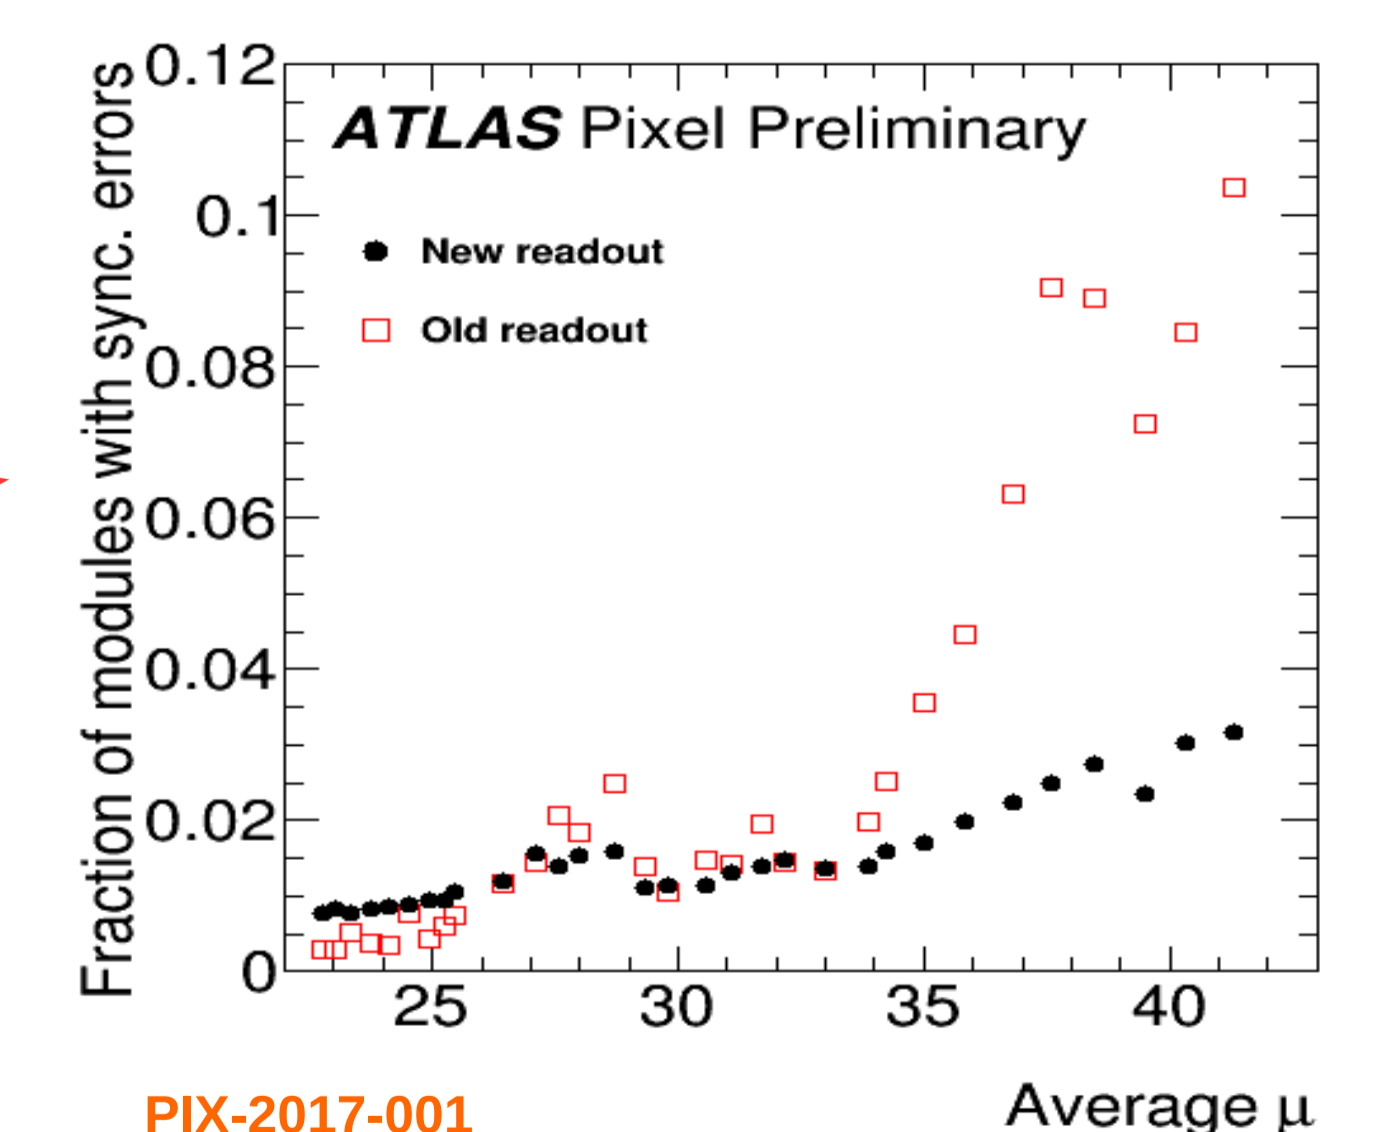
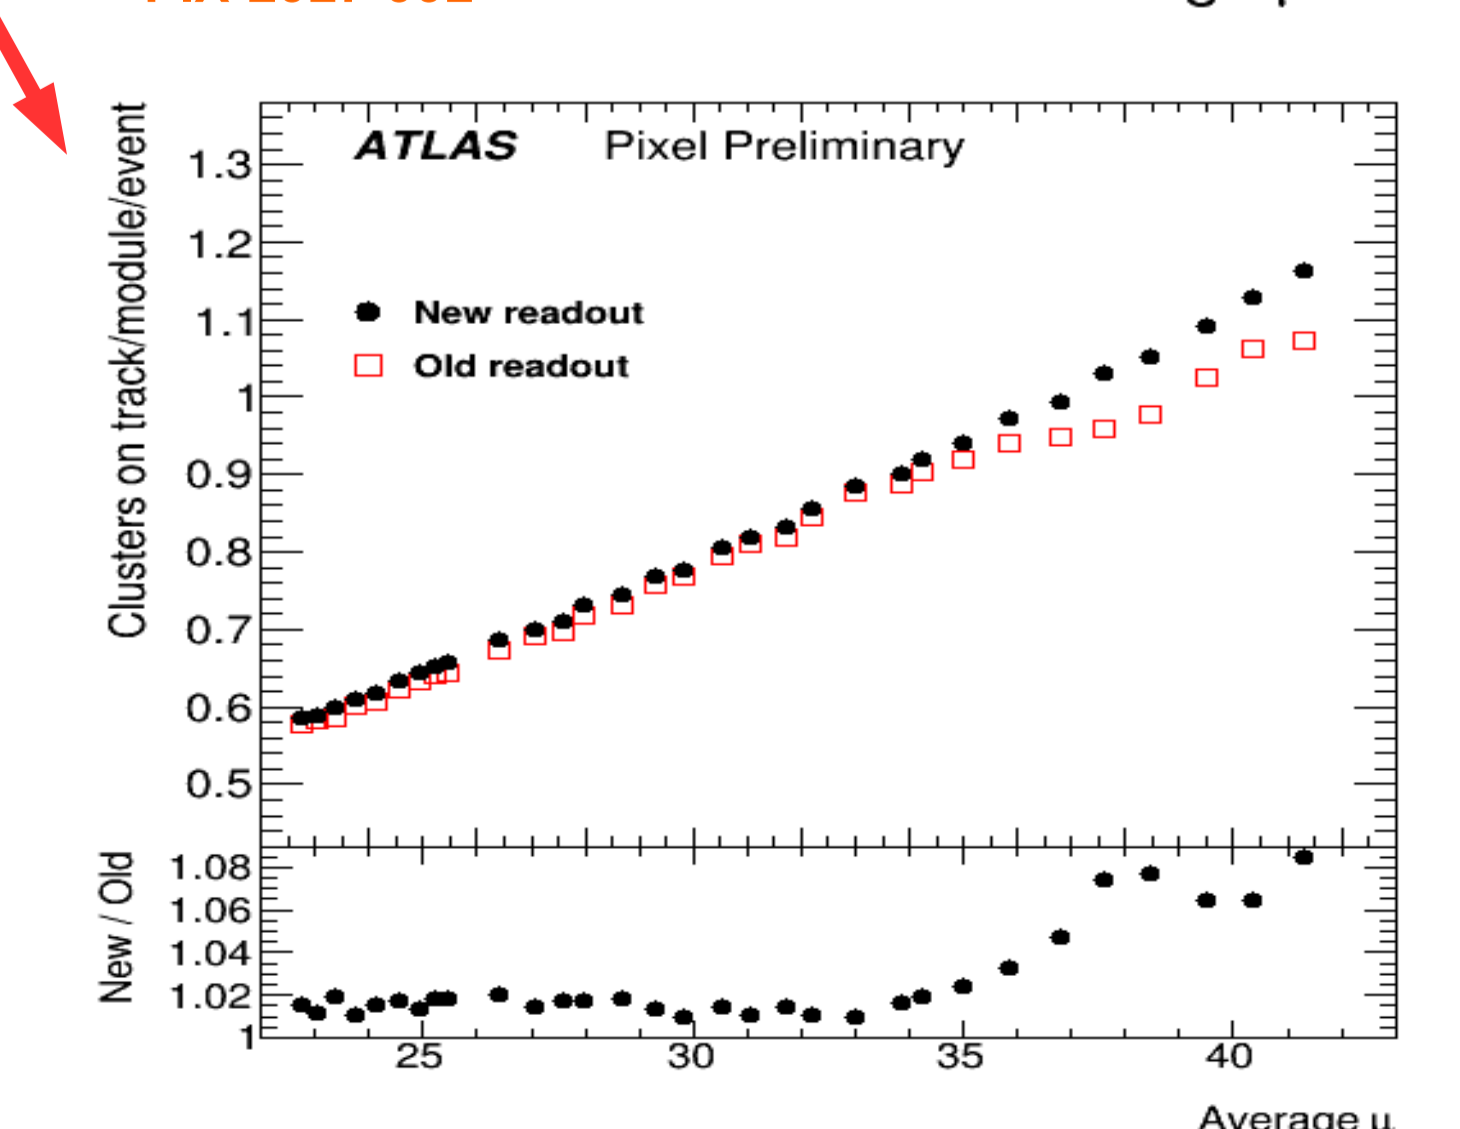
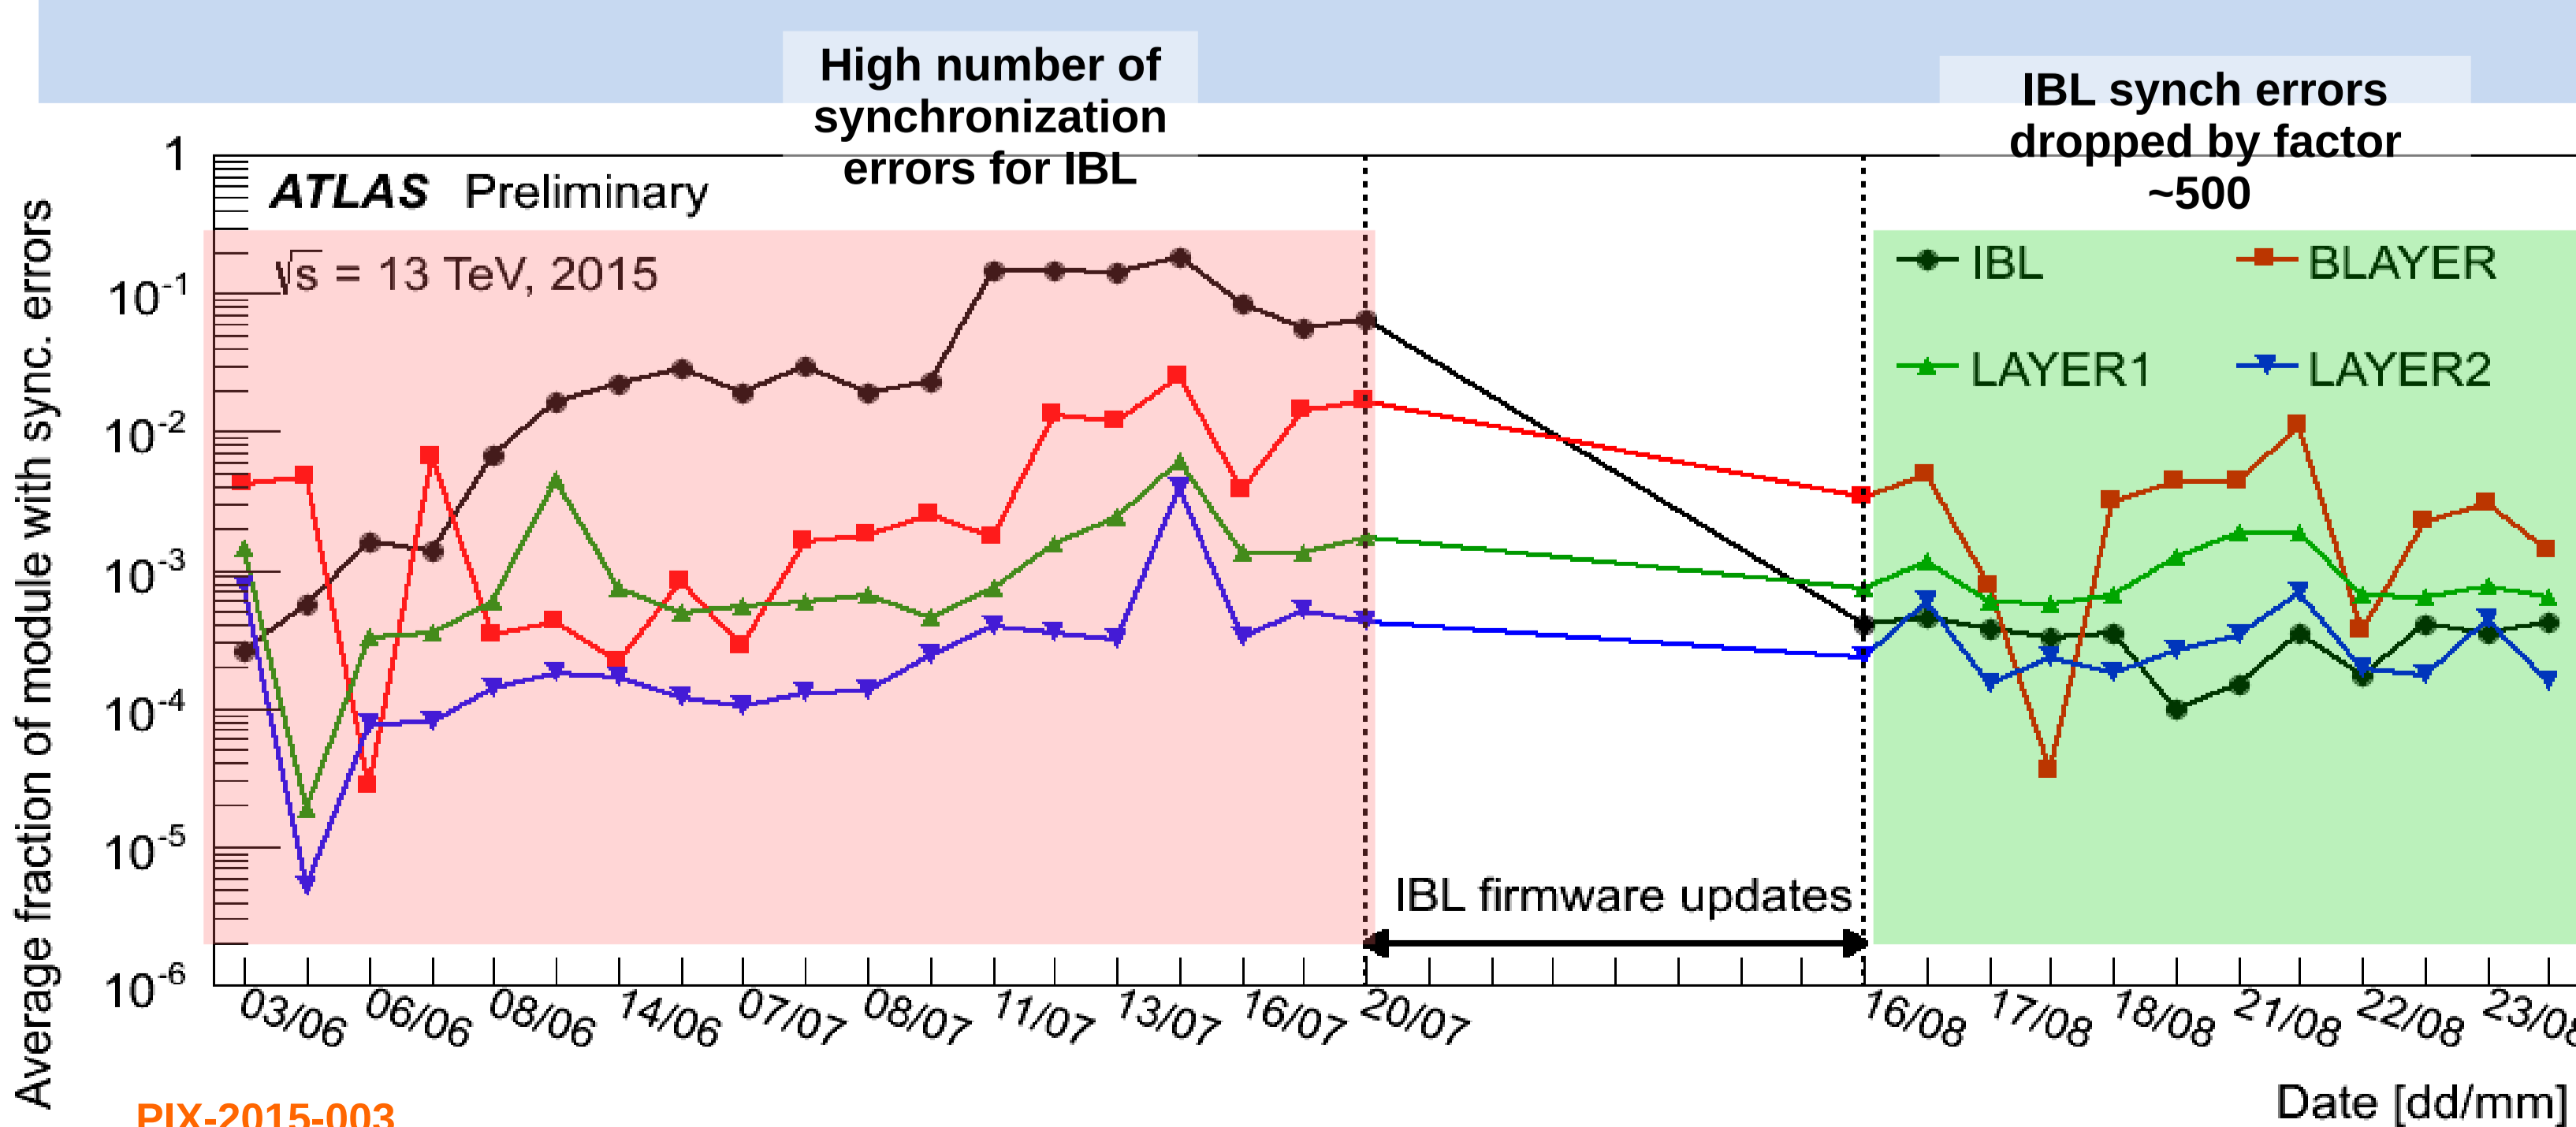
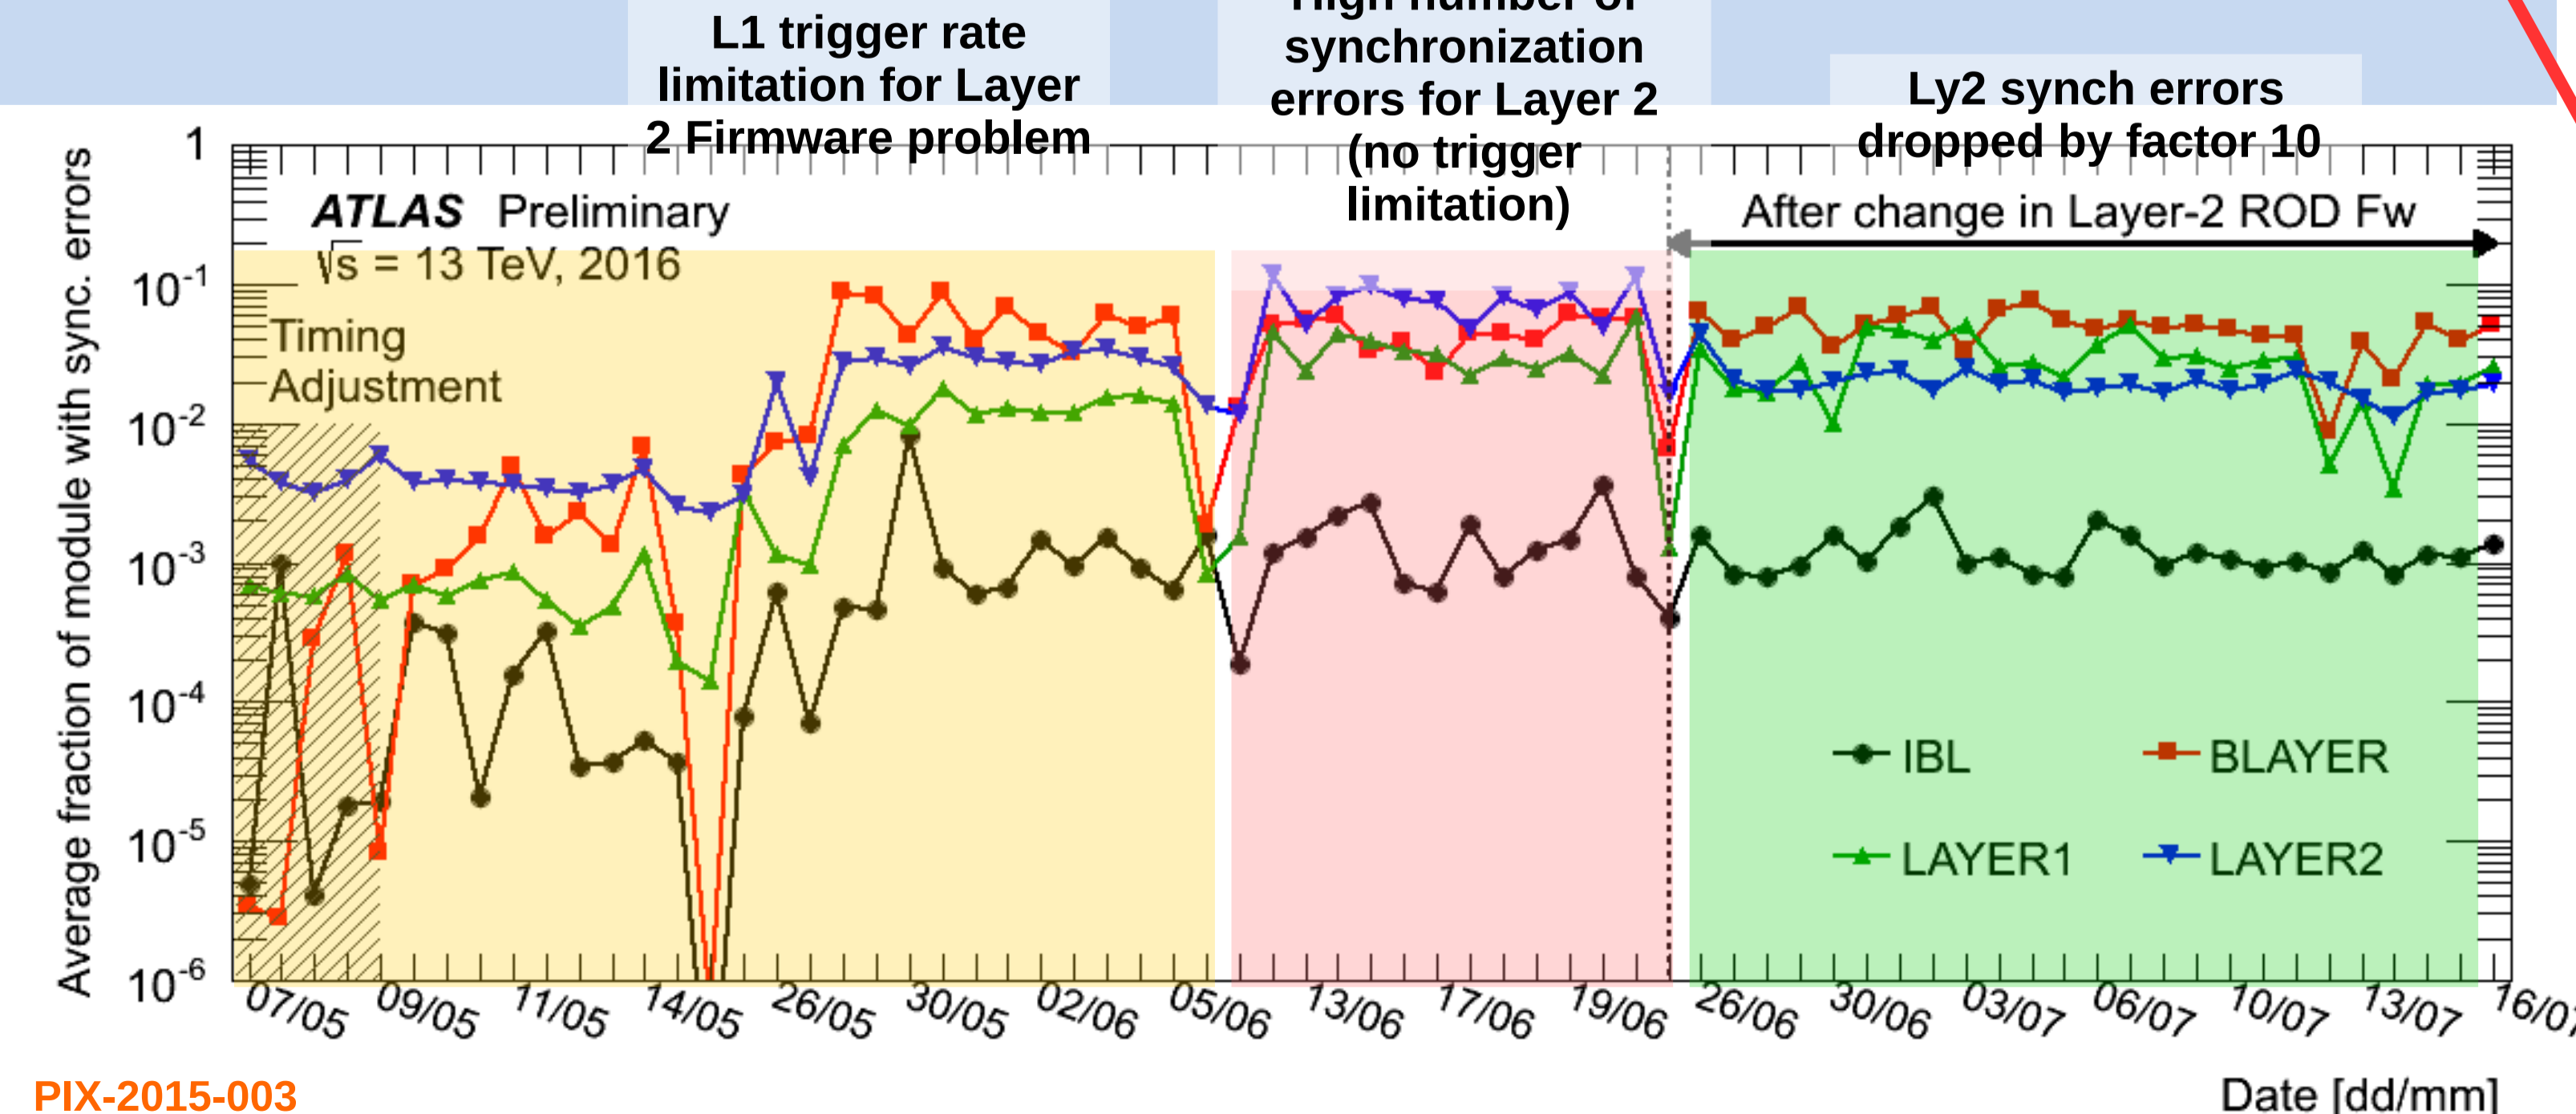
READOUT UPGRADE RESULTS:

- **Link occupancy** reduction
- Reduction in **data-losses**
- Reduction in average **desynchronization**
- **Increased efficiency** in event reconstruction
- Increased **debugging** capabilities

- Firmware development still ongoing → bug correction and new features implementation (i.e. more debugging signals/registers and improvement in the resynchronization algorithm)
- 2015-2016 → firmware problem for IBL and Layer 2: high ROD induced desynchronization and limitation on trigger rate.
