Status and Operation of the ALBA RF system

General overview of the ALBA RF system for the Booster and Storage Ring

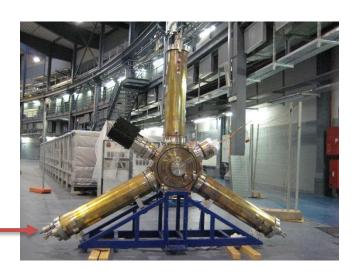
- Arcs only happen with beam
- CCD camera installed in the cavity
- Cavity voltage was reduced to mitigate the problem

Arc pictures courtesy of A. Nosych (Diagnostics group)

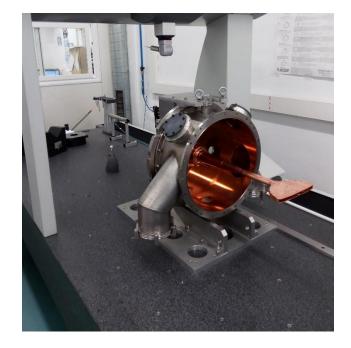
CIEMAT collaboration

September 2016: conditioning of a cyclotron cavity
