SOI CHIP - TESTBEAM PREPARATION STATUS

BUGIEL Szymon*, DASGUPTA Roma*, IDZIK Marek*,
KAPUSTA Piotr[†], KUCEWICZ Wojciech*

June 20, 2016

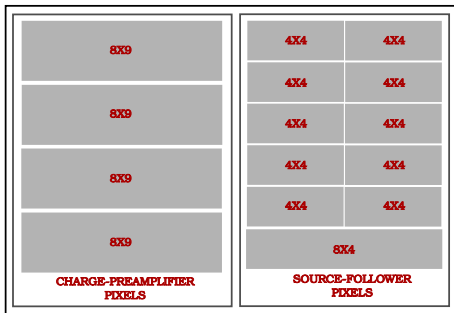
Cracow SOI pixel matrixes

CHIP INFO:

- ① charge-preamps + source-follower pixel matrix
 - 16×36 pixels
 - $30 \mu\text{m} \times 30 \mu\text{m}$ pixels size $\rightarrow \sim 0.52 \text{ mm}^2$ matrix area
 - rolling shutter
- ② self-triggering pixel matrix
 - charge preamp pixels, column 6b SAR ADC, time information
 - 4×8 pixels, $100 \mu\text{m} \times 30 \mu\text{m}$ pixels size $\rightarrow \sim 0.1 \text{ mm}^2$ matrix area

Differences in submatrixes

- different sensor layouts
- different transistor types in switches
- different input transistor sizes

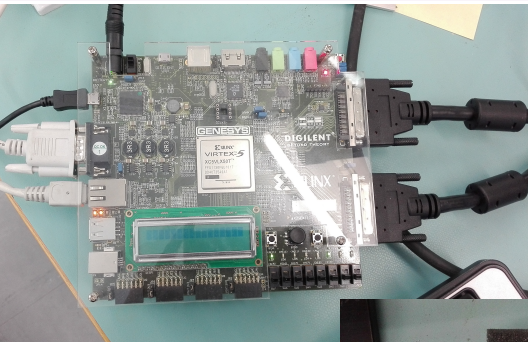
Setup

- FPGA - PC → Ethernet
- one readout PCB + 4 mezzanine boards with chips
- DAQ Software - ROOT 6

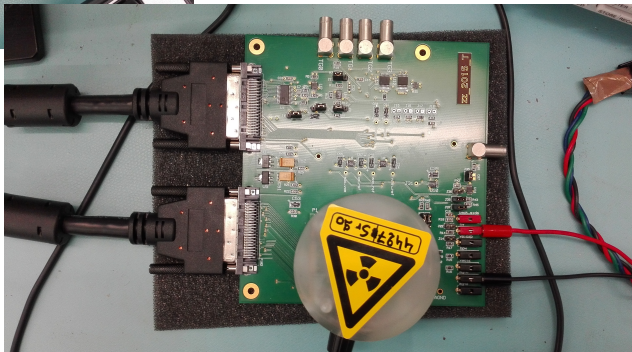
Setup

PCB version 1

- Reasonable data → no "blinking" pixels,
- **Preliminary results looked promising.**

PCB version 2

For testbeam issues the second version of readout PCB was prepared.

Planned changes:

- Detector position,
- Trigger signals.

PCB v2 + updated firmware → need to be debug more carefully.

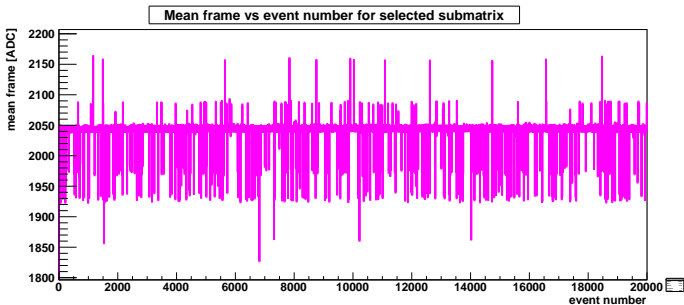
Measurements

- CZ(n) wafer, only pedestal

- mean pixel pedestal ($\langle ADC_{pix} \rangle$) calculated from 50k events
- spectrum of single pixel ($ADC_{pix} - \langle ADC_{pix} \rangle$) should be Gaussian with $\mu = 0$
- **observation: many peaks on binary scaling distances** → **probably there is some bits shift in firmware**

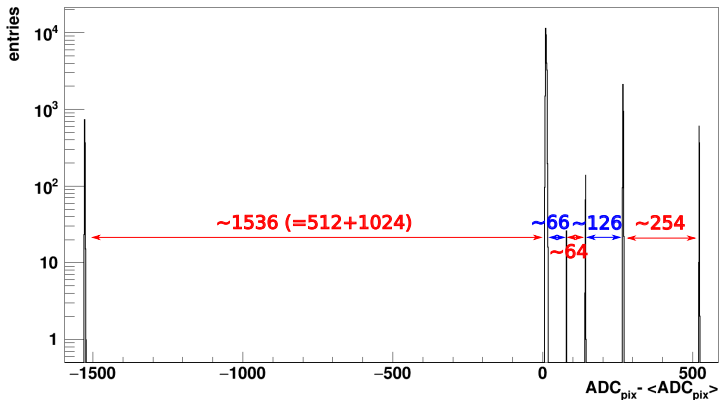
hPedestalSinglePixSpec[0]

Pedestal analysis

Histogram Statistics	
Entries	50000
Mean	0.000
Std Dev	256.000
Skewness	0.000
Kurtosis	0.000
