# Long-distance fiber tests

# Setup in SG8

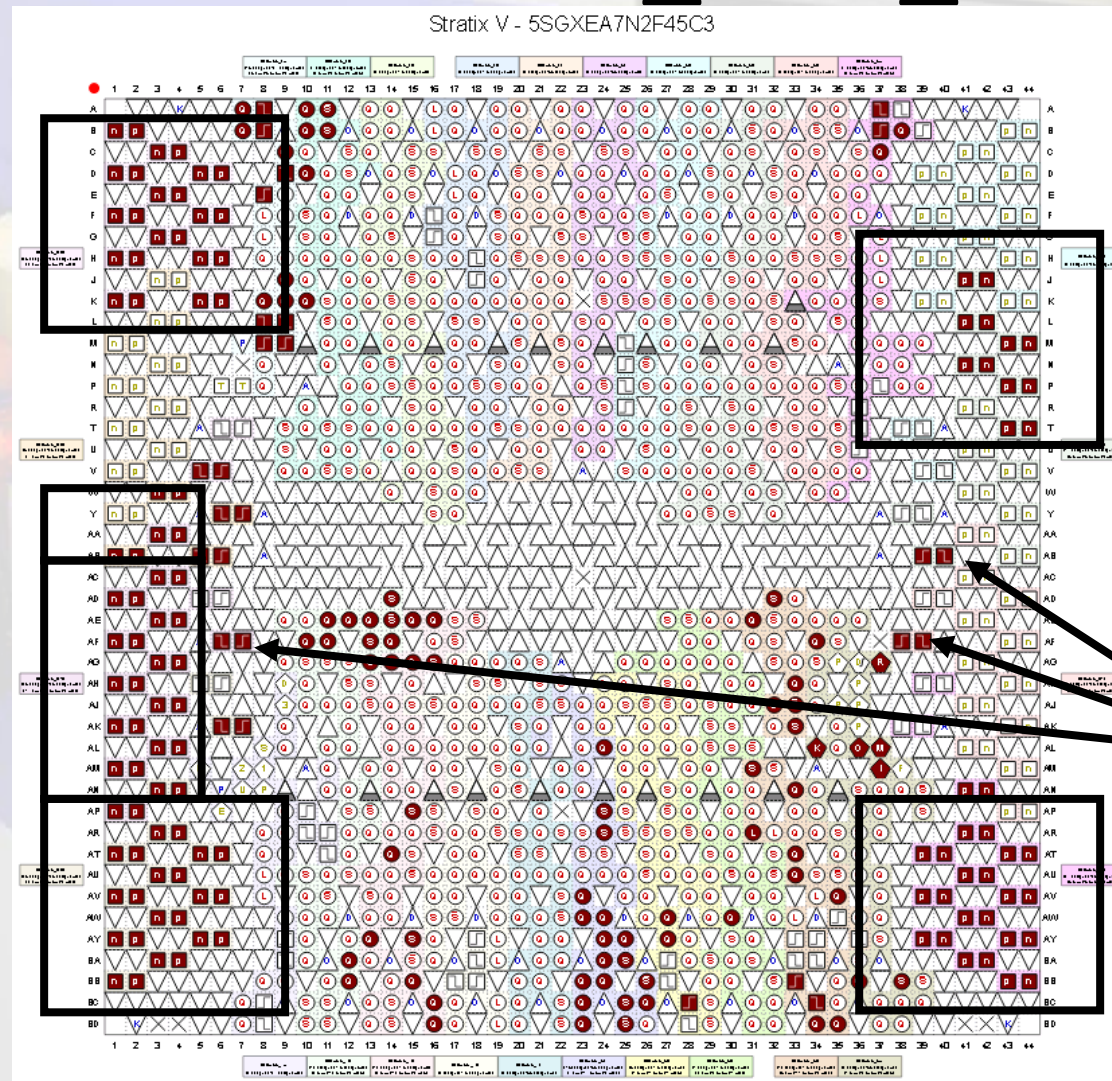
# Firmware pinout: amc40\_bert\_versatile

LEFT MPO: N/A

RIGHT MPO: GBT\_4 (TFC)

CCPC PCIe

LEFT MPO:  
GBT\_2, GBT\_1 (WBUSx6)

GBT\_REFCLK (120MHz)

MIDDLE MPO: N/A

MIDDLE MPO:  
GBT\_3 (WBUSx3), others N/A
