# ***Status of CMS GEM production in Korea***

***RD51 @ CERN***

***Feb. 22, 2016***

***Inkyu PARK on behalf of the Korea CMS***

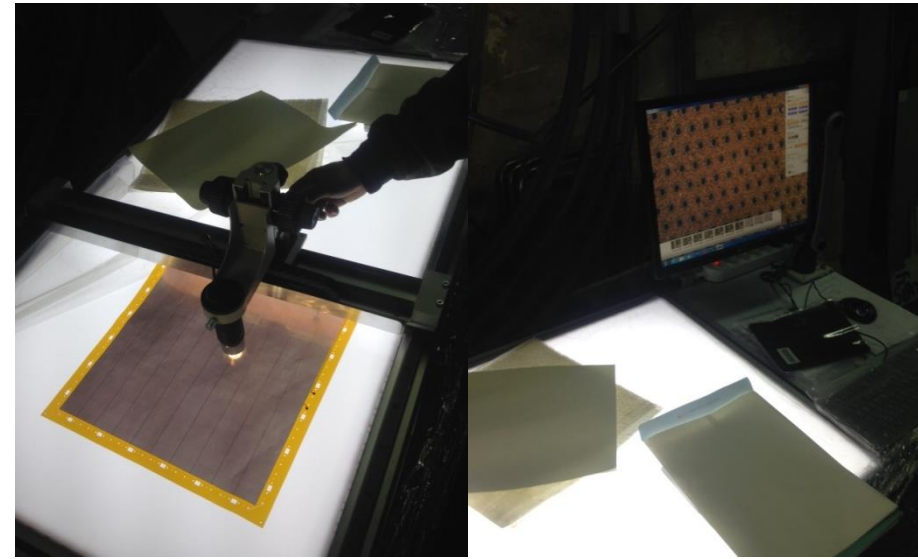
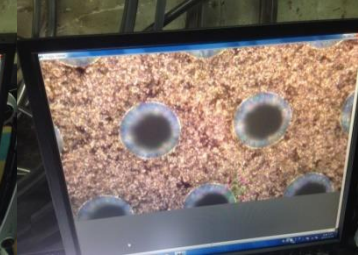
## Optical Inspection System

Hole inspection  
x400

Inner holes  
x1200

Outer holes  
x1200

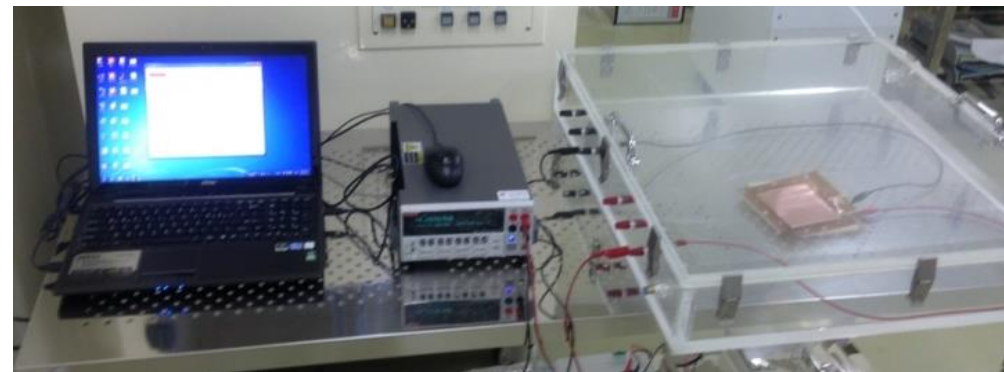
## Leakage Current Measurement System

DAQ Laptop

KEITHLEY  
2410 PS

N<sub>2</sub> box & GEM

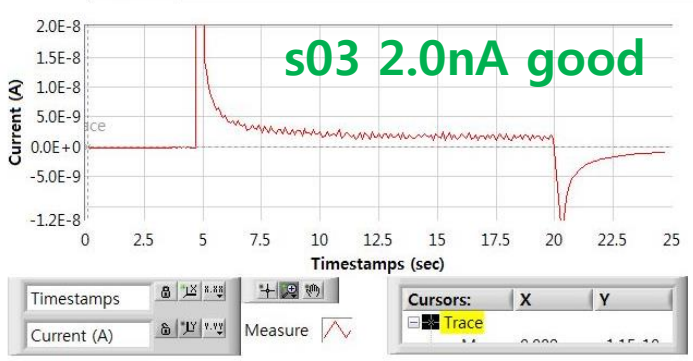
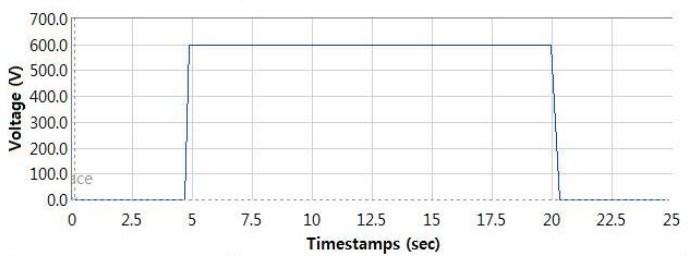
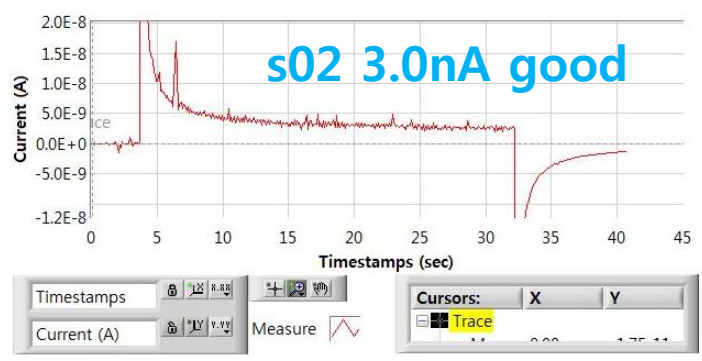
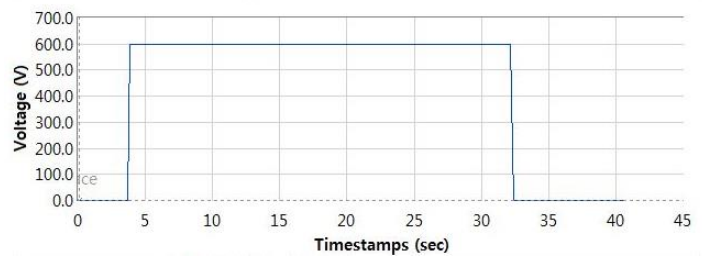
# Mass production of small size GEM Mecaro-50 RH%

## Leakage current ( $\Delta i$ )

- s01 3.5 nA good
- s02 3.0 nA good
- s03 2.0 nA good
- s04 4.0 nA good
- s05 5.0 nA good
- s06 3.5 nA good
- s07 3.5 nA good
- s08 2.0 nA good
- s09 2.5 nA good
- s10 4.0 nA good
- ...

**Yield is good enough. Mass production stage.**

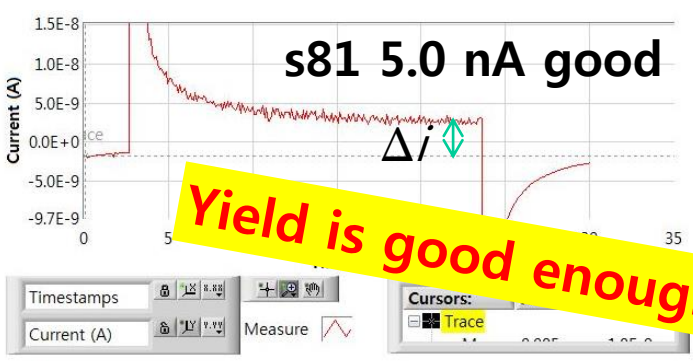
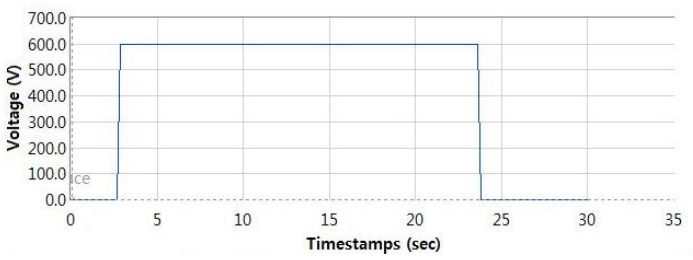
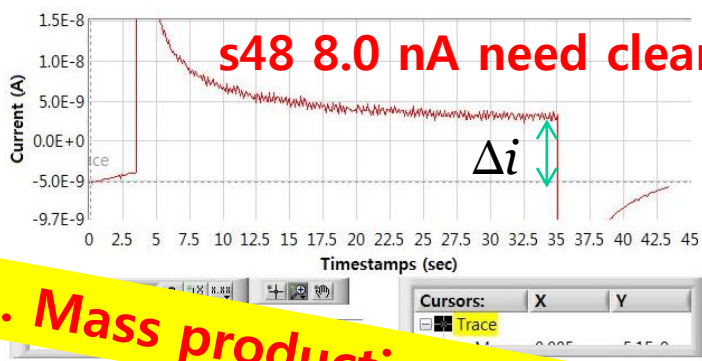
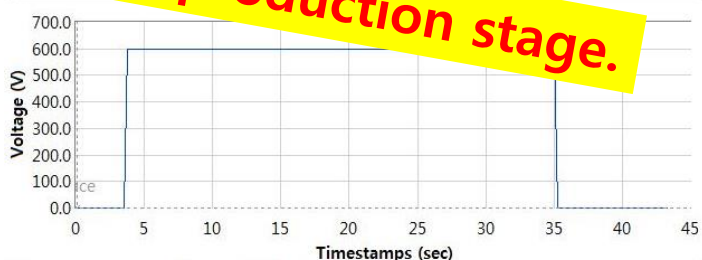
- s31 3.0 nA good
- s39 5.0 nA good
- s41 5.0 nA good
- s42 2.0 nA good
- s43 3.5 nA good
- s44 5.0 nA good
- s45 5.0 nA good
- s46 5.0 nA good
- s48 8.0 nA need clean
- s49 4.0 nA good
- ...

- s81 5.0 nA good
- s82 3.0 nA good
- s83 3.0 nA good
- s84 3.0 nA good
- s85 3.5 nA good
- ...

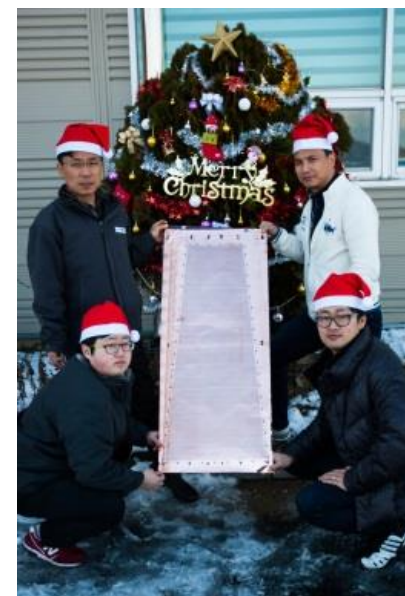
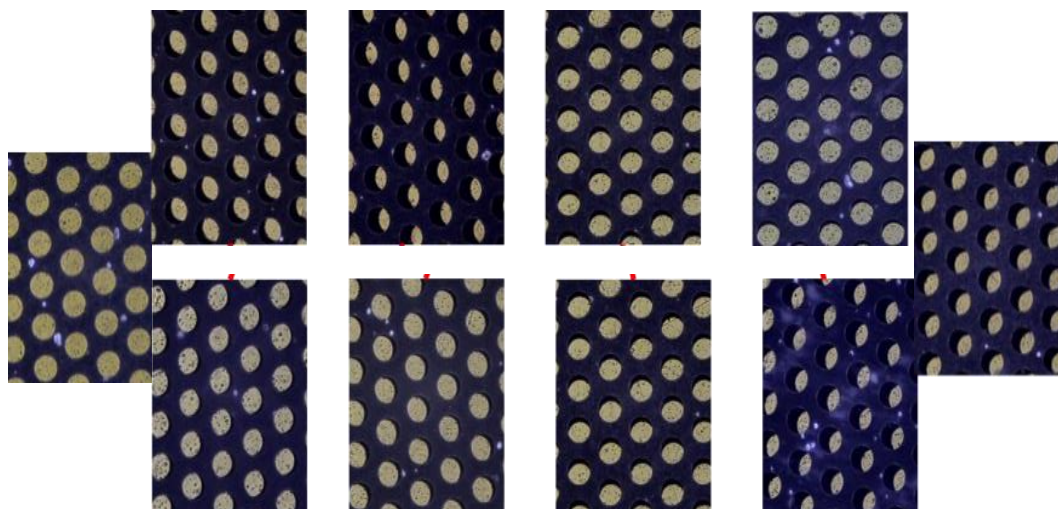
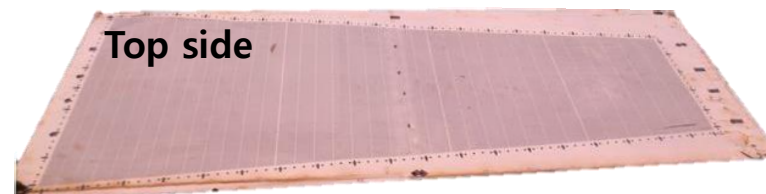
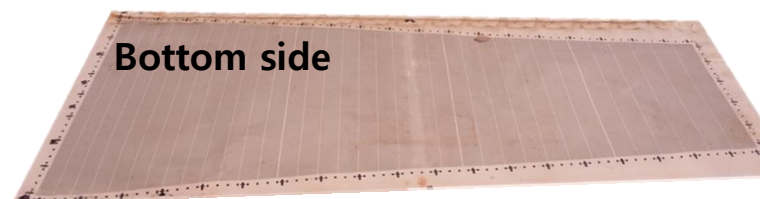
□ 2013: A very first GE11 foil was produced by the double-side etching method

– Mask misalignments  $\sim 10\mu\text{m}$

- Thus, we concluded that we needed a finer mask alignment tool.

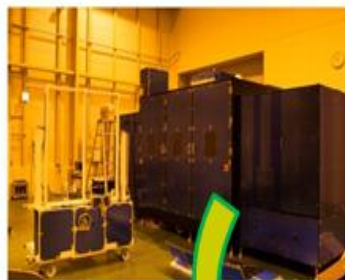
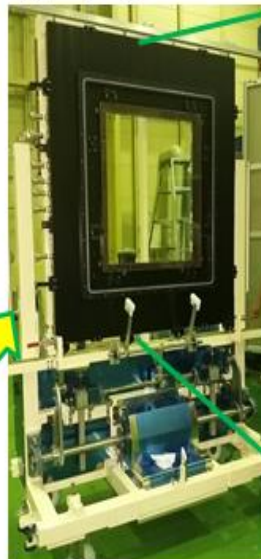
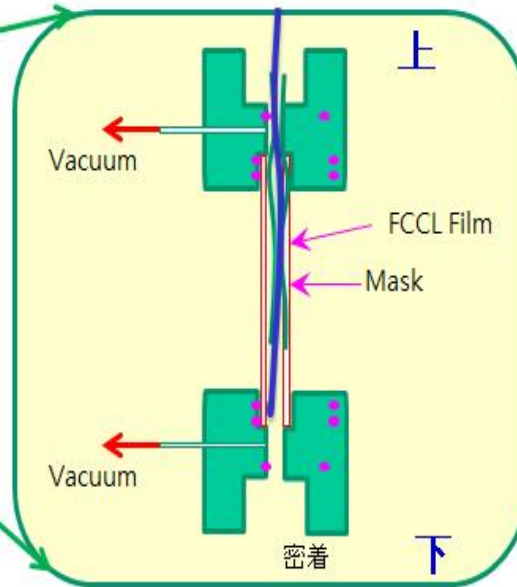
Double-mask Cu lithography in 2014

- A successful GE11 production was done.
  - By using a high definition bi-polar lithography machine with the alignment precision of  $\sim 1\mu\text{m}$  (Japanese optics company)
  - However, the machine price  $\sim 1$  million dollars! KCMS wanted to buy this machine anyway, if the CMS management was willing to consider the investment as the in-kind contribution of Korea  $\rightarrow$  But, denied.
  - We hold the procedure to purchase the machine.

- Using single-side method: doable, but hole shape uniformity is not good
- Using double-side method: recommended, but the machine cost is high (additional 300kCHF needed)

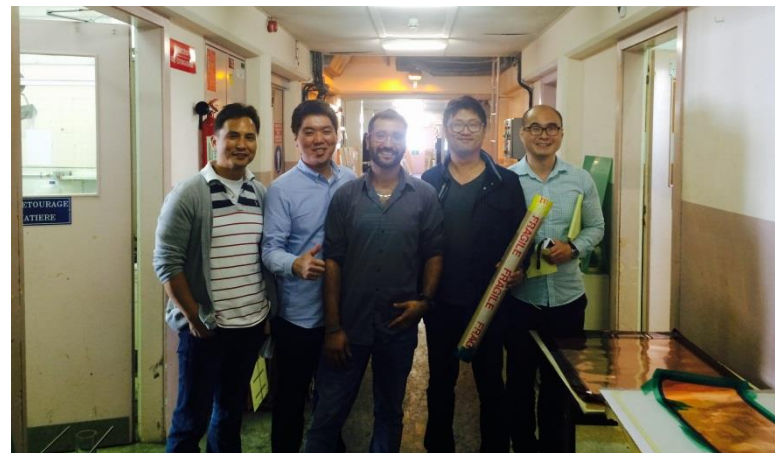
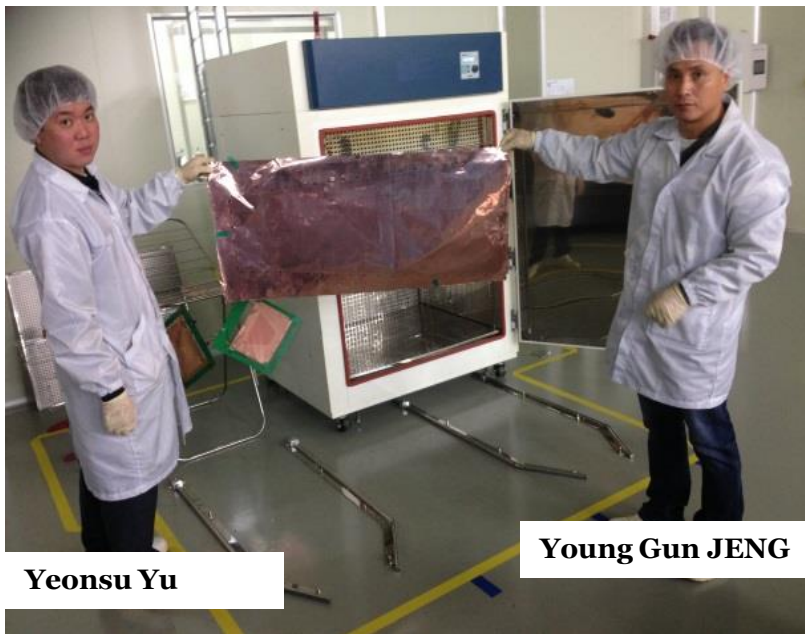
□ Thus, we started the single-side etching method in 2015, as followed in CMS

– The production seemed to be quite straightforward, and well progressed.

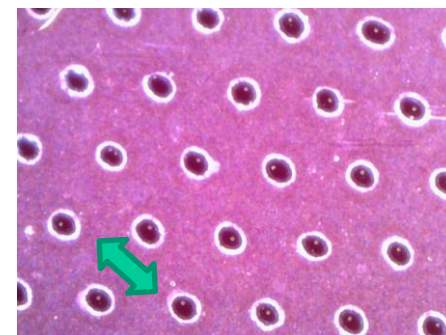
The production qualities were not stable over the productions. The PI hole shapes were not uniform over the GE11 area for some production. → serious yield cut.

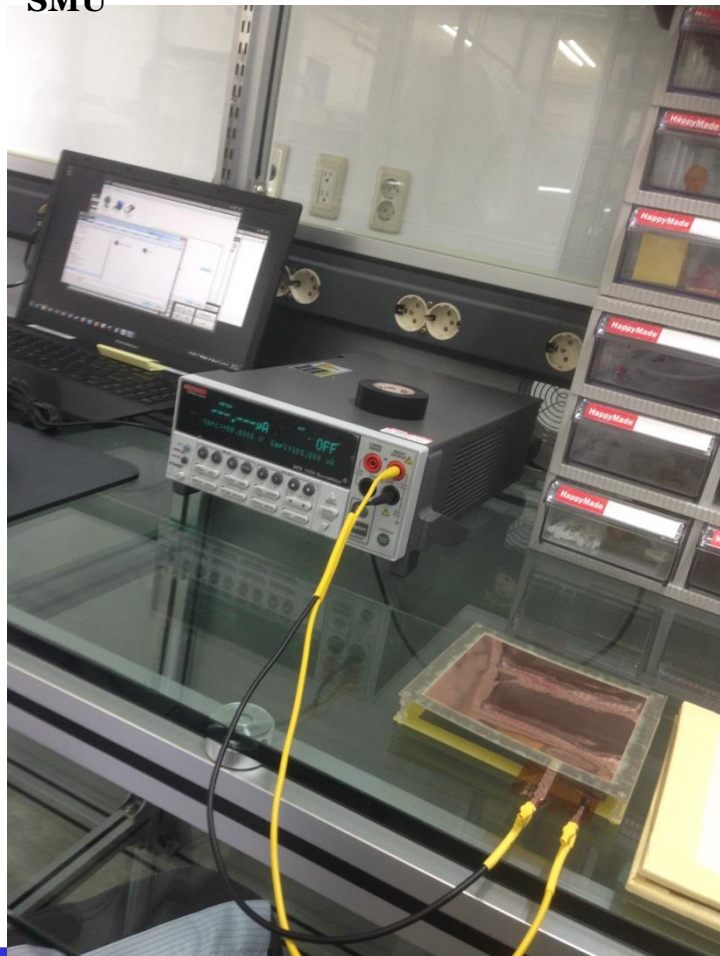
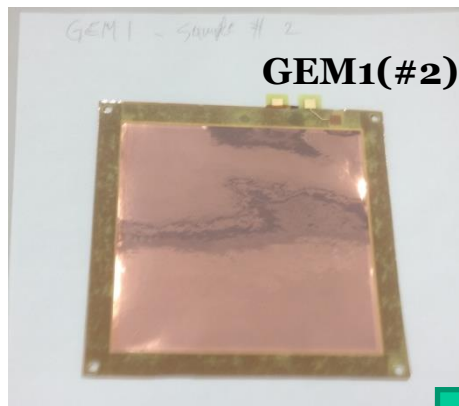
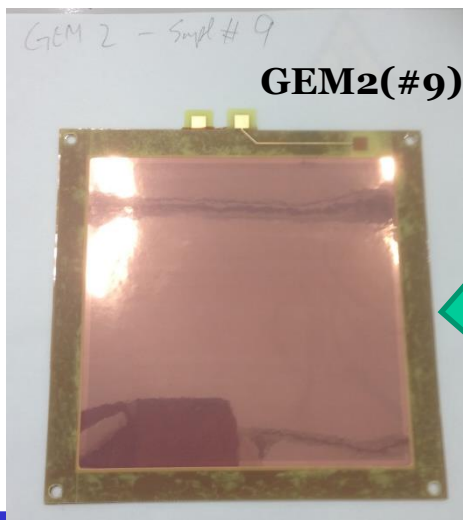
# 2DxID with GEM1(#2), GEM2(#9), GEM3(#10) at LHC lab

GEM test in LHC lab in UoS

Customized DAQ program with K2410 SMU

GEMs are stretched about  $4-7 \text{ N/cm}^2$  summed with values in opposite direction.

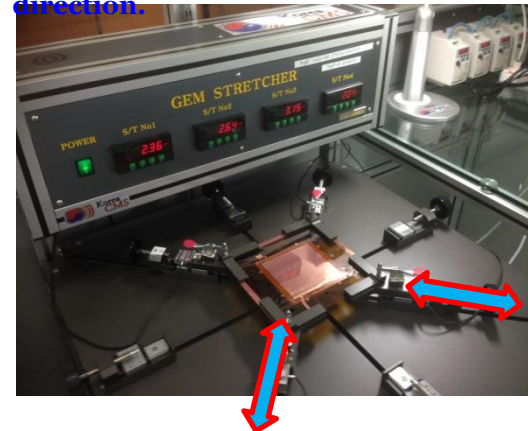
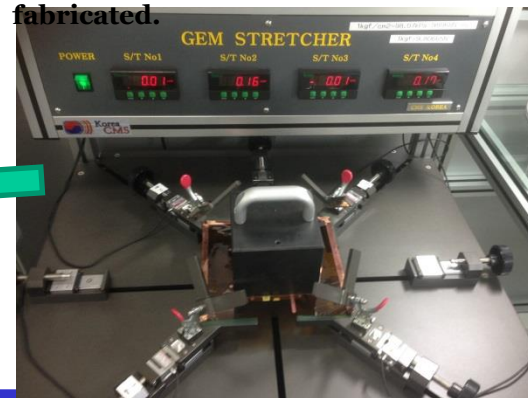
Typical stretching tension  $\sim 5-10 \text{ N/cm}$

GEM3(#10) is on the stretcher now (2016.03.09), we designed and fabricated.

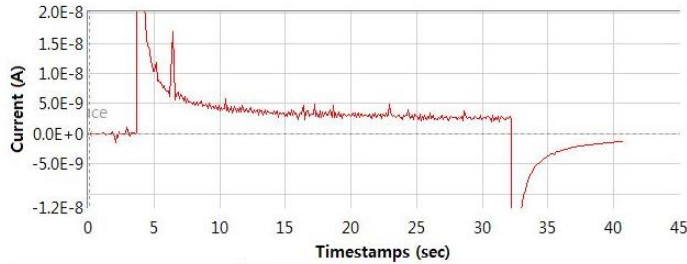
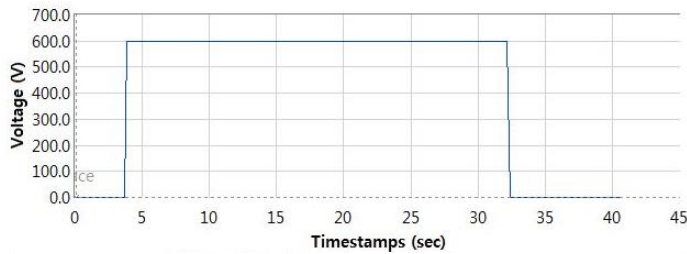
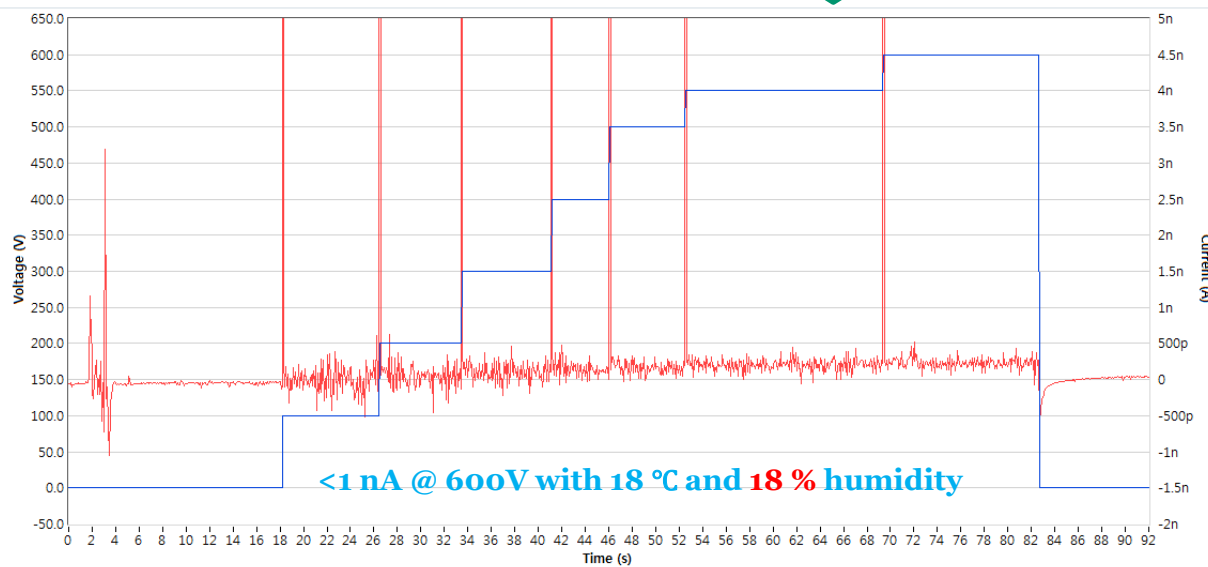
# Leakage current of GEM from MECARO (2015)

sample #2 → s2 on the right list

3 nA @ 600V with 18.3 °C and ~52 % humidity

TEST in MECARO  
(August 2015)

TEST at Univ. of Seoul (UoS)  
in Korea (March 2016)

<1 nA @ 600V with 18 °C and 18 % humidity

★ s1 and s48 used for  
GEM stretcher, we've  
designed.

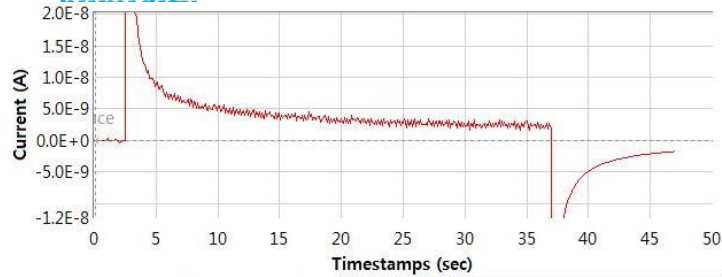
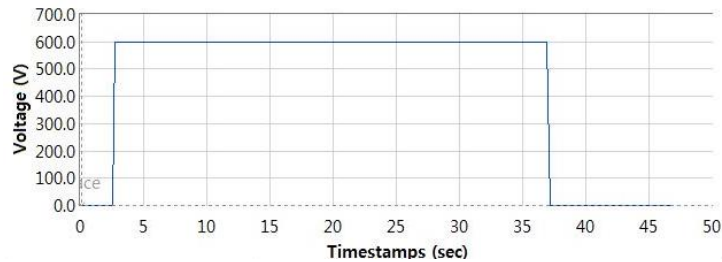
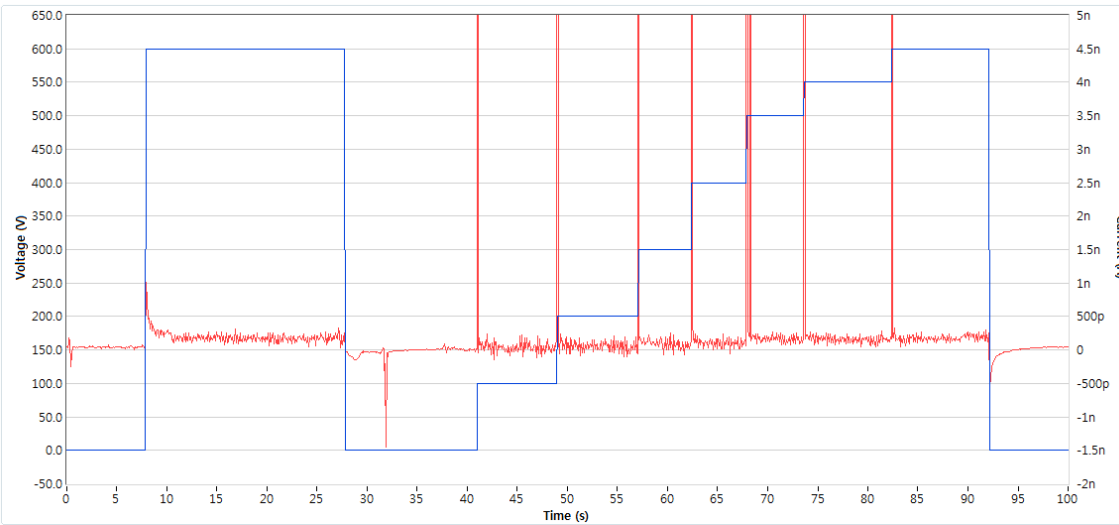
# Leakage current of GEM from MECARO (2015)

sample #9 → s9 on the right list

2.5 nA @ 600V with 18.3 °C and ~52 %

TEST in  
MECARO  
(August 2015)

TEST at UoS in Korea  
(March 2016)

<1 nA @ 600V with 18 °C and 18 % humidity

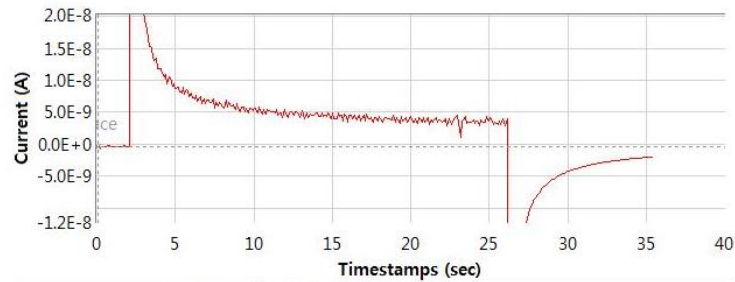
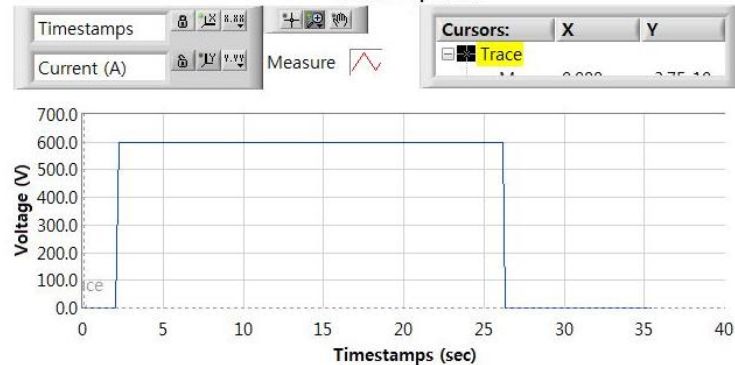
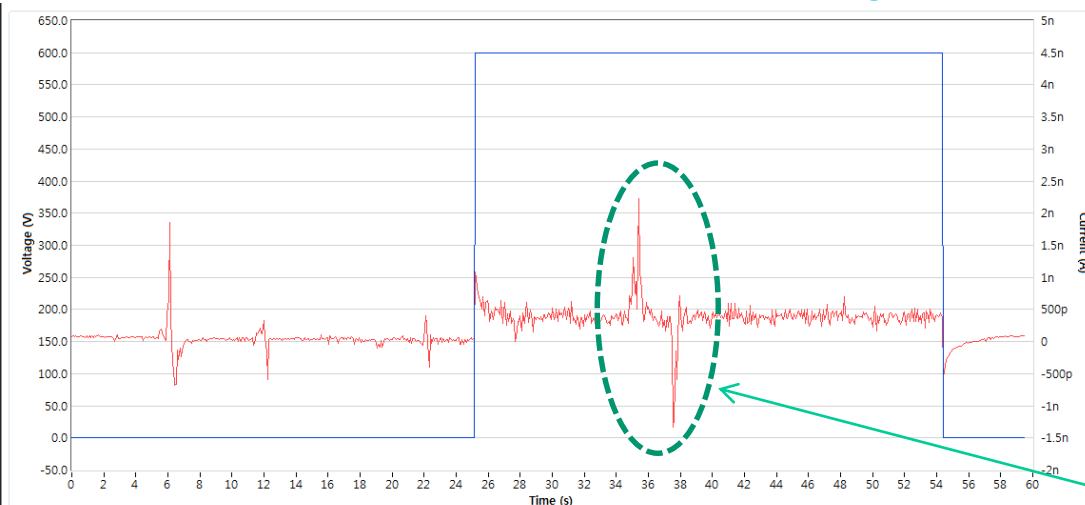
# Leakage current of GEM from MECARO (2015)

**sample #10** → s10 on the right  
list @ 600V with 18.3 °C and 52 % humidity

TEST in MECARO  
(August 2015)

TEST at UoS in Korea  
(March 2016)

<1 nA @ 600V with 18 °C and 18 % humidity

It is due to the noise from static

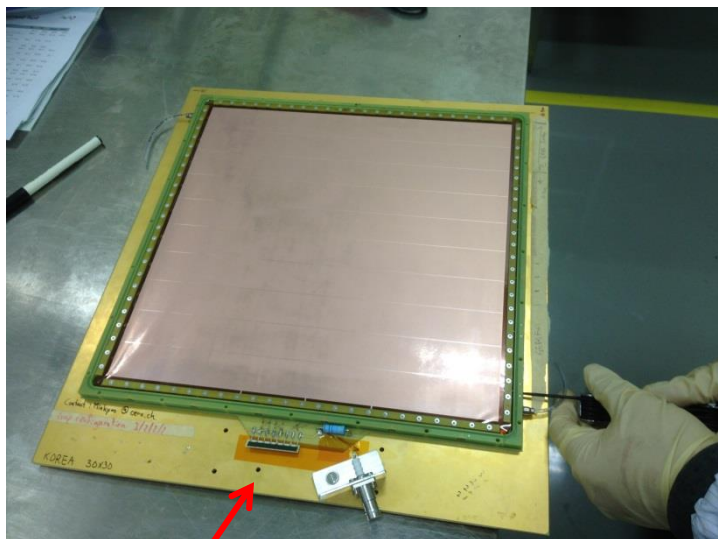
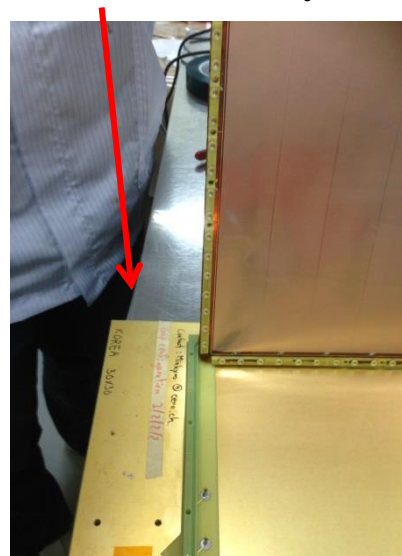
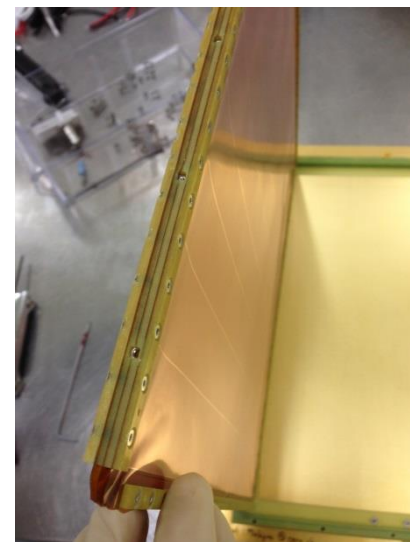
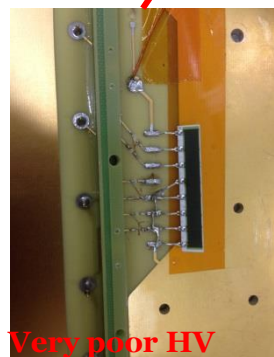
# 30x30 GEM detector with MECARO GEMs (FCCL from 3M)

Open Detector in Dec 2015

Bad sector check by message on the board

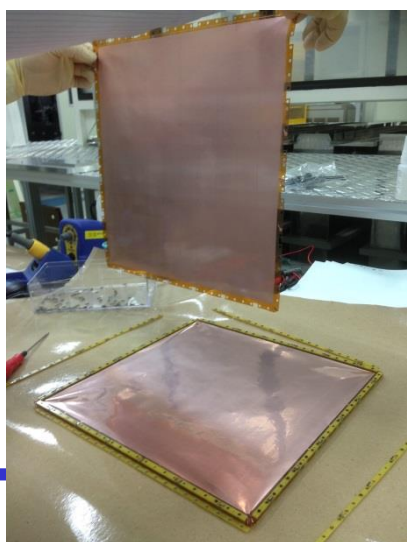
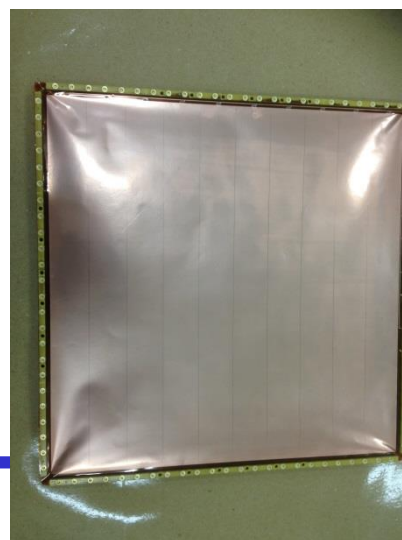
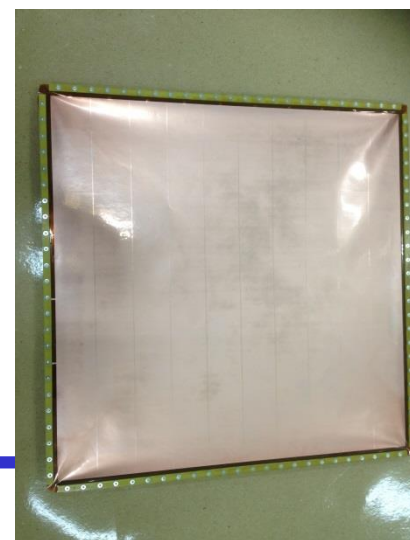
Very poor HV connection by customized ceramic resistance ???

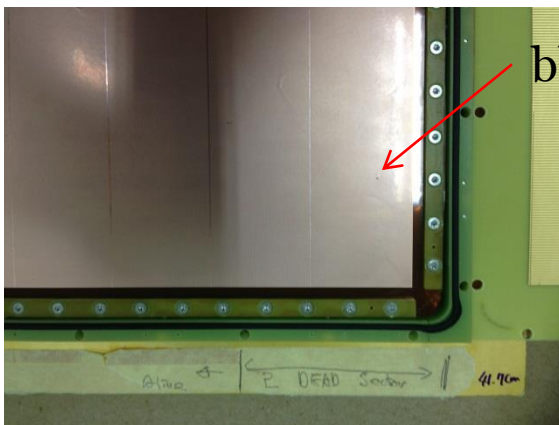
# Leakage current of GEM (30x30 cm<sup>2</sup>) from MECARO (3M) in Dec 2015

It was tested at CERN in 2015 but there was bad sectors.

Holes ??

black dot at GEM1

GEM2&3 are OK.

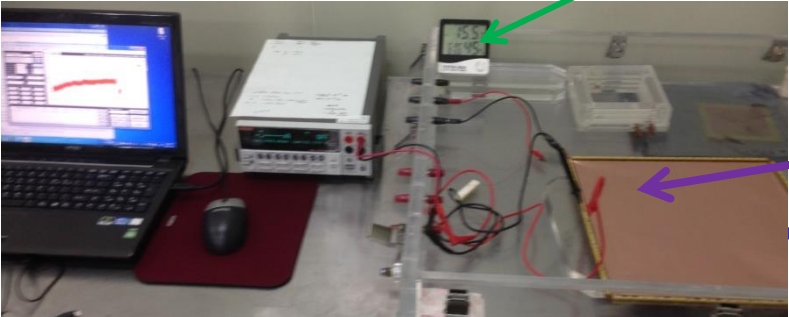
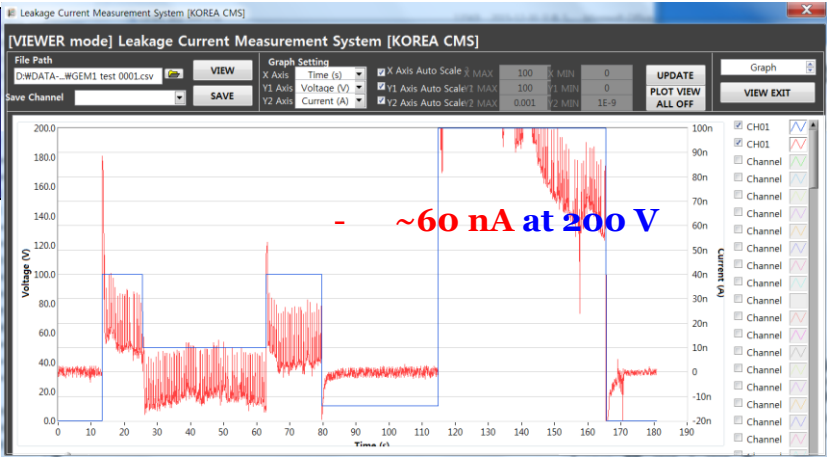
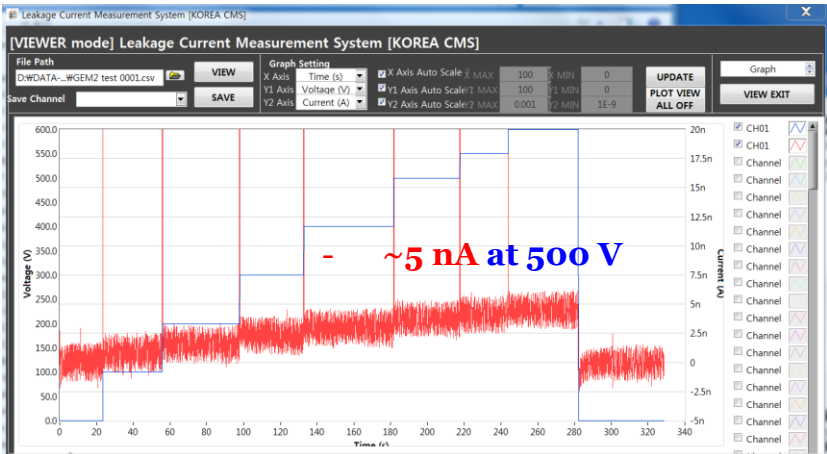
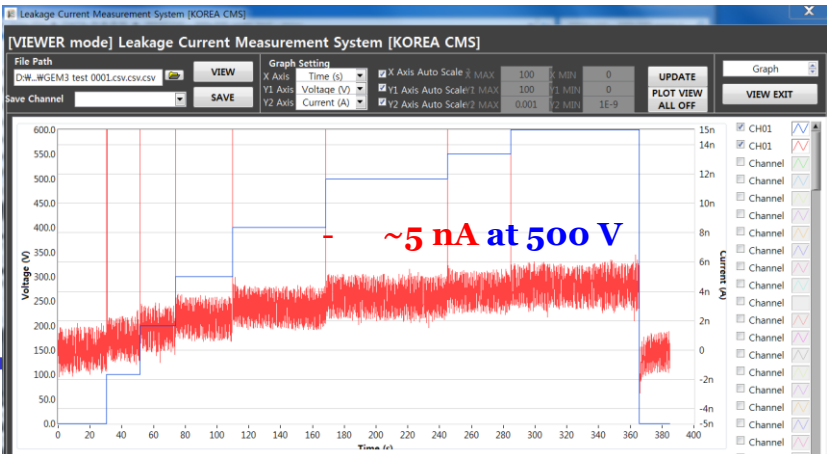
## TEST SETUP (MECARO)

15.5 °C  
45 % humidity

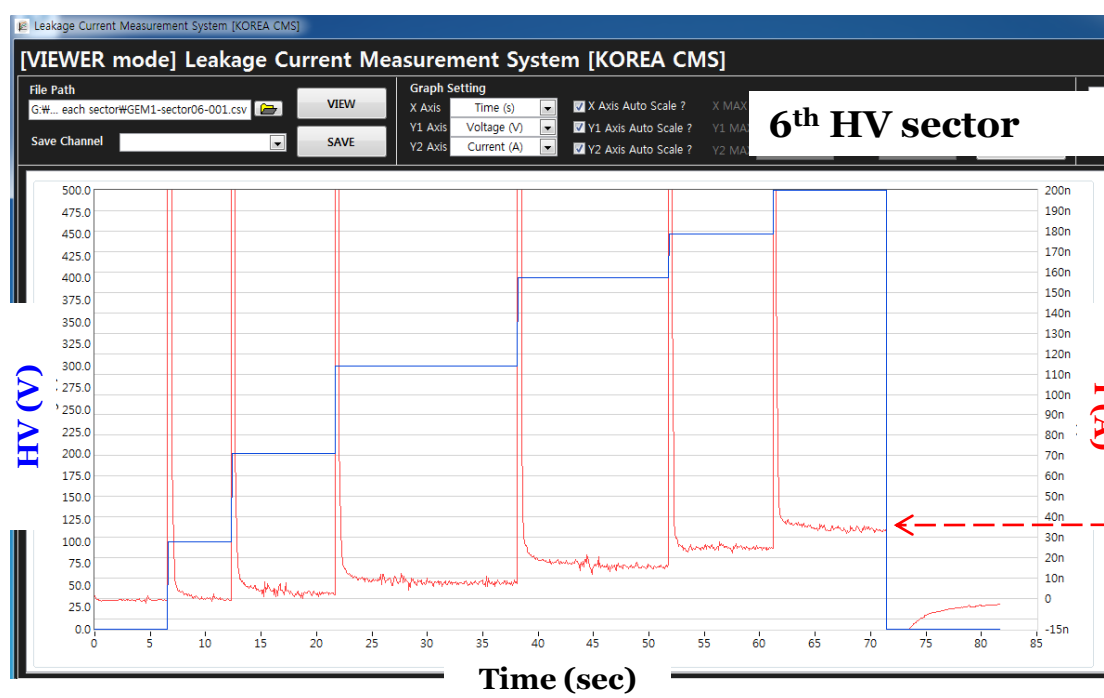
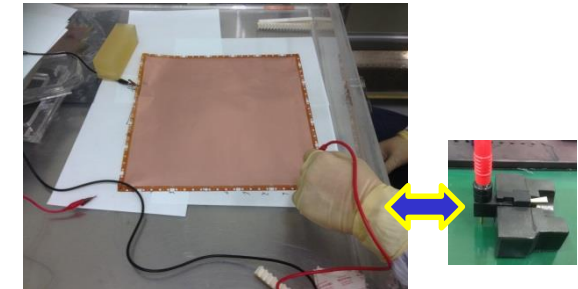
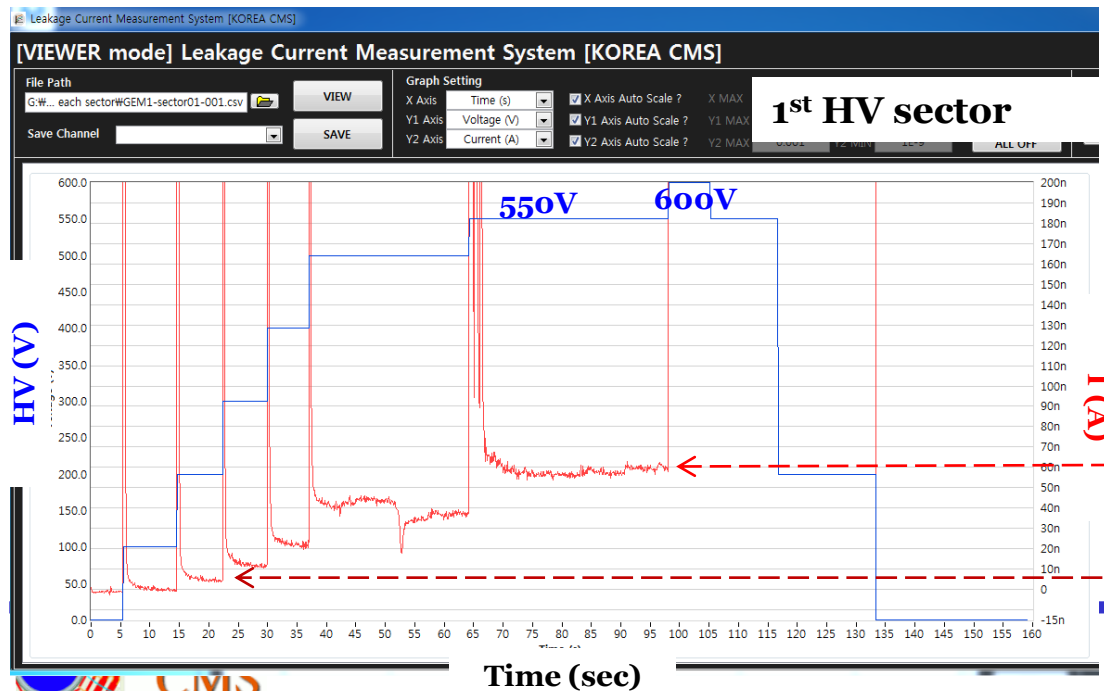
# Leakage current of GEM1 (30x30 cm<sup>2</sup>) from MECARO (3M) in Jan 2016

- Leakage current at 500V: **20-50 nA** for each HV sectors

- Similar pattern
- **~60 nA at 550 V**
- **Damaged at 600 V**

**GEM1 showed ~60 nA at 200 V.**
