SYSTEMS PERFORMANCE: CIRCUITS

A. Antoine, M. Bednarek, Z. Charifoulline, G.J. Coelingh, G. D'Angelo, R. Denz, V. Montabonnet, J. Nielsen, D. Nisbet, B. Panev, F. Rodríguez Mateos, I. Romera Ramírez, H. Thiesen, S. Uznanski, CERN, Geneva, Switzerland

Abstract

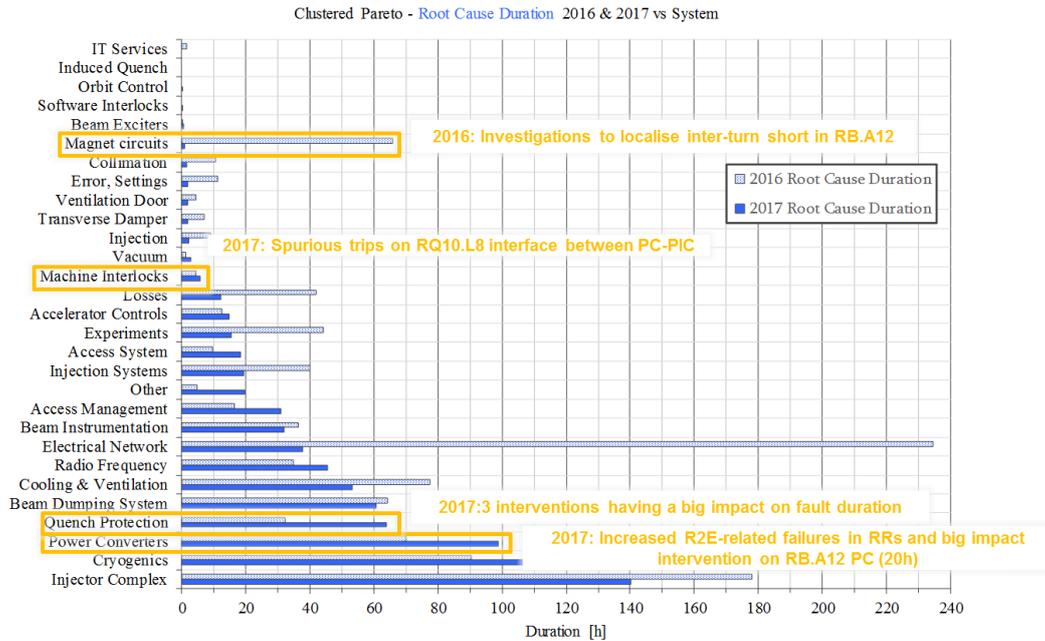
Figure 1: Root cause duration per system as observed in 2017 vs 2016

The increase on the power converter fault duration with respect to 2016 can be explained by an increment of the R2E suspected events in the RRs and several interventions on the RB.A12 power converter to fix a leak on the water-cooled busbars. The Quench Protection System was also penalized by lengthy interventions on the RQD.A12 Energy Extraction system and a main quadrupole acquisition system. The contribution from magnet circuits was drastically reduced as a lot of time was dedicated in 2016 to localise the inter-turn short in RB.A12.
