# Experience with Hydrostatic Levelling Systems at Diamond

Diamond Light Source  
TW-DULER 2018

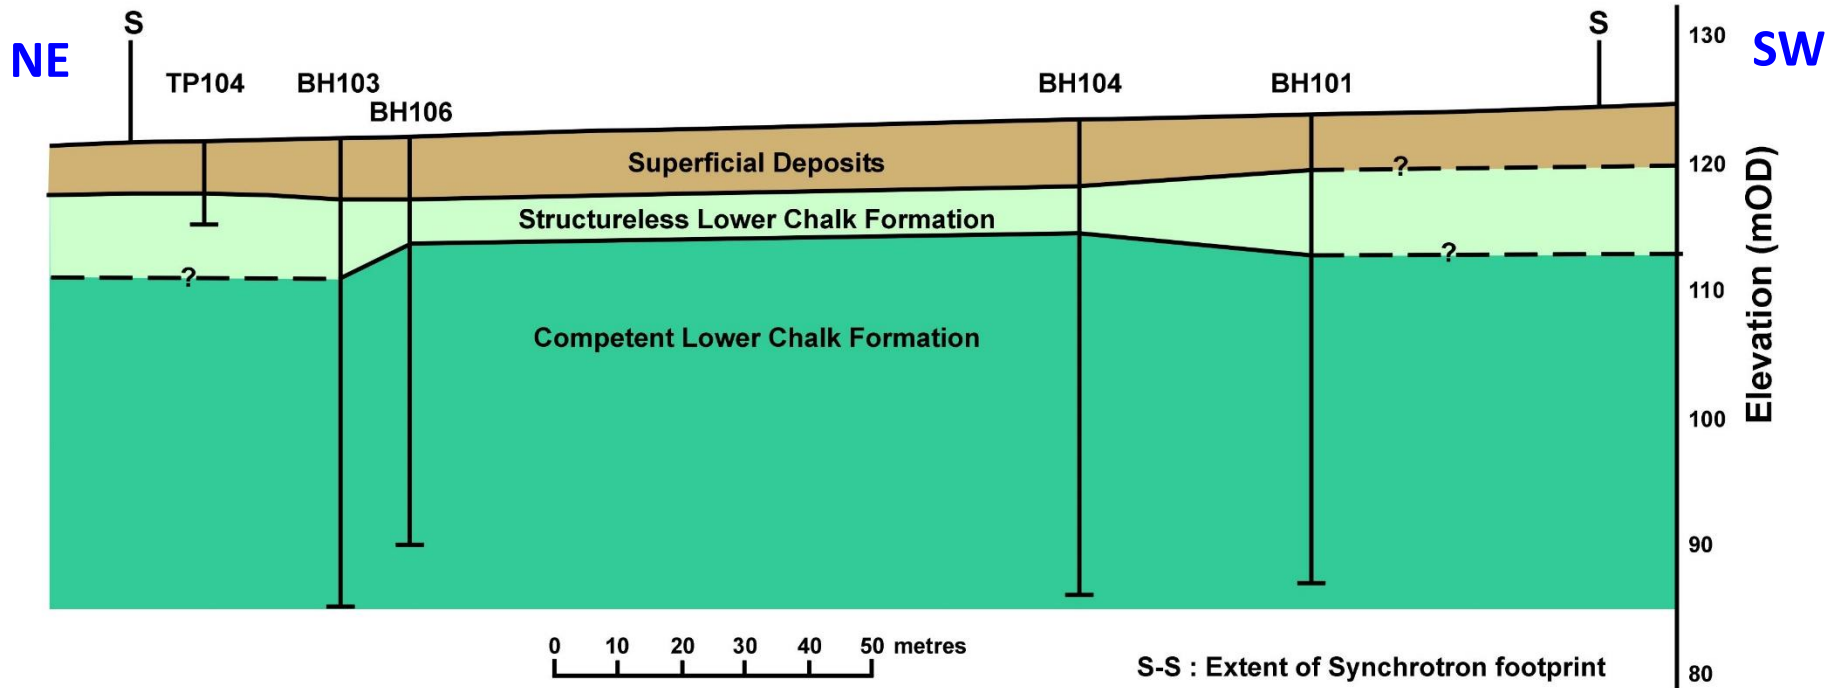
NE-SW Geological cross-section interpreted through the centre of the Synchrotron  
(based on Norwest Holst Engineering Ltd., 2001)

- **Chalk strata**, stretching to a depth of ~65 m
- Contains aquifer with **varying water table height** (between 12 m to 20 m below surface)
- Expected that **upper layer** of structure-less chalk would **swell and contract**, causing surface **height to change** (dominant factor)
- Anticipated some settlement, decreasing over time
- Some **local non-uniformities**: “soft-spot” in NE of site?

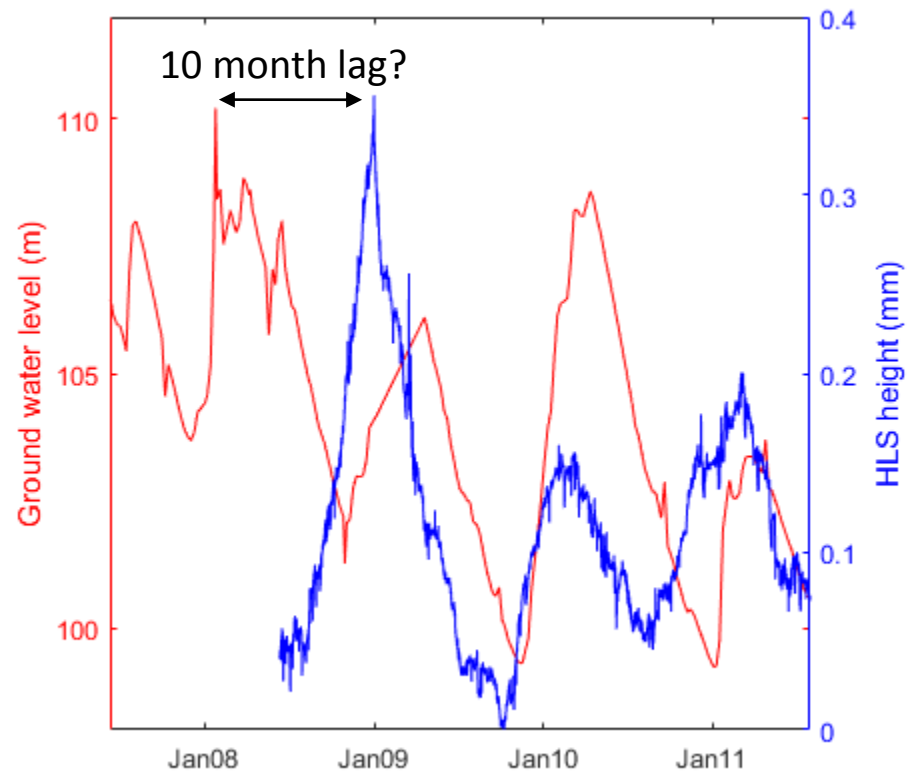
Correlation between water table and walkway

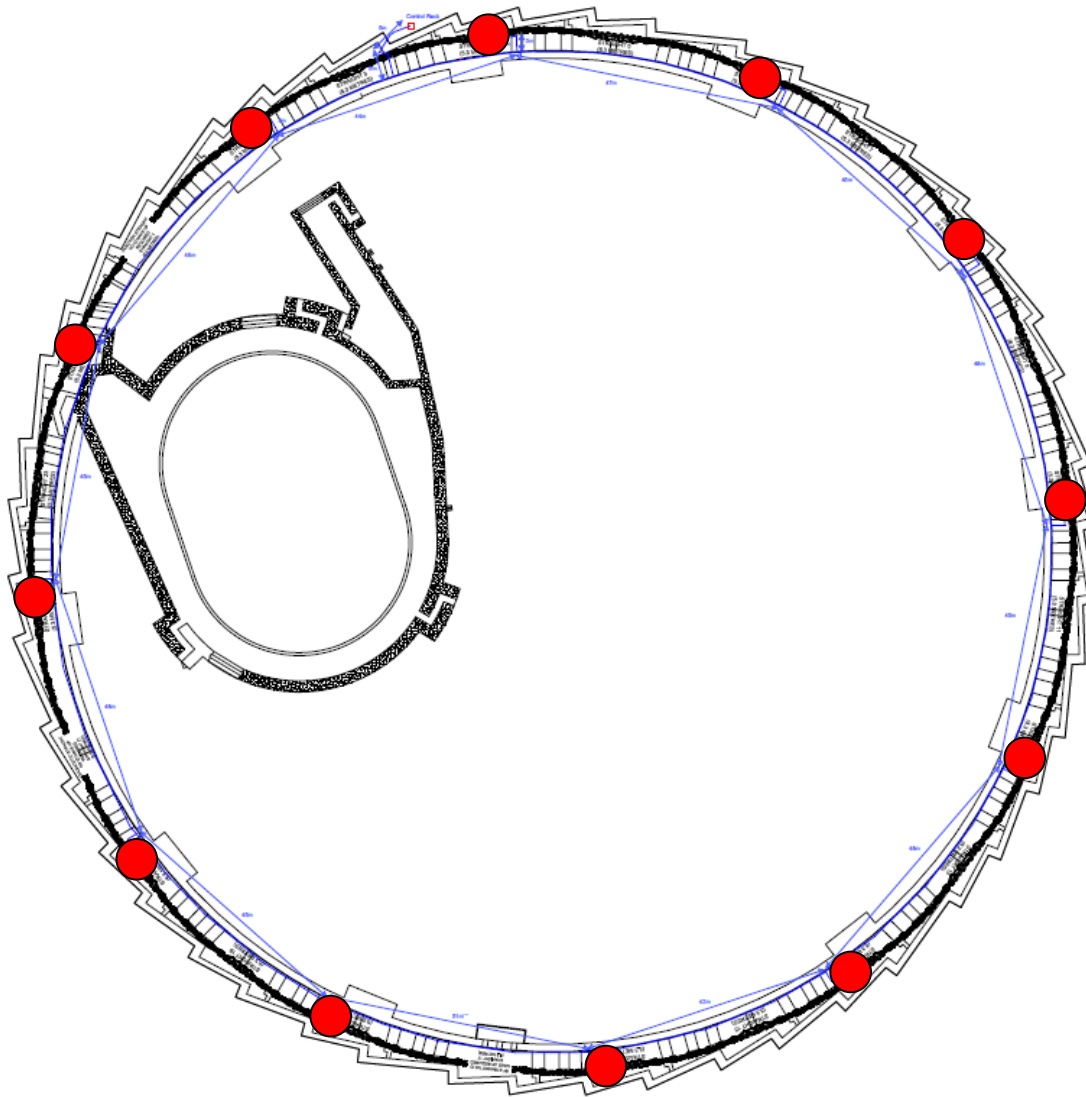
- HLS system moved to SR tunnel in 2012
- 12 sensors
- Evenly distributed
- Located under girders

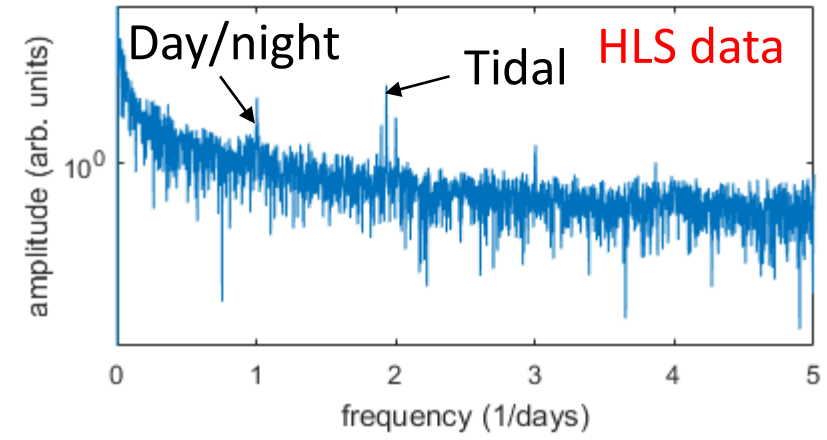
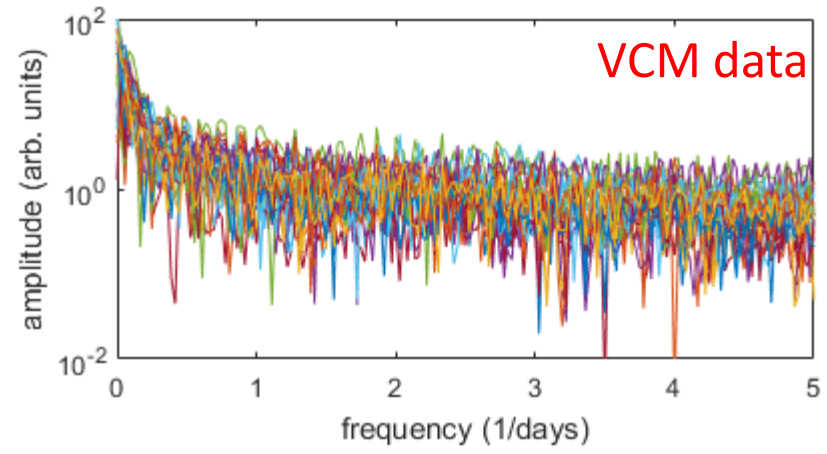
HLS looks to show a tidal pivot along this line

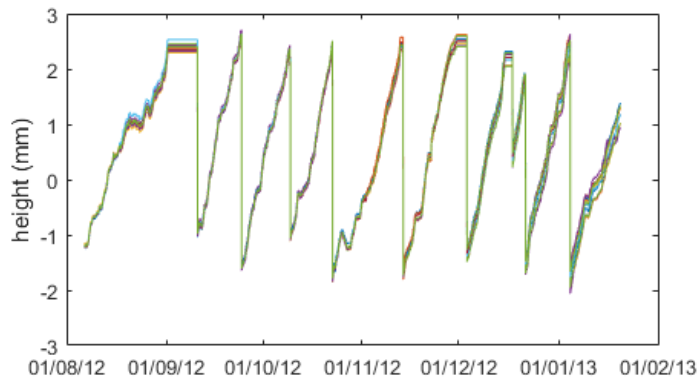
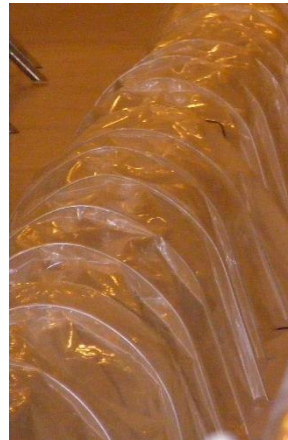
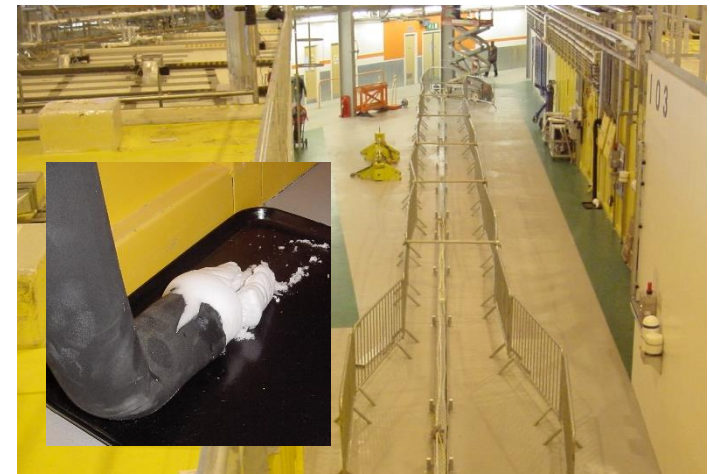
- **Regular top-ups** to water level required
- **Thermal effects** apparent for sensors close to external loading doors (improved when garden cloches added)
- **Air bubbles trapped** in system (some high points particularly problematic)
- **Adjustments in pipework** during beamline installations
- **Faulty sensors**
- **Slow leaks** – water level has to be regularly topped-up giving discontinuities and settlement times in data (typically ~300 ml every 3 weeks, but up to 100 ml per day in worst case)
- **Water in air pipes** after DDBA installation
