ELENA electron cooler status

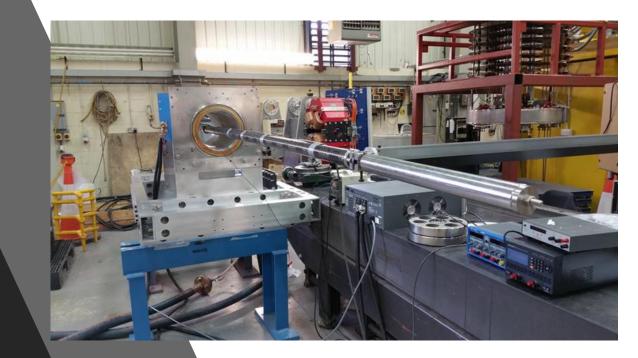
Measurement Setup

- Lakeshore Model 460 Gaussmeter with 3-axis HSE probe (1 mG resolution in range up to 300 G, accuracy of ±0.1%).
- Probe holder with mirror for precise alignment. Has 4 possible rotational positions with 3 mounting points (0, 10 and 25 mm).
- Counter balanced carbon fibre tube to hold probe holder.
- Probe carrier and tube driven and positioned with a CMM arm with ± 0.5 mm accuracy.
- Precise probe alignment made with an autocollimator and spider fixtures.

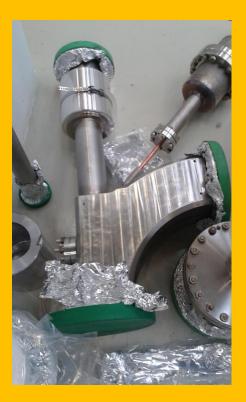
Toroid chamber during acceptance tests

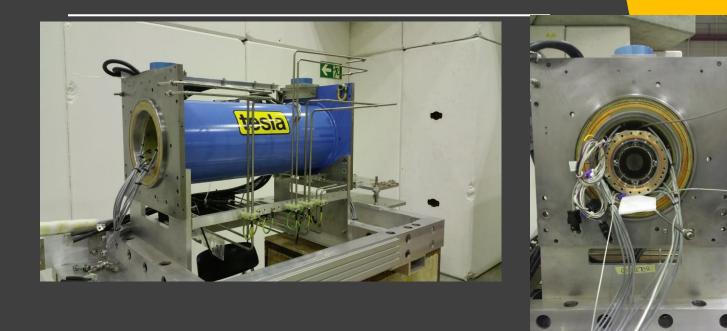
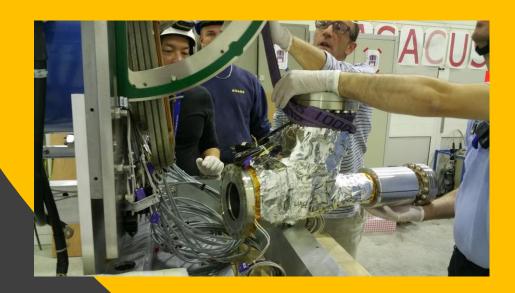
The electron cooler was mounted in the AD hall during November Connected to ELENA beginning December Bake-out has just finished <u>There is a leak! Vacuum level reached after bakeout: 2E-9 mbar!!!</u>
