A Multi-Layer SEU Mitigation Strategy to Improve FPGA Radiation Robustness for ATLAS Upgrade

X. Hu, S. Hou, T. Schwarz, B. Zhou

University of Michigan

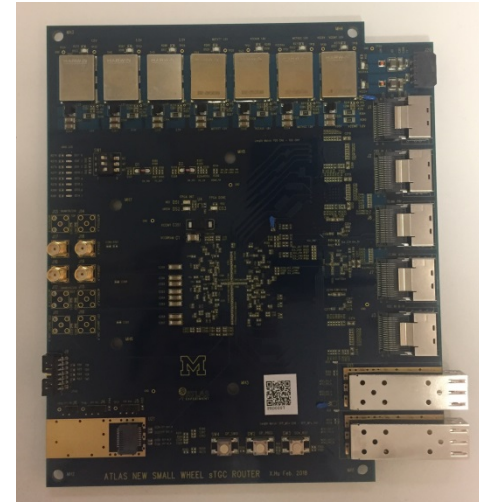
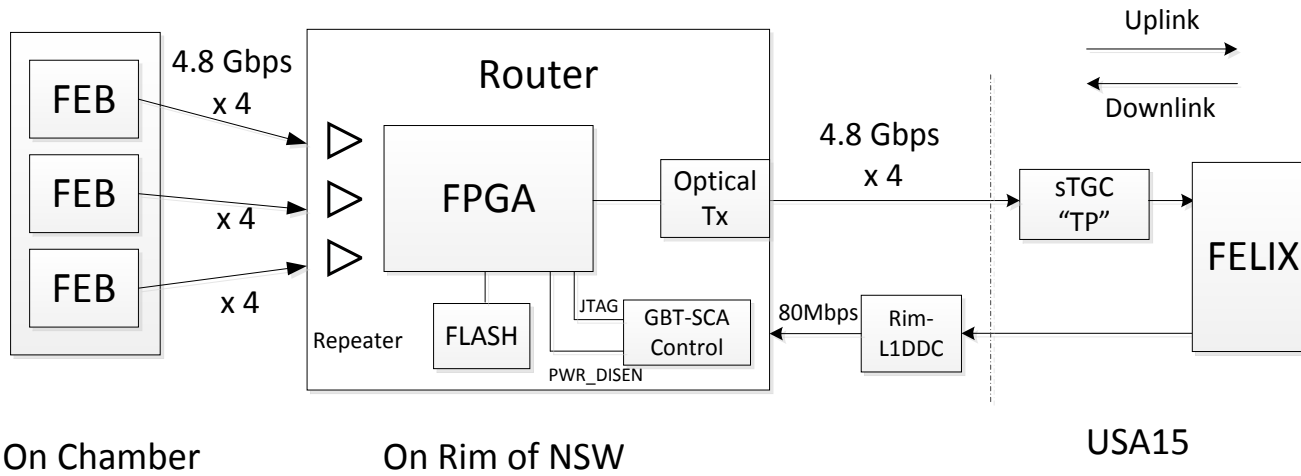
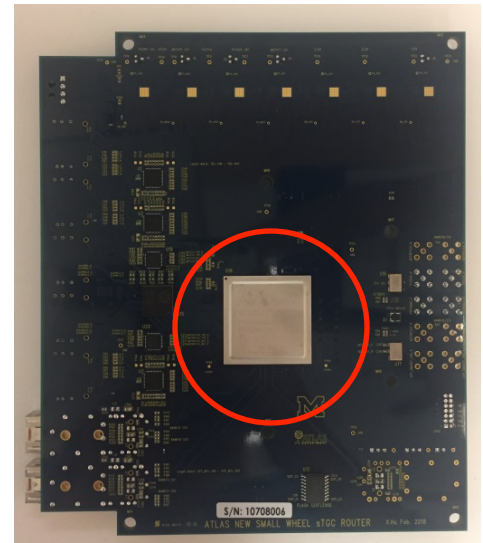
Illustration of serial signal streams through one router in the NSW

- Functionality:
 - Route active strip signals from FEB strip TDS to trigger processor at USA15 and drop NULL packets
- Central Processing Unit:
 - Fixed latency: trigger chain
 - 12-to-4 fast switching: limited bandwidth
 - Giga-bit transceivers: 4.8Gbps data flow

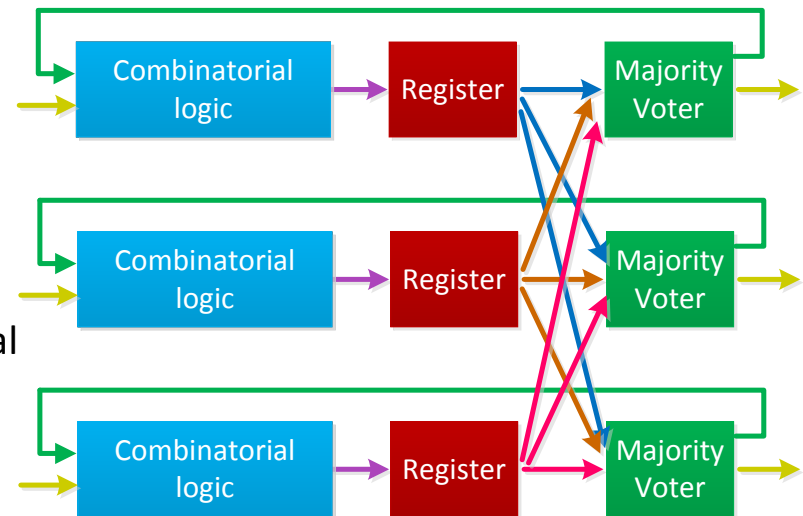
- Triple Modular Redundancy
 - Triplication with 3 voters in fabric design
 - Defeated by MBU
- Soft Error Mitigation Controller
 - Essential bits in CRAM will lead a functional failure
 - Enhanced repair mode: correct single-bit error or double-bit adjacent errors

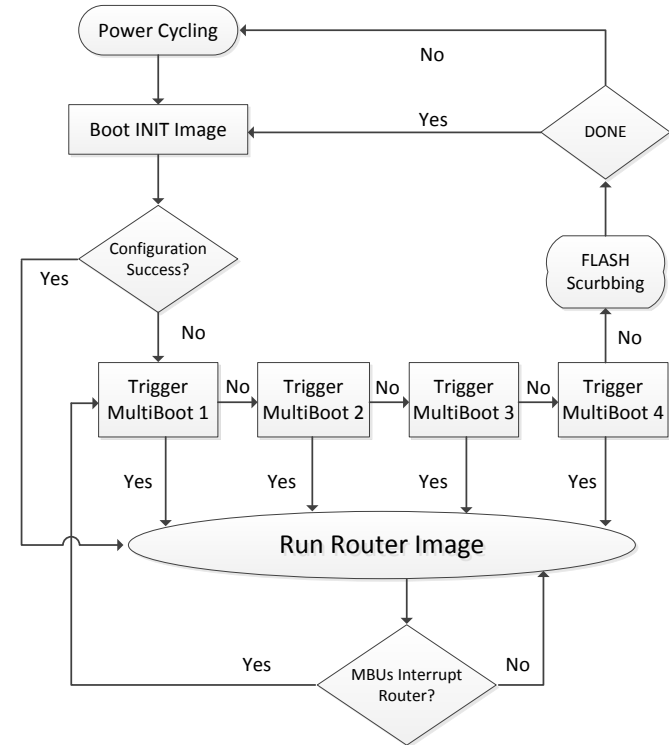
Router Multi-Boot Auto Scrubbing Flow diagram

- Flash Multi-boot Auto Reconfiguration
 - Multiple firmware copies
 - Artix-7 bit stream compress mode: ~4MB
 - 6 copies
 - SPI *4 mode: 4 seconds
- Remote JTAG Reconfiguration
 - Already exist in NSW Trigger Chain
 - CERN GBT link + slow control SCA
 - 9 Seconds: fully scrubbing FPGA
 - Also be able to do FLASH scrubbing

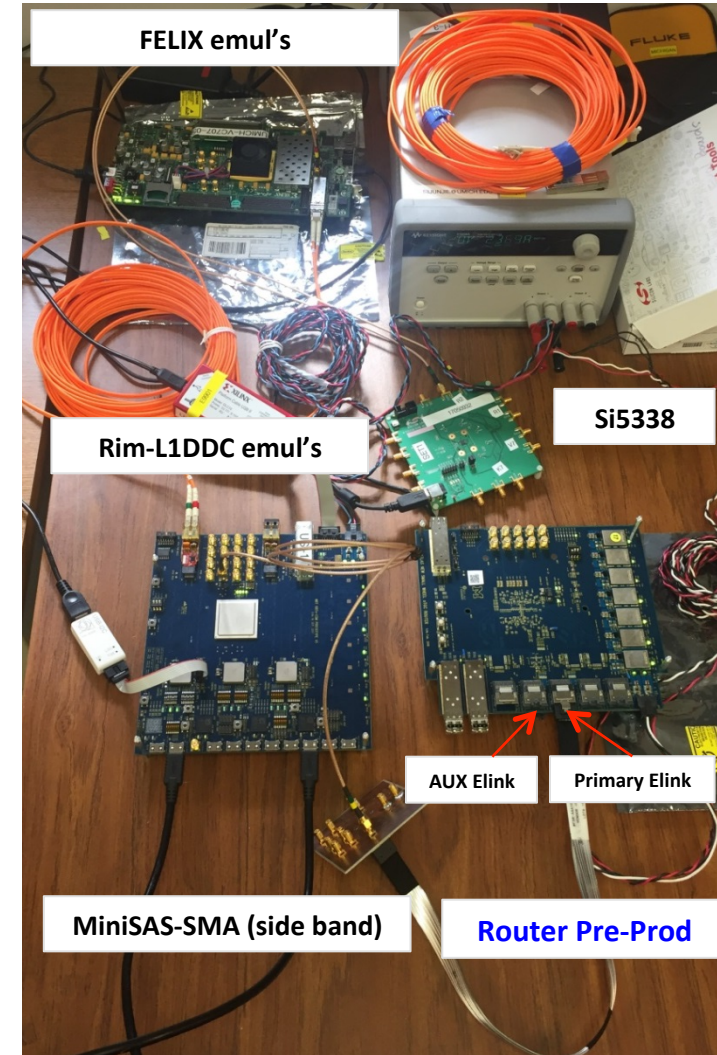
Router Remote power cycling evaluation platform

- Remote Power cycling
 - Control the enable signal of power chip (FEAST)
 - Cooperate with proper power-on sequence of FPGA → Only control the first stage
 - Test platform
 - VC707: simulate partial FELIX fun.
 - GBTx-CSM: simulate Rim-L1DDC
 - VTRx -> GBTx -> GBTx-SCA GPIO -> SMA
 - MiniSAS-SMA: sideband A10 connected
 - SMA-> Router Elink Interface B10
 - Router v-pre: DUT

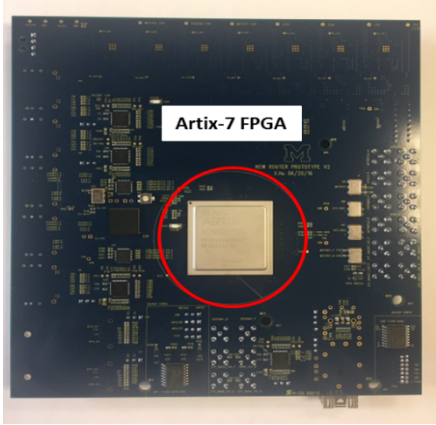
Router Top View

- Mocking Router running @ NSW
 - VC707: 12 CHs fake “TDS signal Generator”
 - Router**: Artix-7 DUT FPGA
 - Router v1: 4 CHs fake “Trigger Processor Checker”
 - KC705: Rim-L1DDC emul’s + Ethernet

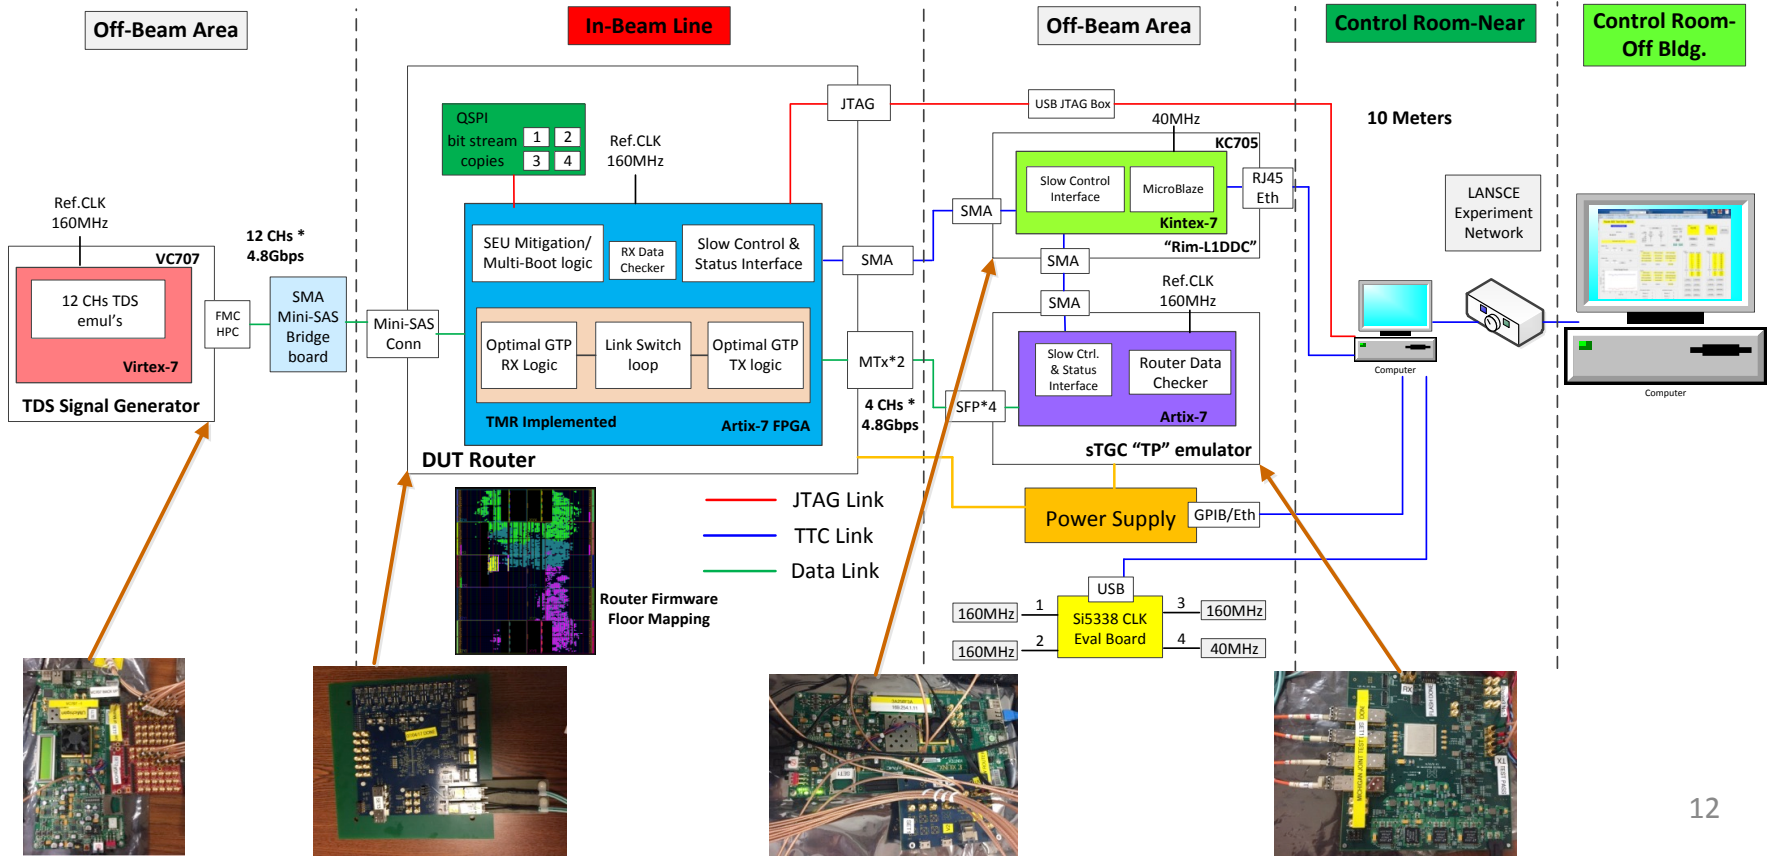
- Router DUT Firmware
 - Deserialization (GTP RX) + Flexible Router (12-to-4) + Serialization (GTP TX)
 - SEM+ Multi-boot trigger
- Auxiliary Firmware

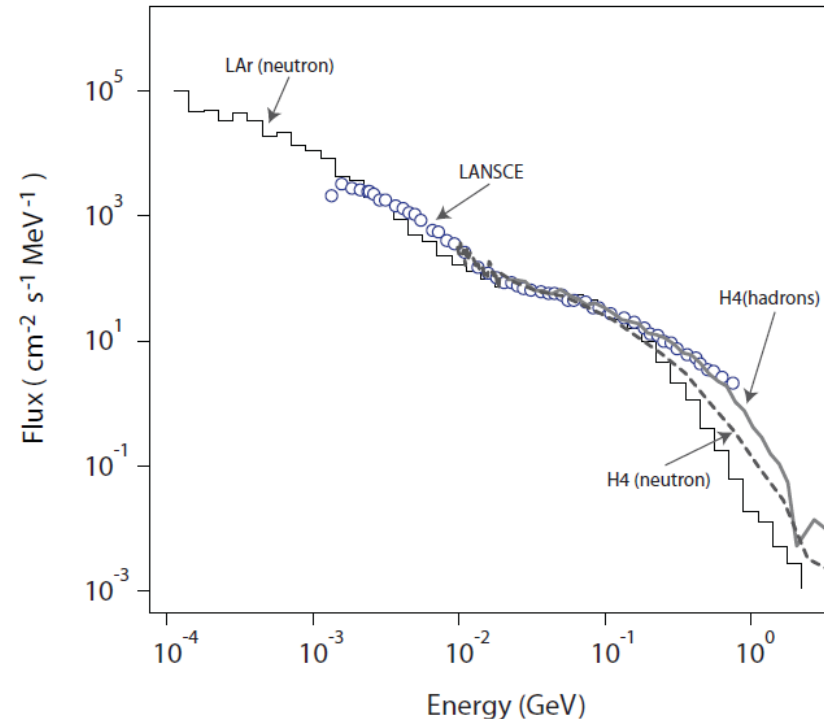
**LANSCE Beam spectrum
matched well with ATLAS LAr**

**Beam Degraded Factors
Router Set #1: 0.868
Router Set #2: 0.844**

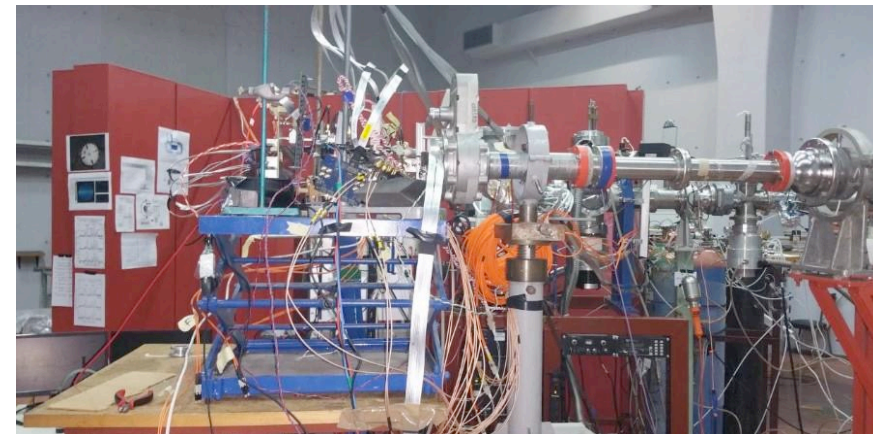
- In total, 17 soft failures observed
- Beam energy 24MeV with 10* parasitic rates makes router links unstable (This Rate is not expected at NSW Rim)
- 9 soft failures accumulated in 5 hours 30 mins at comparable flux for comparison with Los Alamos Test (~800MeV)

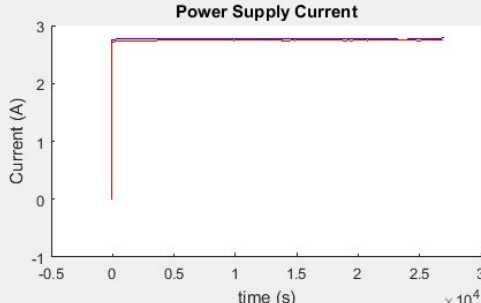
Run I Result Example: ~7.5 Hours
 Set 1: 23 soft failure + 0 hard failure
 Set 2: 27 soft failure + 0 hard failure

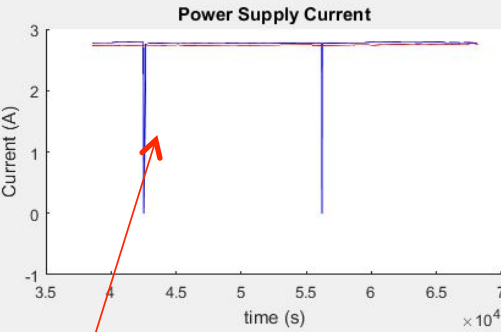
Run II Result Example: ~19 hours
 Set 1: 43 soft failures + 3 hard failures
 Set 2: 40 soft failures + 1 hard failures

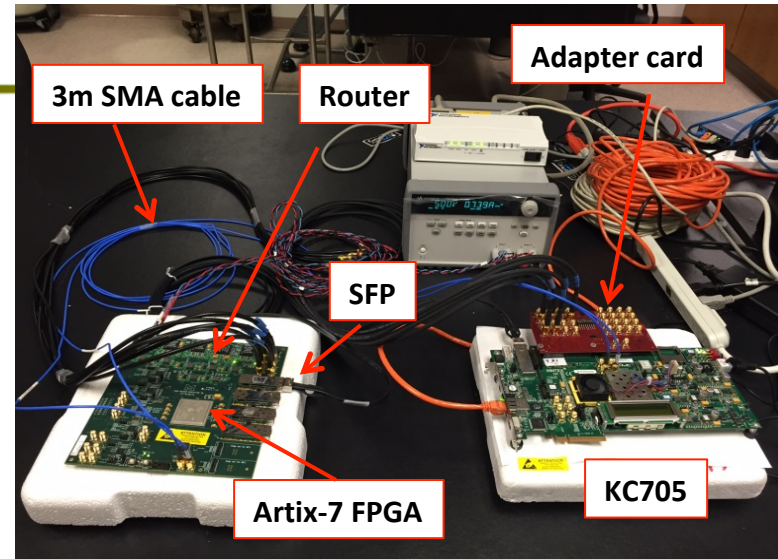
- Artix-7 FPGA TID test
 - Test Two prototypes
 - Test 3 data channels @ 4.8Gbps with PRBS-31, measure BER
 - Monitor current/voltage/die temperature information via SFP (8b/10b)
- Firmware Implementation
 - DUT firmware: PRBS-31 Gen+ GTPs+ 8b/10b coding scheme
 - DAQ firmware: MicroBlaze (MB) soft processor + Ethernet+ + PRBS-31 Checker + GTXs

FPGA TID Test system @ UM
 Lab Stress test @ 40 hours NO ERROR

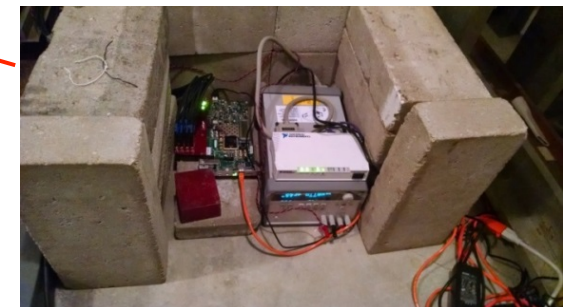
Current & Power consumption of router #2 5V Input CH 1 (Digital) ~550kRad

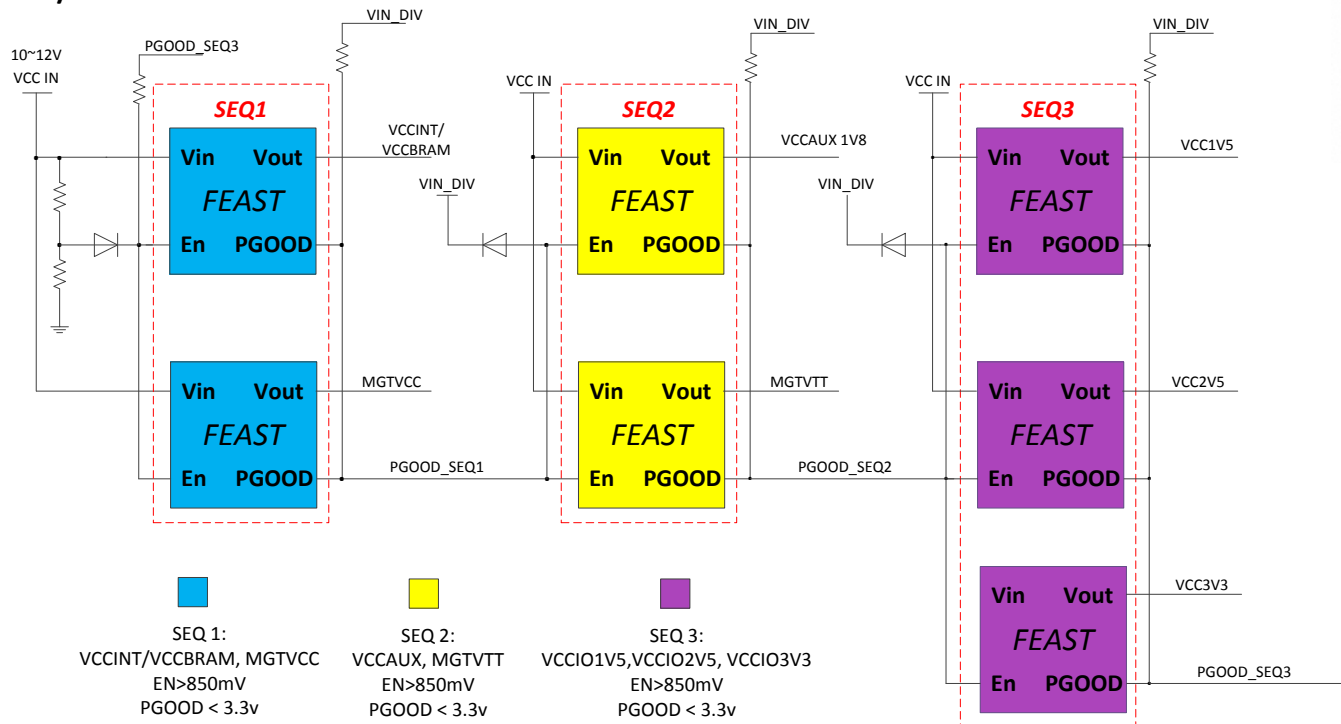
43650-0401

- Connector: Micro-Fit 3.0 43650
- Input Voltage: 10~12V max
- Power Consumption: 13W (Xilinx XPE tool), 9W max (tested on router prototype v2)
- FEAST: 1 CH. , current max 4A
- Power-on SEQ: Xilinx Requirement
- 7 FEAST/Router
