MWPCs path to stability

M.Alexeev

Turin University & INFN sez. Torino

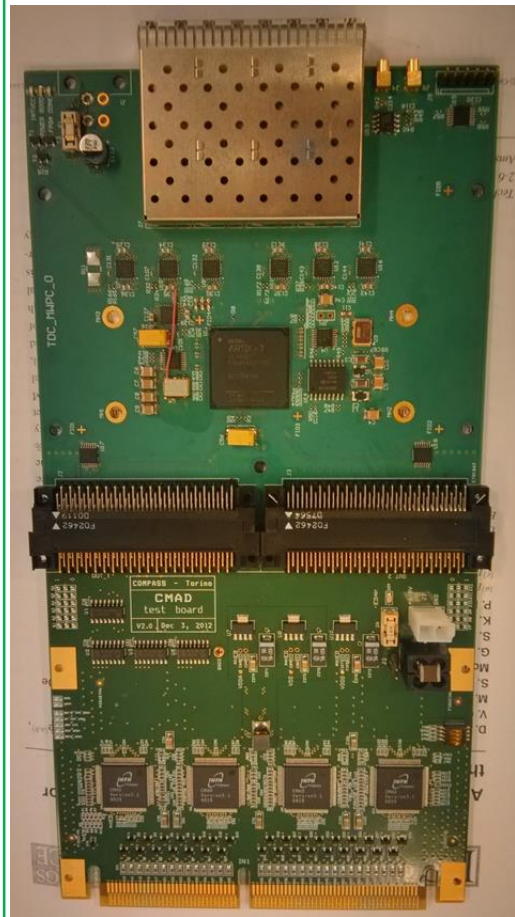
Long term upgrade validation

- FPGA based TDC
- Single card configuration
- Optical readout(IPbus + UDP)
- Separate digital and analog parts

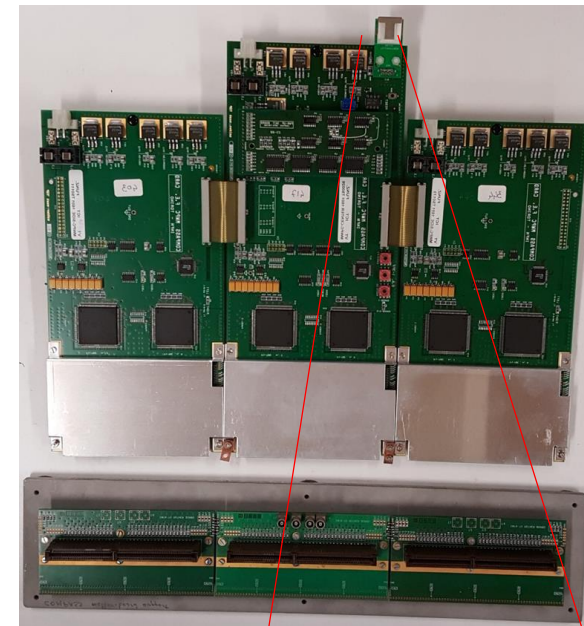
Urgent R/O stability fix

- Get rid of the connector

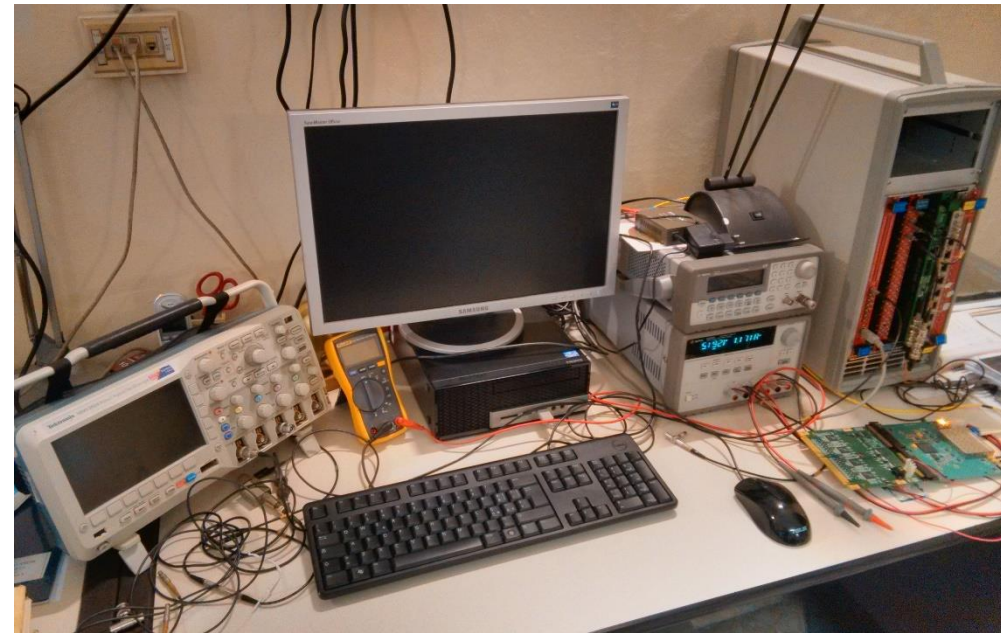
Long term upgrade validation

- The initial planning was foreseeing the test of single card during the last days of the 2017 data taking. Due to a configuration problem only the DAQ implementation part was tested with success. The card had a low efficiency due to wrong THR settings.
- Laboratory test of the problem was performed and the error in the THR programming fixed.
- Presently the test for the high trigger rate and consecutive double pulse noise was delayed to the beginning of March due to manpower issues.

- Mid March validation in laboratory conditions
- TB presentation
- Possible installation in the beginning of April

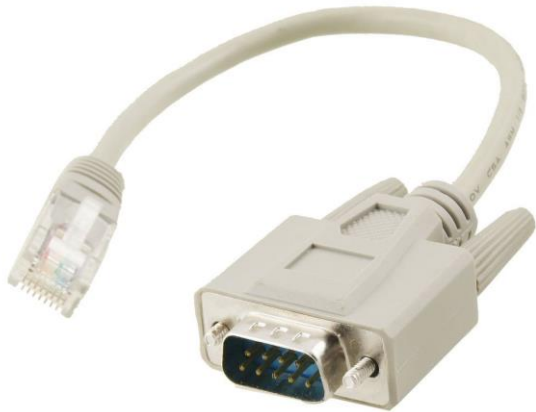
- The main problem of the connection was traced to the RJ45 connector that apparently has contact degradation.
- We came to the idea to try to substitute the RJ45 altogether with a com port connector that is a time proven solution.
- This modification would require the exchange of both the FE and the Hotlink cable connector.
- Presently a prototype is ready to be tested to validate the idea.

If the prototype does not show any problem we would prepare the substitution of 36 FE cards & cables to be able to equip the 3 most problematic chambers (PA03-05) that were responsible for the majority of the MWPCs problems in 2016-2018.
