SPring-8 Storage Ring RF system

Presented by: Shigeki SASAKI

Slides prepared by: Hiroyasu EGO

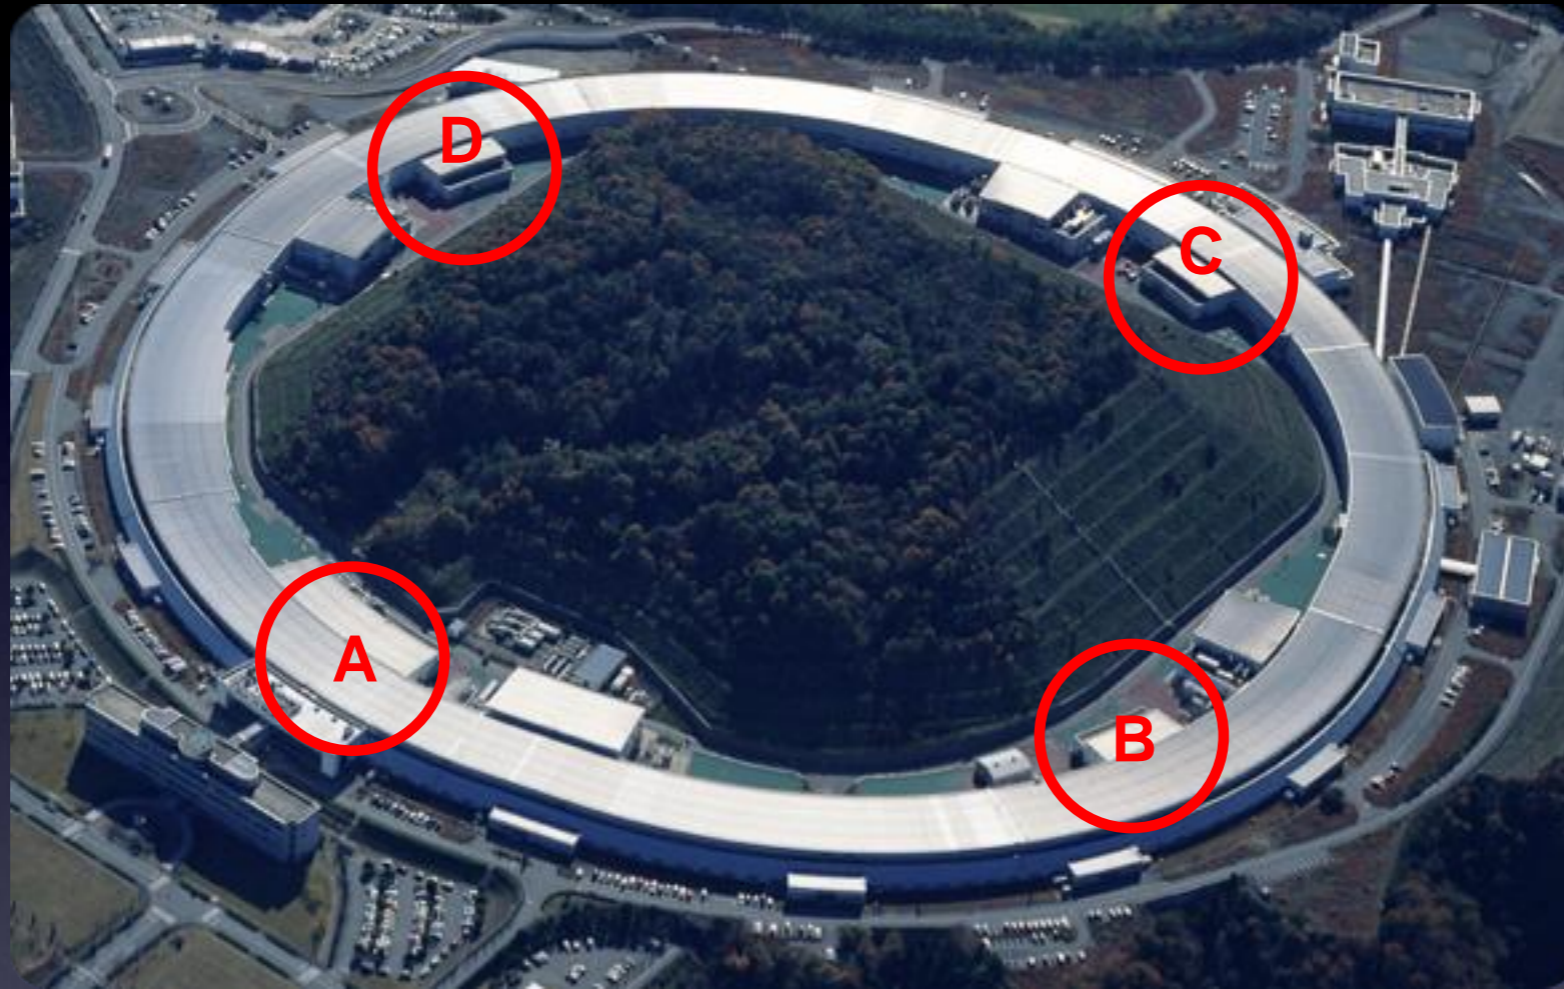
RF stations

Four RF systems in storage ring
named A-, B-, C- and D-station

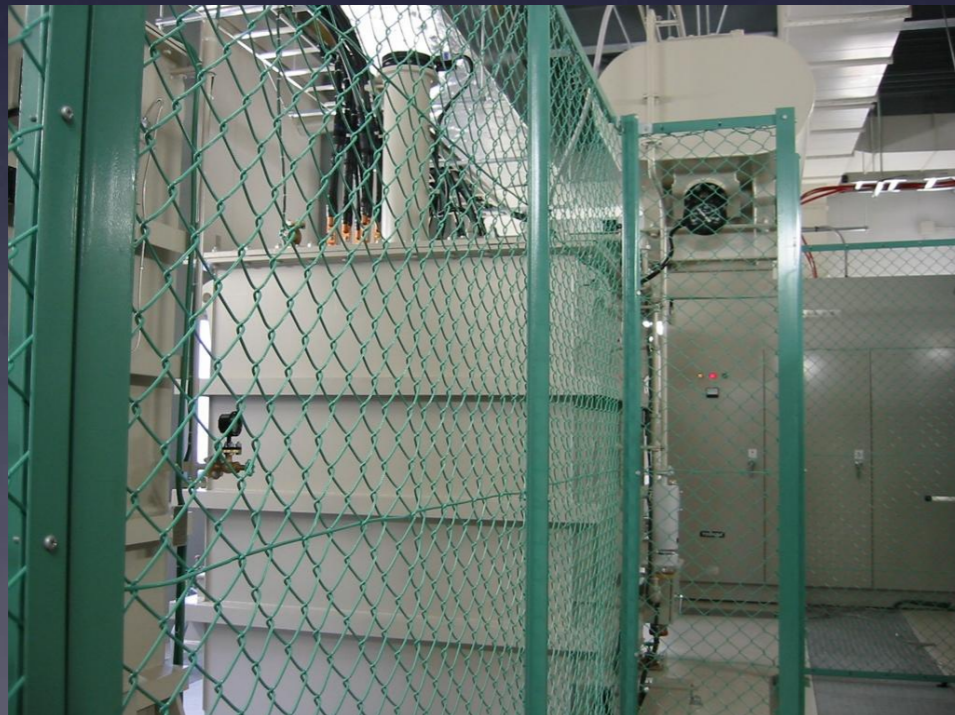
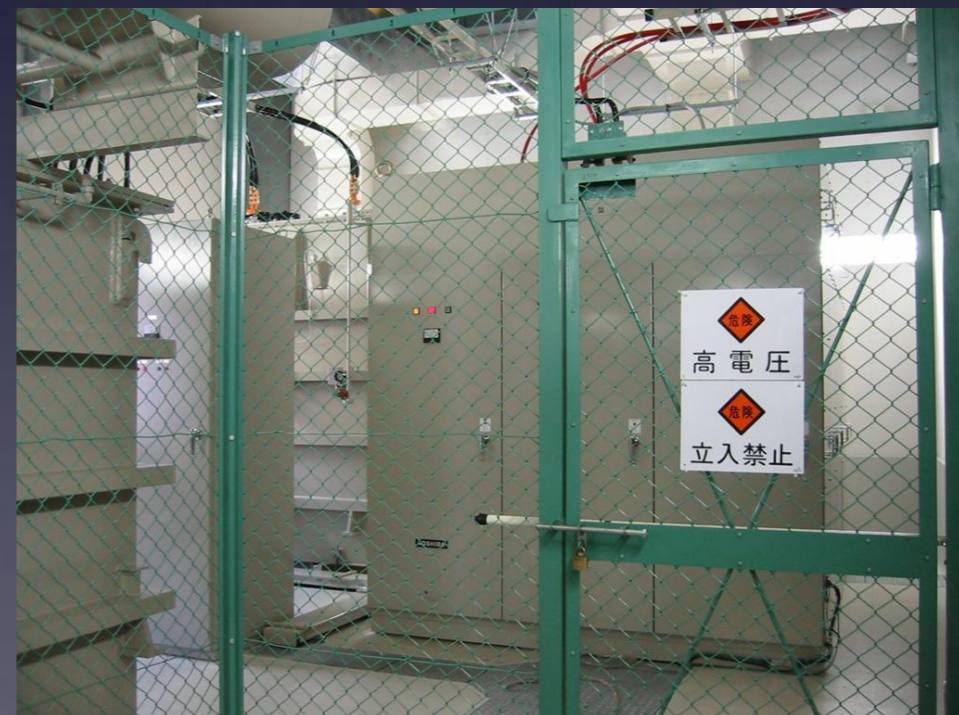
klystron power supply

- Thyristor-regulated type
- No crowbar circuit
- Six-phase rectifier circuit
- Ripples at multiples of 360 Hz : $\delta V/V \sim 10^{-3}$

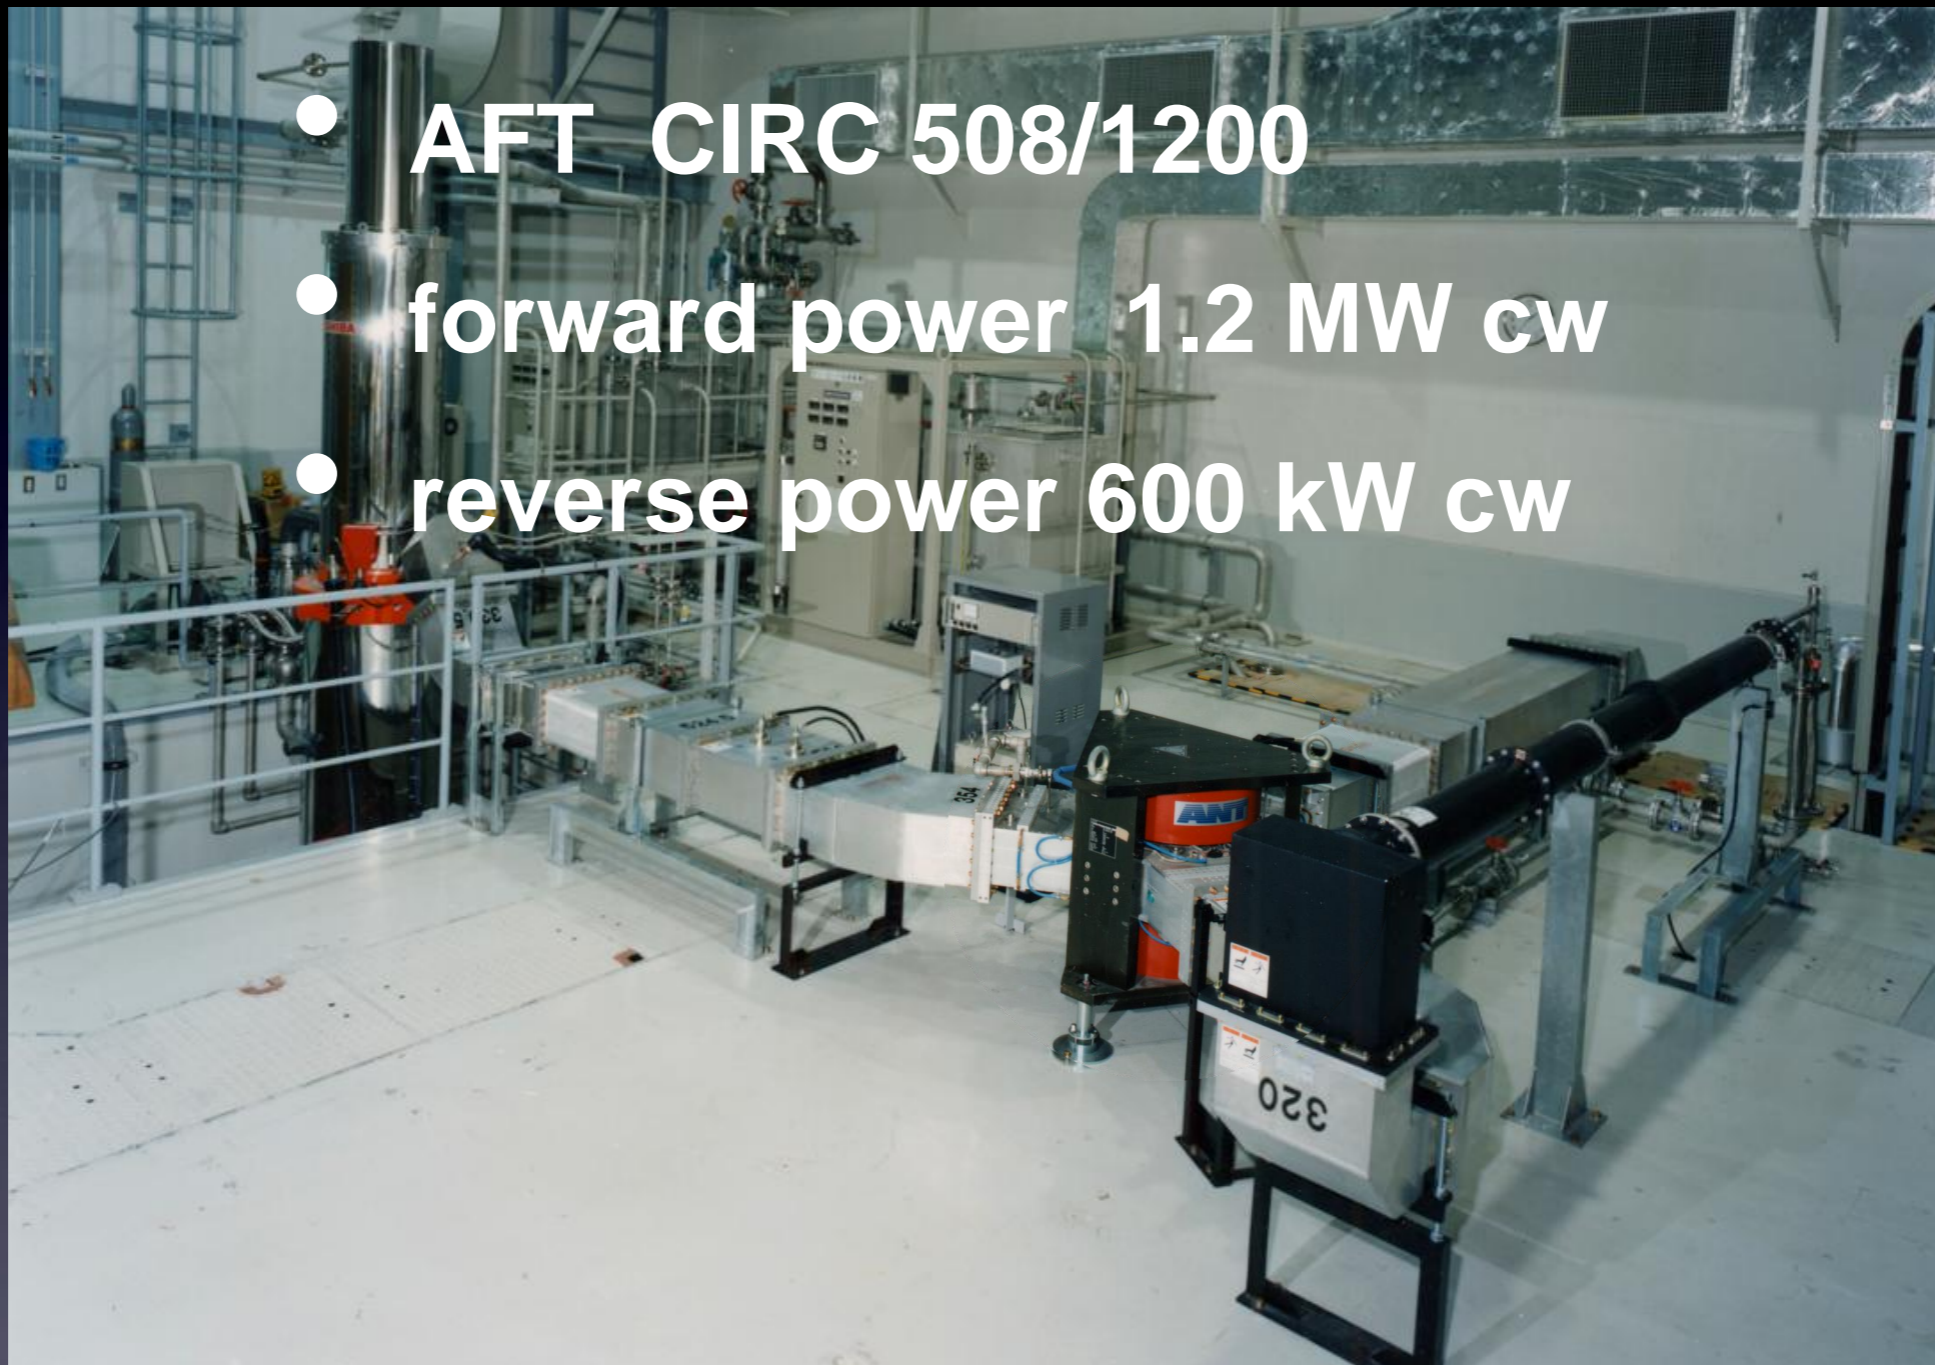
Y-junction circulator

- AFT CIRC 508/1200
- forward power 1.2 MW cw
- reverse power 600 kW cw

- Arc detection
- Water leakage at cooling pipes

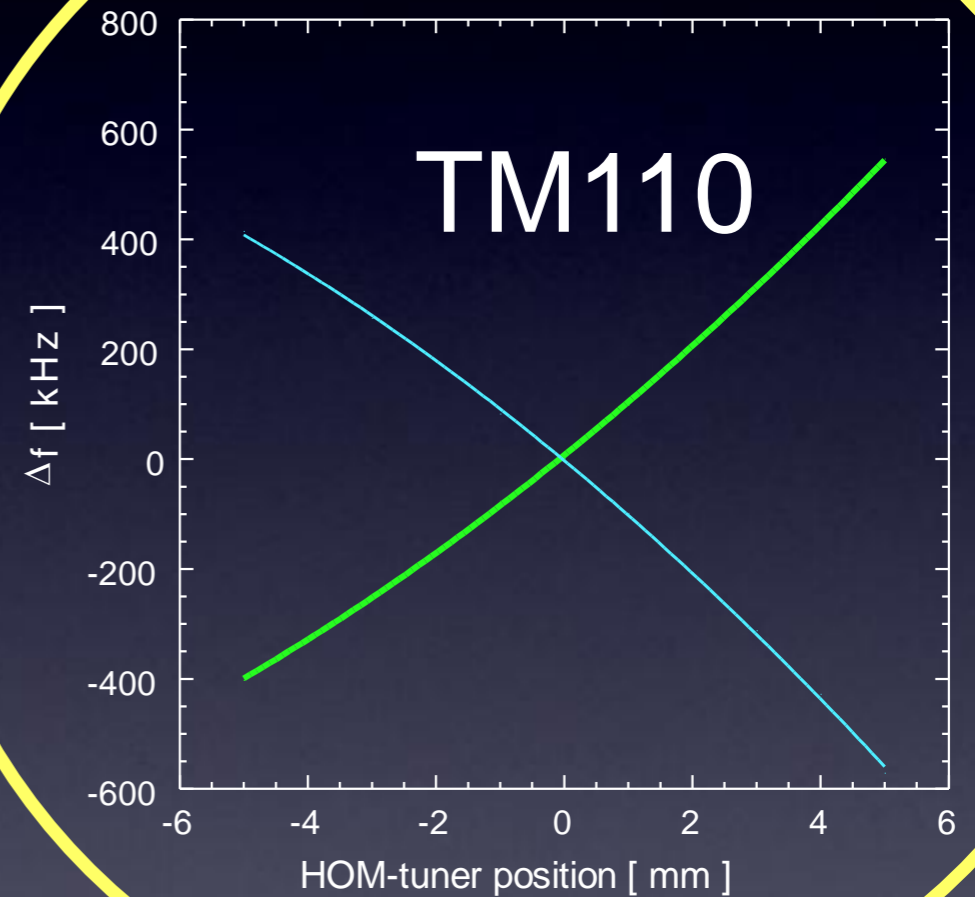
HOM frequency tuner avoiding the CBI conditions

TM010-tuner keeping the TM010 frequency 508.58 MHz

HOM frequency tuner

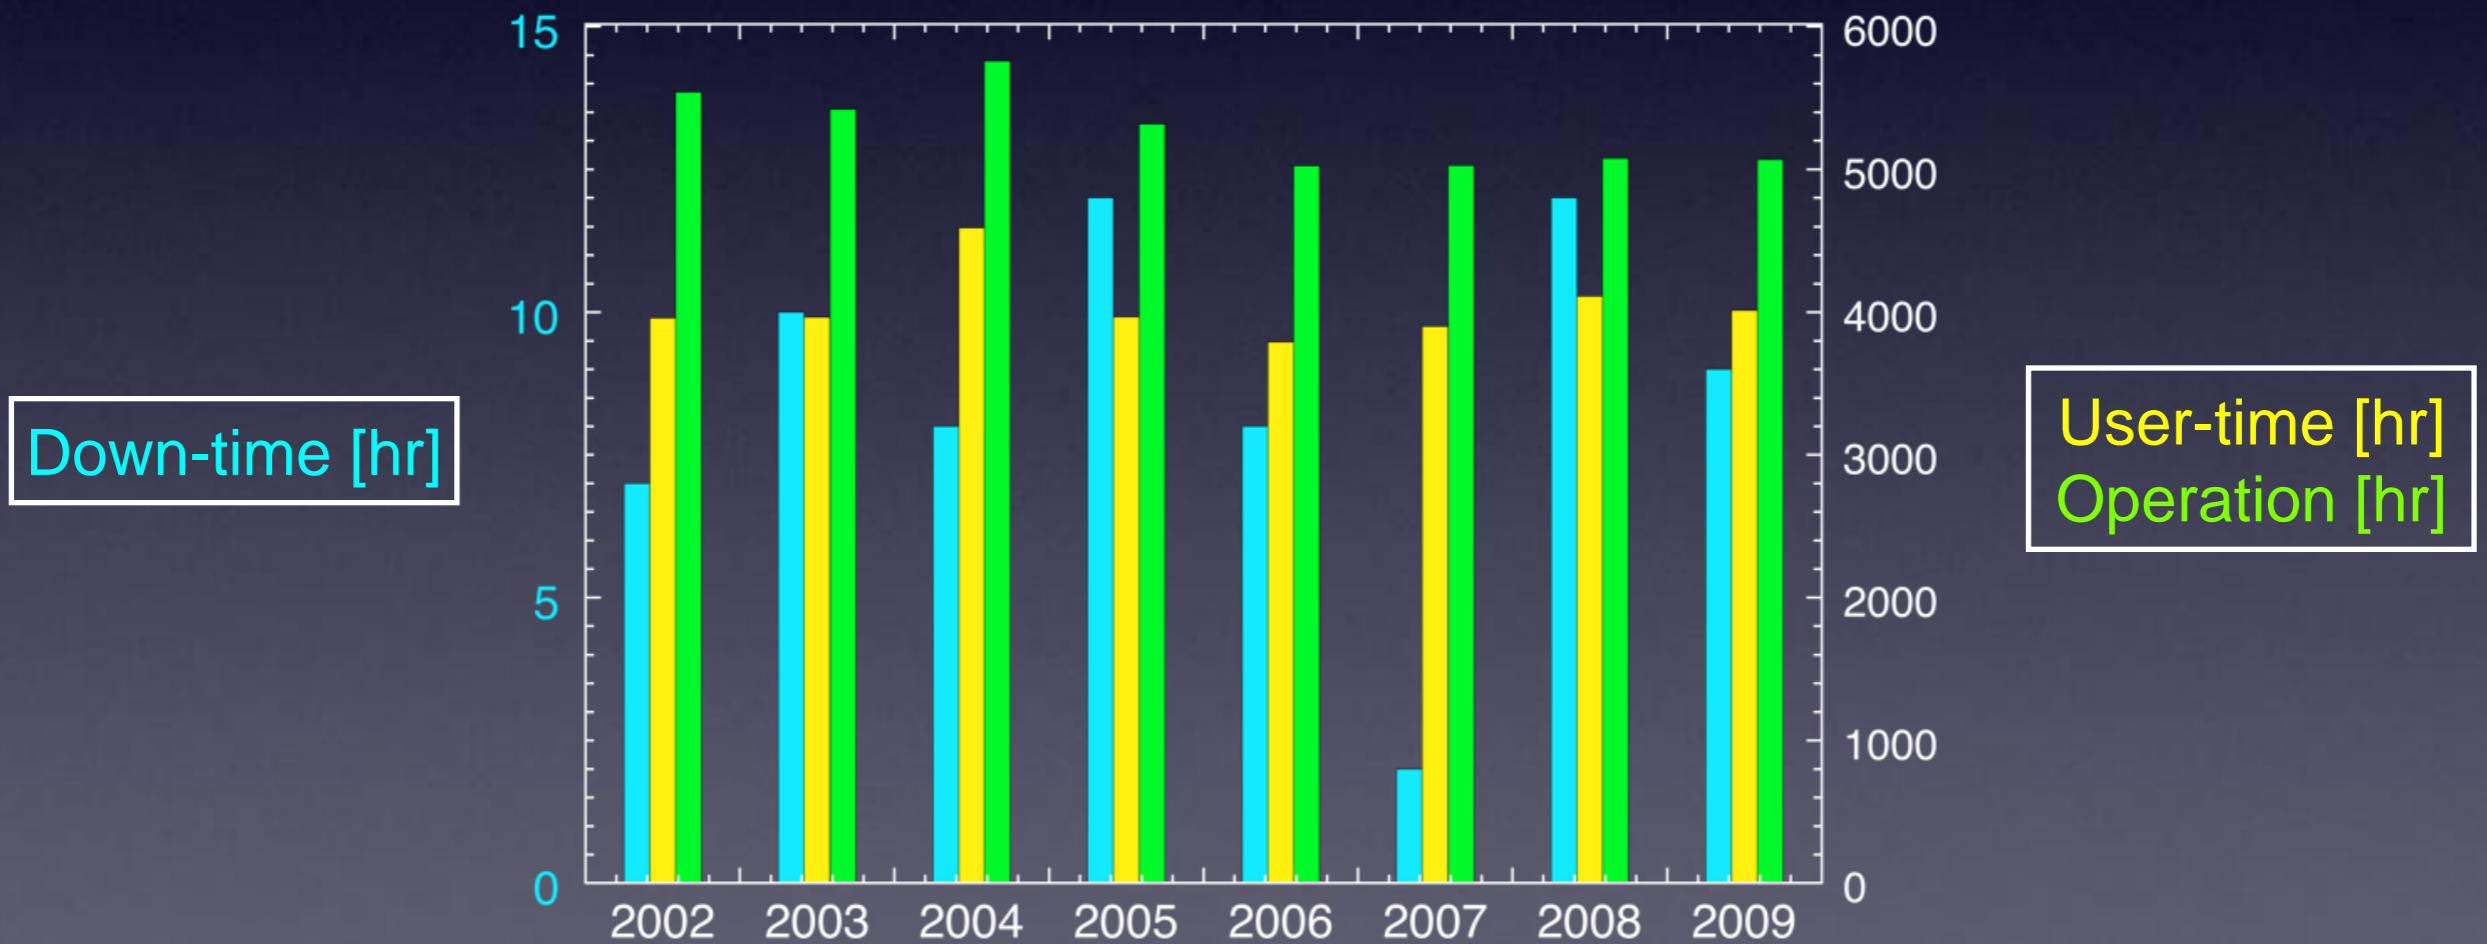
Mean annual down-time by the troubles of RF system

8 hours (2002-2009)

user-time 4000 hours / operation 5300 hours
