# Status and Plans of MQXFA Magnets

Giorgio Ambrosio – Fermilab

8<sup>th</sup> HL-LHC Collaboration Mtg – October 15 - 18, 2018

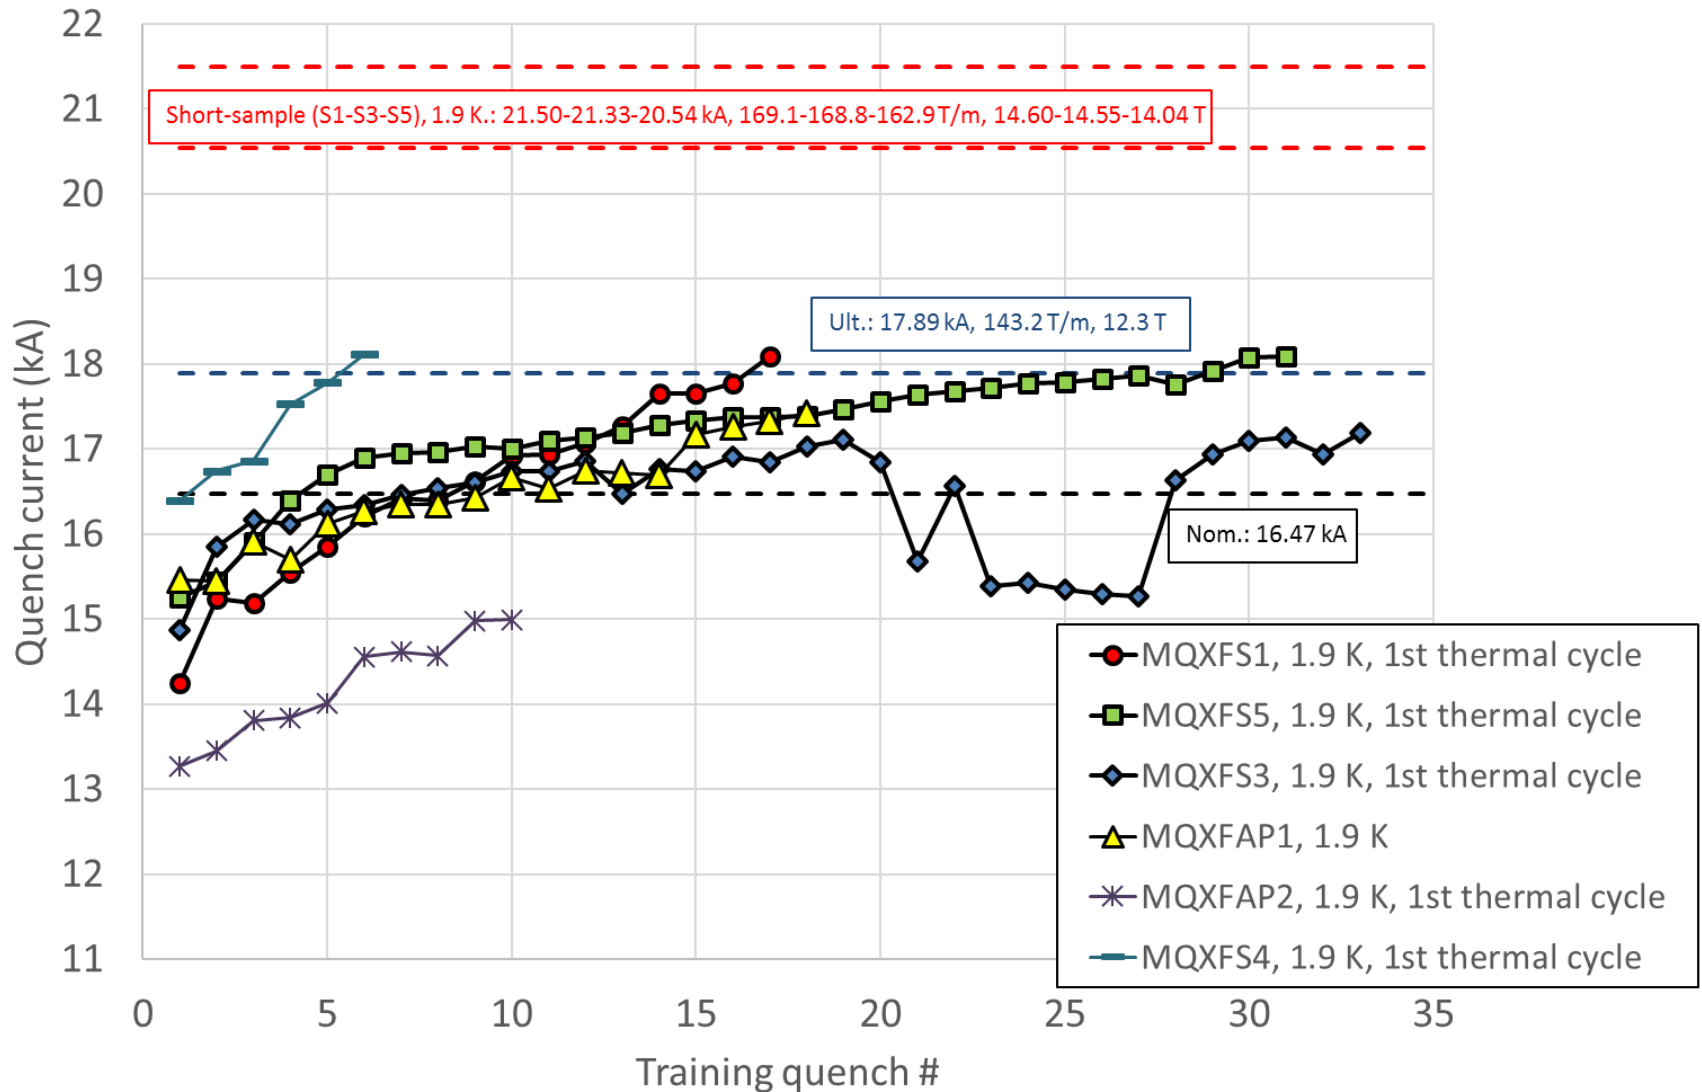
# MQXFAP2 Quench History

- See presentation by J. Muratore

- Why did MQXFAP2 training start so lower than all other MQXF magnets?
- Exploration in progress:
  - Pre-stress, pole-key gap, coil-collar interface appear within range of previous magnets
  - Quench Antenna “*may be showing all quenches starting close to return end*” (Work in progress)
  - All voltage taps in Inner Layer Return End lost
