CMS Phase-1 Pixel Detector :

Operational Experience, Performance and Lessons Learned

Atanu Modak

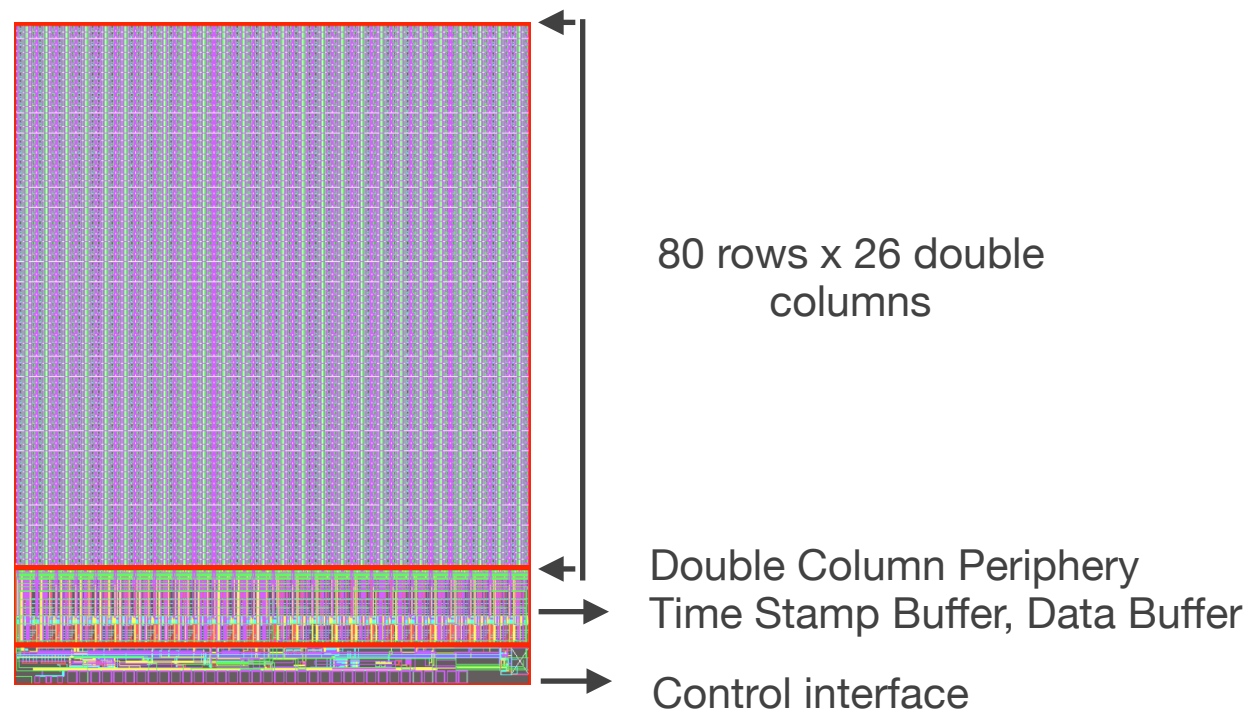
Layout of the read out chip (ROC)

- 8 bit ADC for pulse height
- Increased buffer size for timestamp (24) and data (80)
- On chip digitization, readout at 160 Mbps
- Mainly two flavors of ROC:
 - PROC600 for Layer-1 and psi46dig for rest
 - Data rate: PROC600 - 580 MHz/cm², psi46dig - 150 MHz/cm²
 - Data Drain: PROC600 - dynamic cluster draining, psi46dig - double column drain

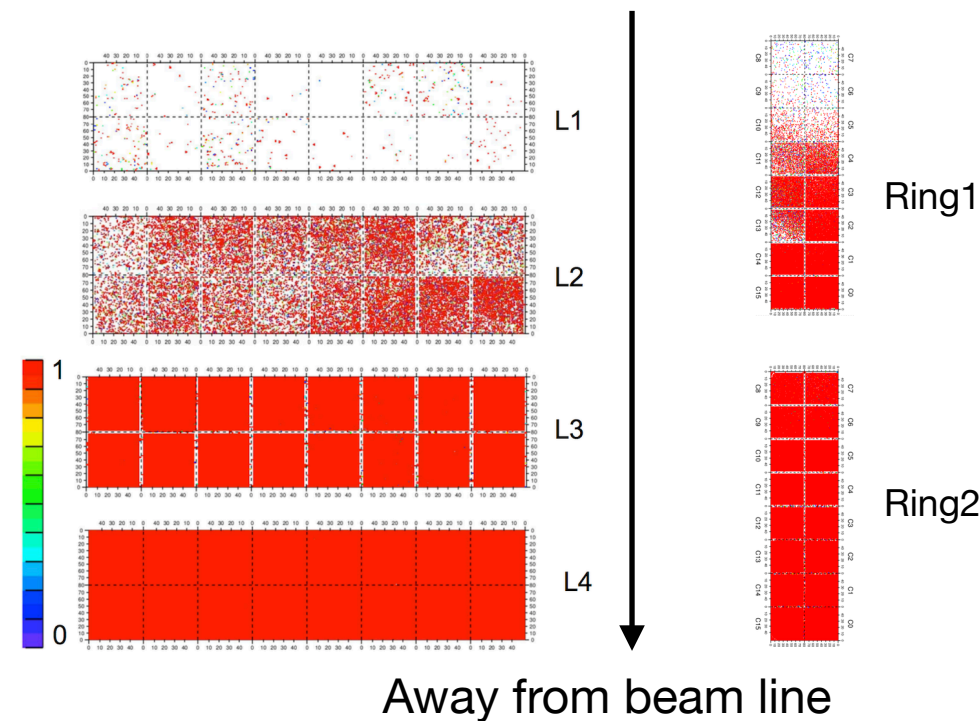
Beginning of 2018: 97.3% Active detector

Tot ROC	Inactive	%Active
L1	1536	56	96.4
L2	3584	224	93.7
L3	5632	88	98.4
L4	8192	48	99.4
Ring1	4224	290	93.1
Ring2	6528	88	98.7

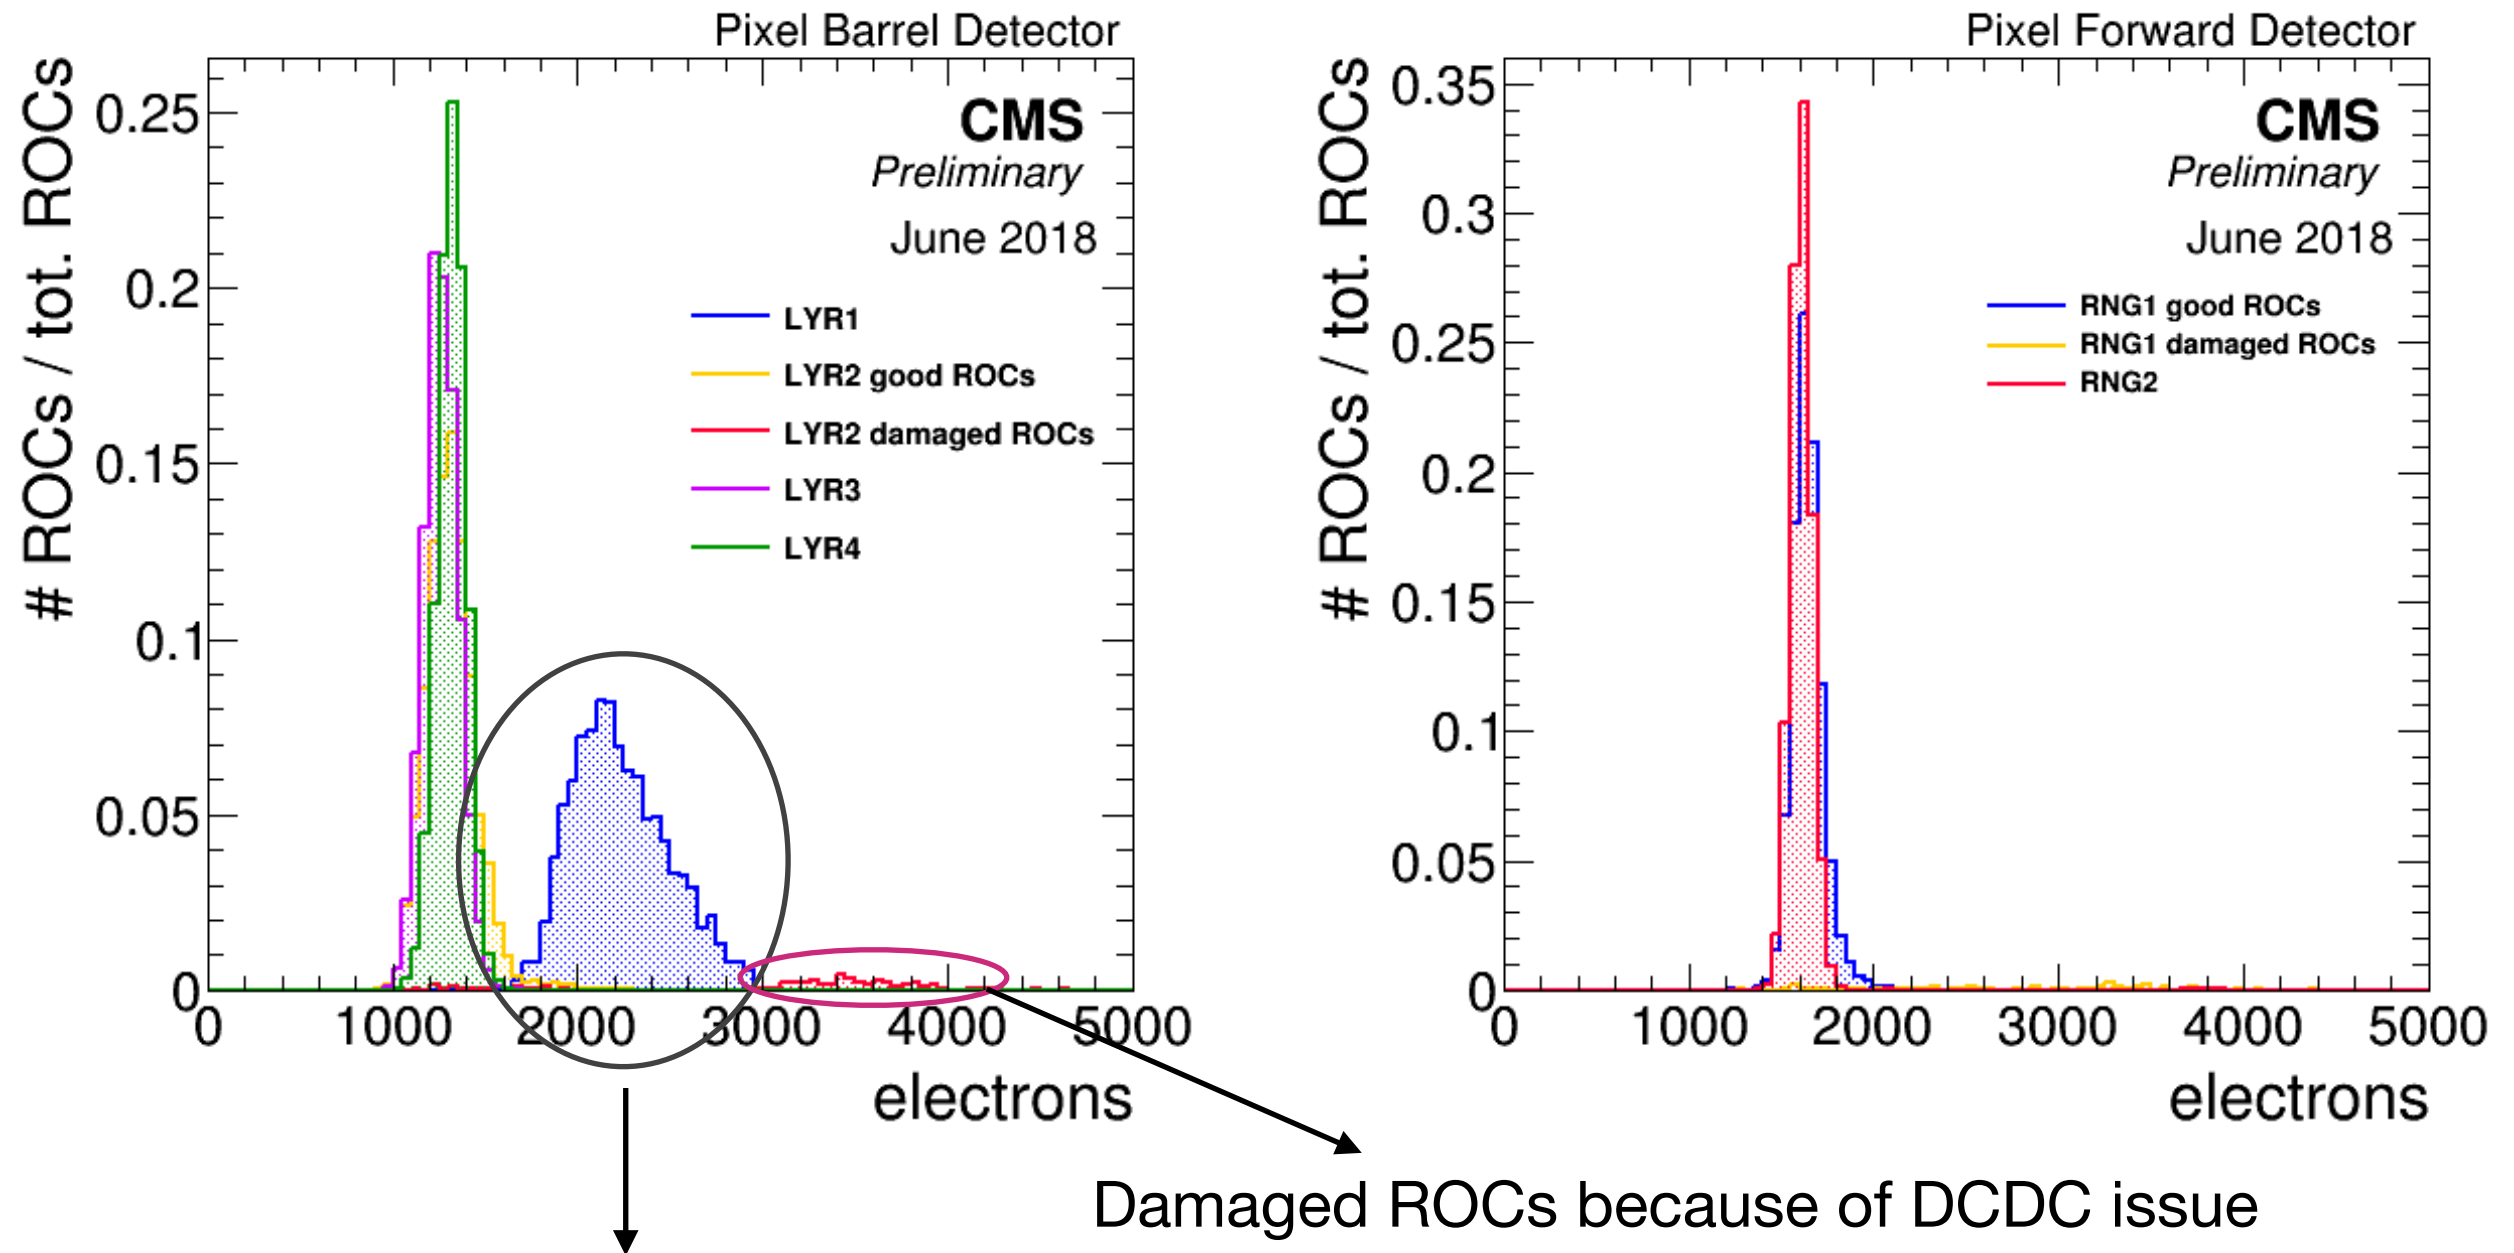
Detector Thresholds:

- Higher threshold in Layer-1 due to cross talk noise
- Changed programming sequence of the ROC to mitigate the issue, recovers hit efficiency
- Problem is being addressed in new version of PROC600

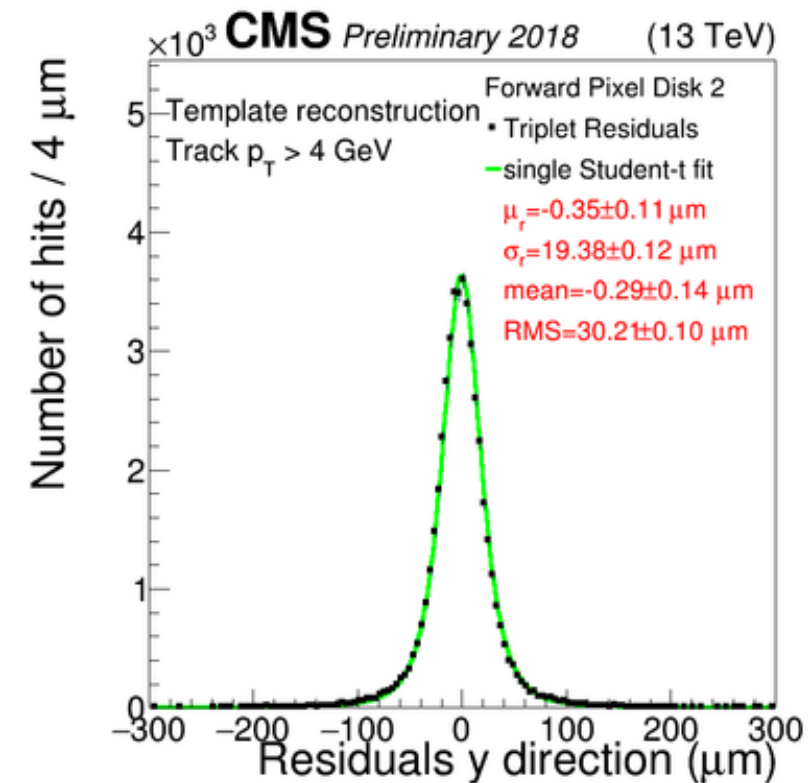
Precision Tracking, Residuals:

$z : 22\mu\text{m}$

Layer-3

$x : 12\mu\text{m}$

Disk-2

$r\phi : 9.5\mu\text{m}$

$y : 19\mu\text{m}$

Excellent hit residuals/resolutions
