XBOXes Update

22/05/2019

XBOX team

Summary

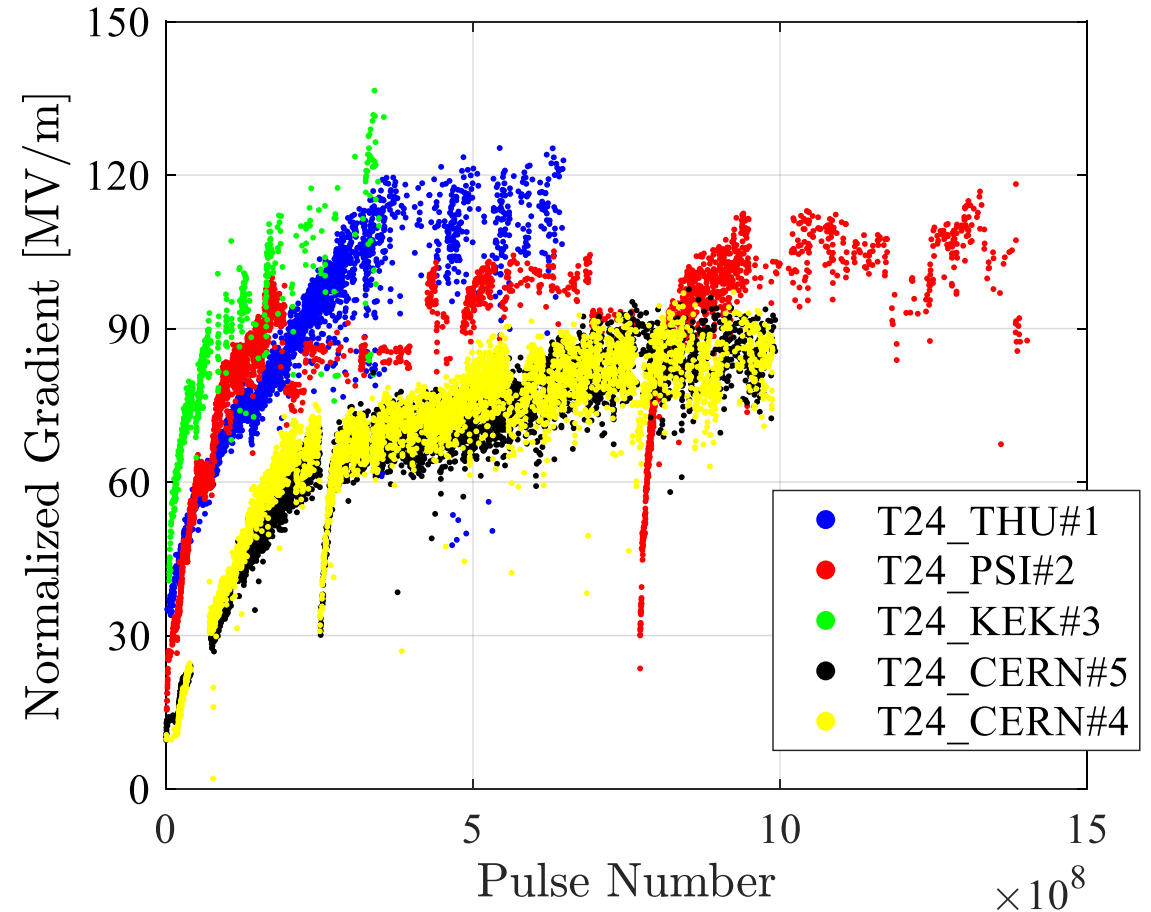
T24 comparison

Ramping speed is slower than the previous T24s

Further investigations need to be carried out
