Linac4 3 MeV Run – August 2019

G Bellodi for the whole Linac4 team

Plans for 3 MeV summer run (5-23 August)

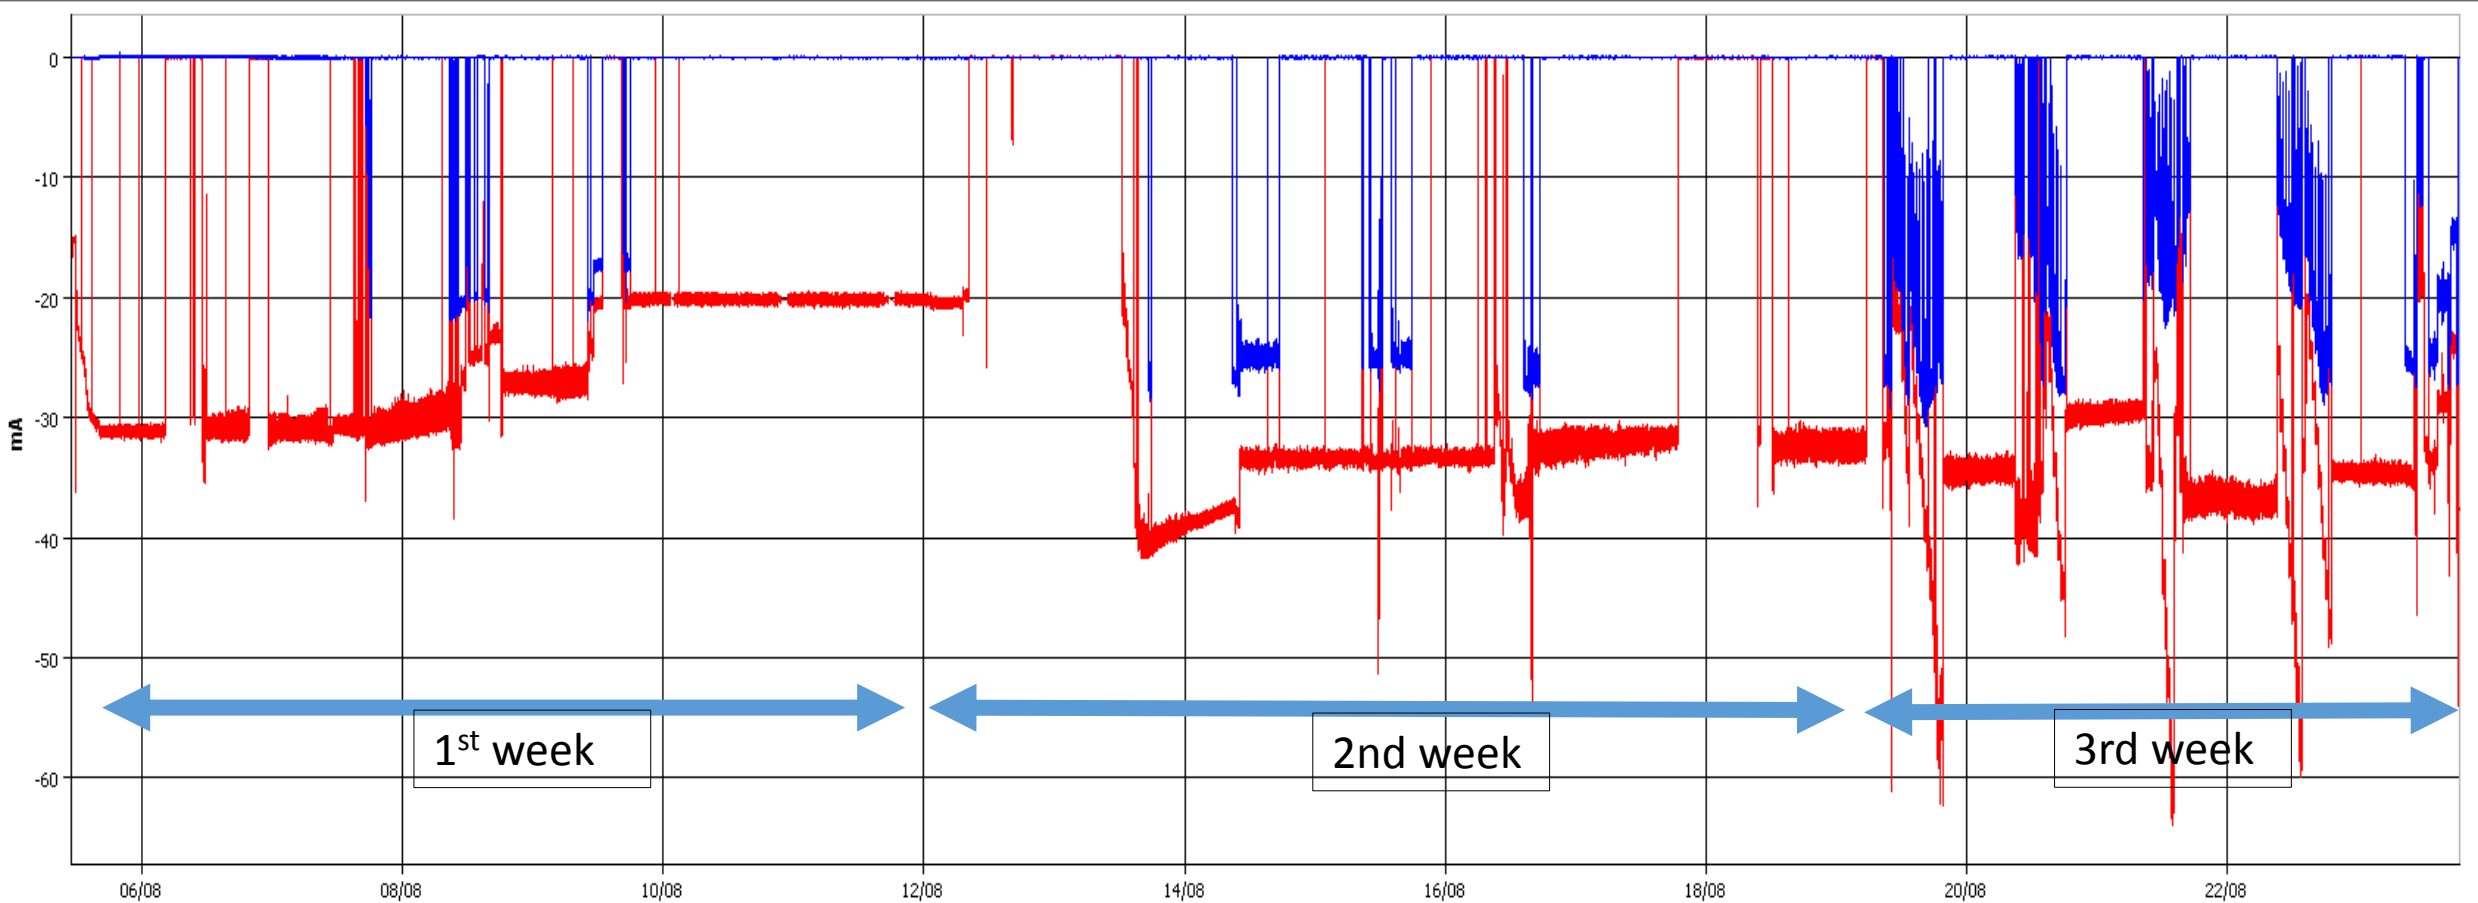
Beam currents at 45keV and 3MeV

- on average beam after the RFQ was available ~50% of the time during working hours
- availability increase with time

Timeseries Chart between 2019-08-05 10:46:00.000 and 2019-08-23 18:46:00.000 (LOCAL_TIME)

→ L4L.BCT.1137:CURRENT → L4L.BCT.3113:CURRENT

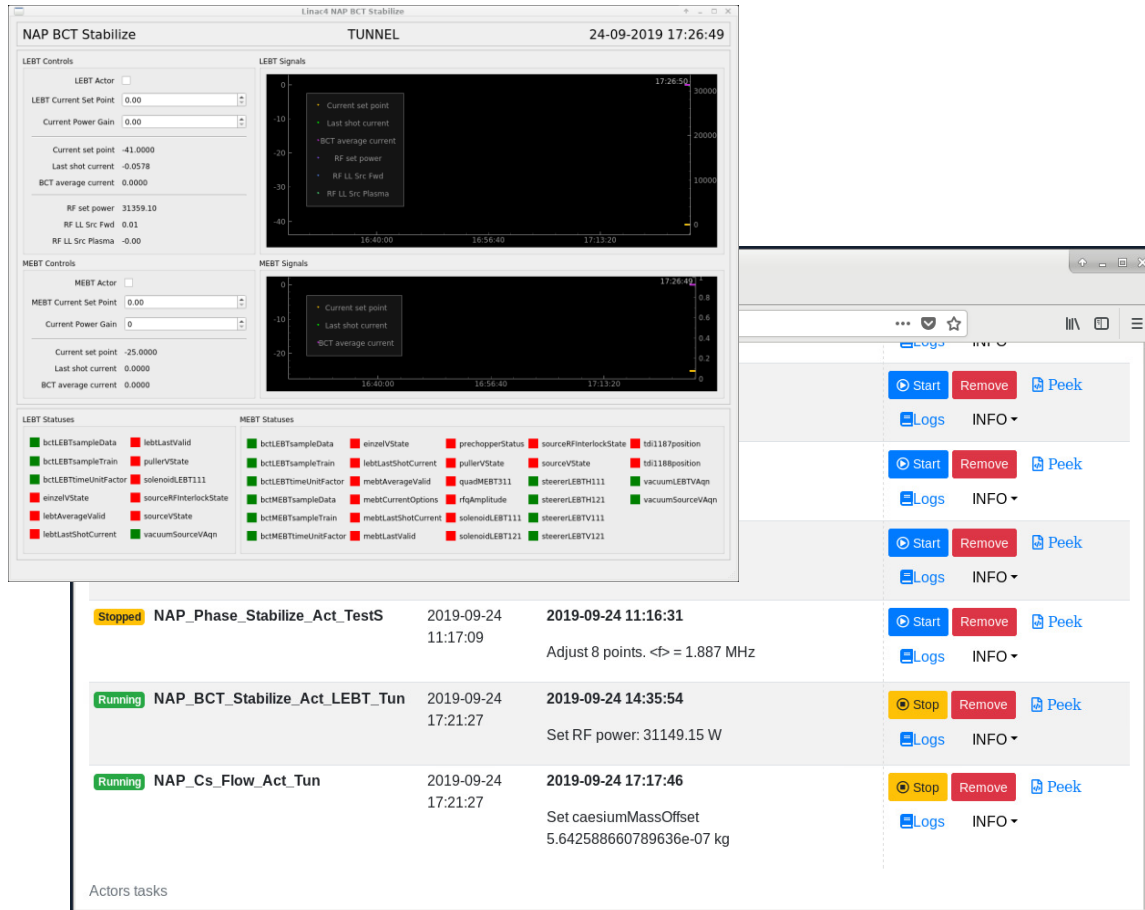
Beam tests: Autopilot

- Hosting environment for Python scripts developed by BE-CO
- Graphical interface in preparation (BE-CO)
- Regulation modules written by BE-ABP
- Modules split into two parts:
 - Monitors provide data verification and logging
 - Actors use information provided by monitor to stabilize source

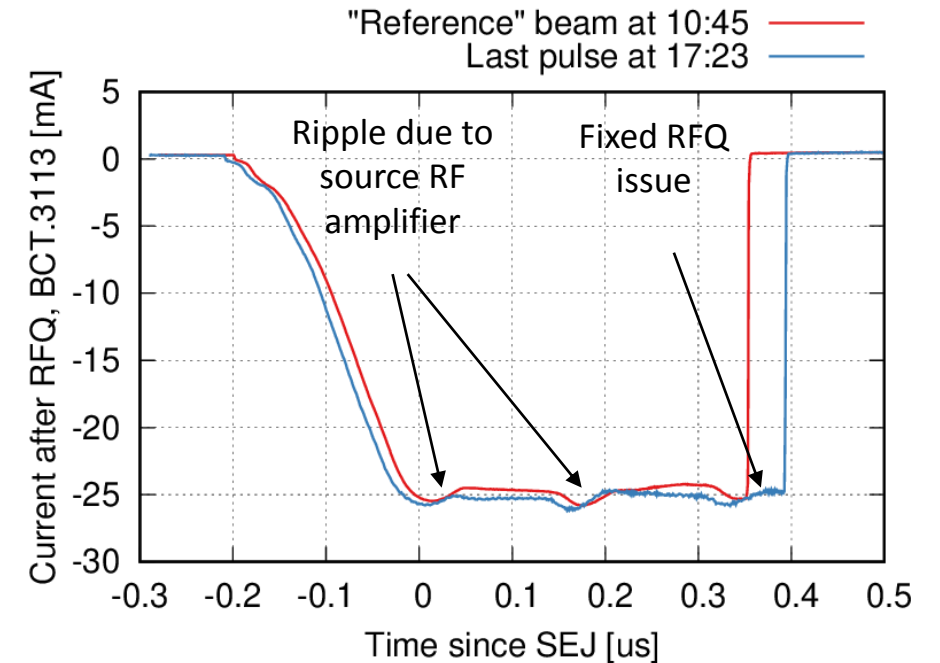
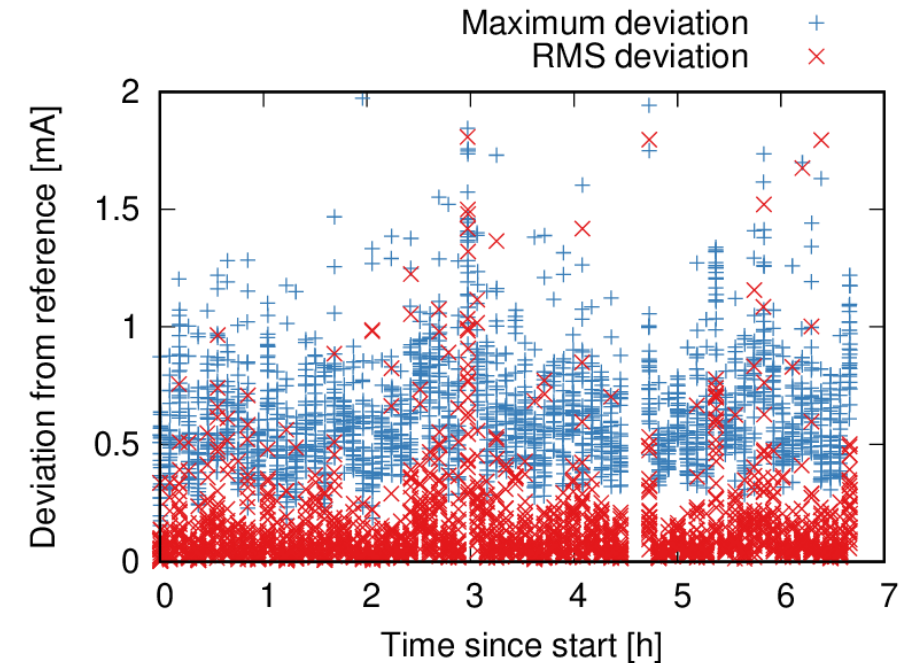
Autopilot: BCT_Stabilize verification

- Light cesiation on 2019/08/13
 - Goal: **reproduce drift** typically seen in timespan of 1 week over a day.
 - **No (manual) retuning** over the day.
- Test performed from 10:45 to 17:30
 - Shorter pulse (350 us) than hoped due to too short/early RFQ RF pulse
 - e/H drift from 5 to 6: less than expected, test should have been directly after cesiation
- Over ~6.5 h
 - Maximum deviation: $< \sim 1$ mA
 - RMS deviation $< \sim 0.5$ mA

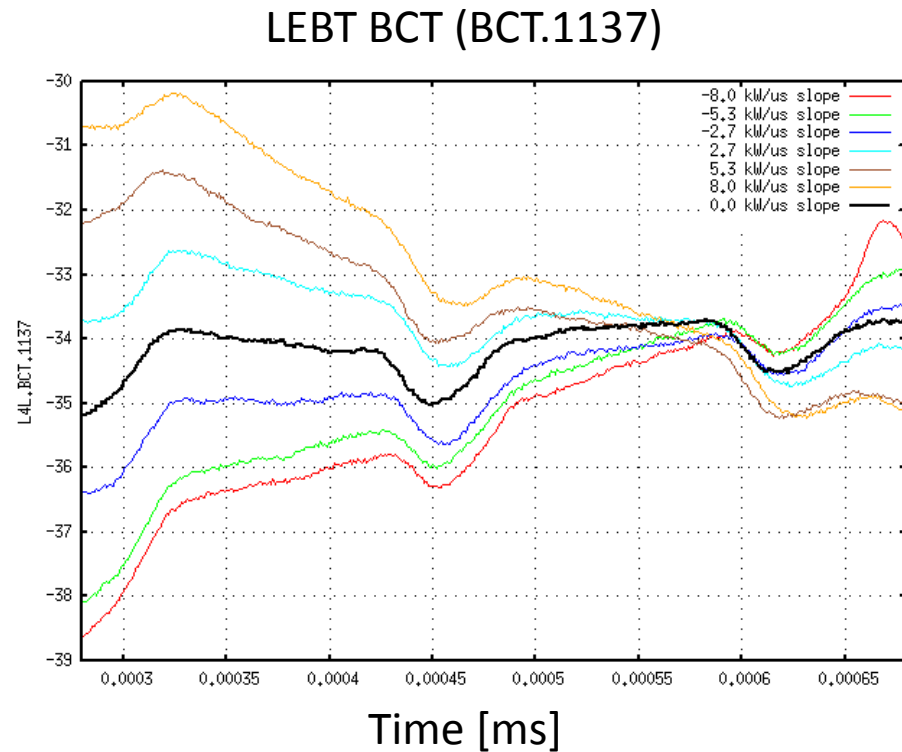
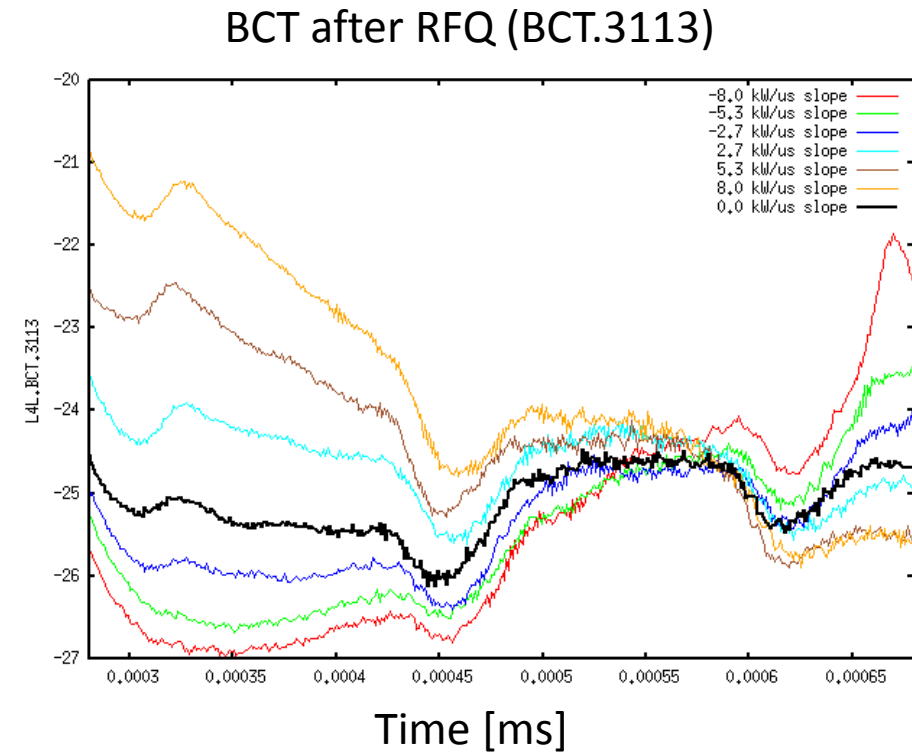
Autopilot: Slope correction on the RFQ

- Basis of an slope correction algorithm after the RFQ:
correct **beam current slope after RFQ** with **slope of beam current in the LEBT**
- Preliminary implementation (insufficient data validation) tested and works:
long-term test required

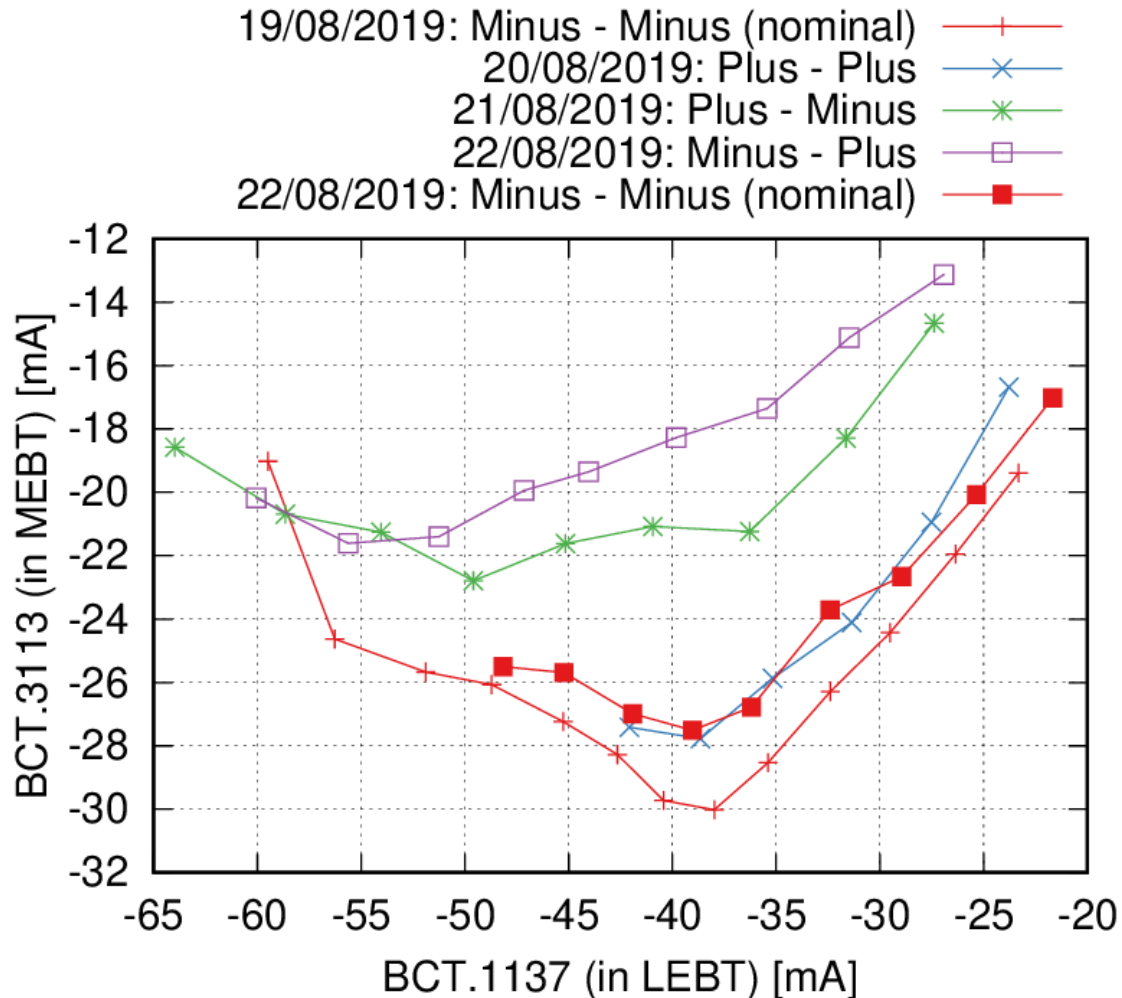
Solenoid polarity scan

- Measurement procedure
 - Flip solenoid polarity (manual)
 - Scan source RF (beam current)
 - Rematch beam for maximum transmission at each current (solenoids and steerers)
 - NB
 - Decreasing level of source cesiation (19/08: e/H = 2 to 22/08: e/H = 5)
 - Sudden drop of RFQ voltage during first scan
 - Results
 - Configurations with parallel field alignment roughly equivalent
 - Significantly reduced transmission for anti-parallel configuration
- confirms initial beam offset and asymmetry

- 3 weeks of testing dedicated to Autopilot and RFQ transmission studies.
- Test of solenoid polarity revealed issues with beam steering or asymmetry in the LEBT.
- Approx. 2 % of 2 MHz beam ripple after the RFQ observed.
- Tests of Autopilot:
 - Test of monitor and actor for BCT_Stabilize: different current averaging methods, data validation in PPM operation with different pulse lengths, stability tests
 - Preliminary modules for pulse flatness and source RF frequency stabilisation tested

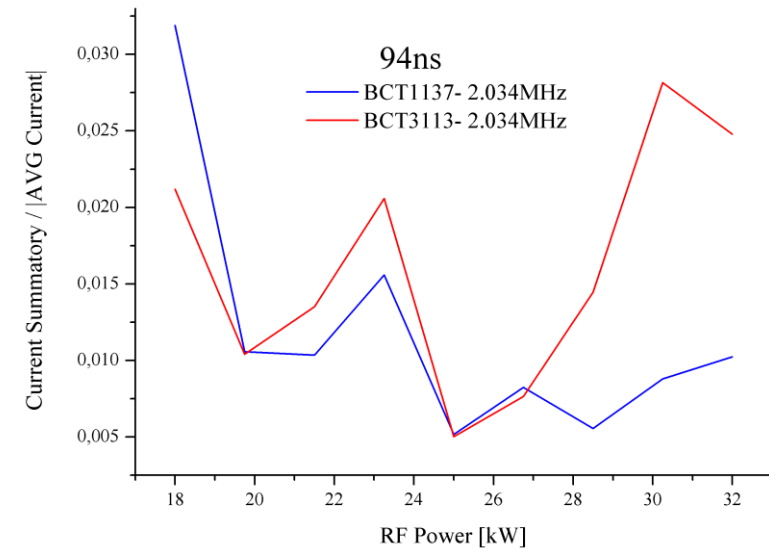
2 MHz noise evaluation

- The plasma in the ion source is driven by a 2 MHz RF through an antenna.
- Record BCT.1137 and BCT.3113 for different source RF power levels (200 μ s after SEJ, 47.05 ns and 94.1 ns sampling times)

- $\approx 0.5\%$ beam ripple 2 MHz after the source
- $< 3\%$ beam ripple 2 MHz after the RFQ
- Higher frequency ripple in the per-mille level
- RFQ does not seem to damp oscillations
- Statistics may be too low to draw conclusions on the dependence on power
