# Report: 26

## Activity: SPS

*Chiara Pasquino,  
Meeting 22/06/2020*

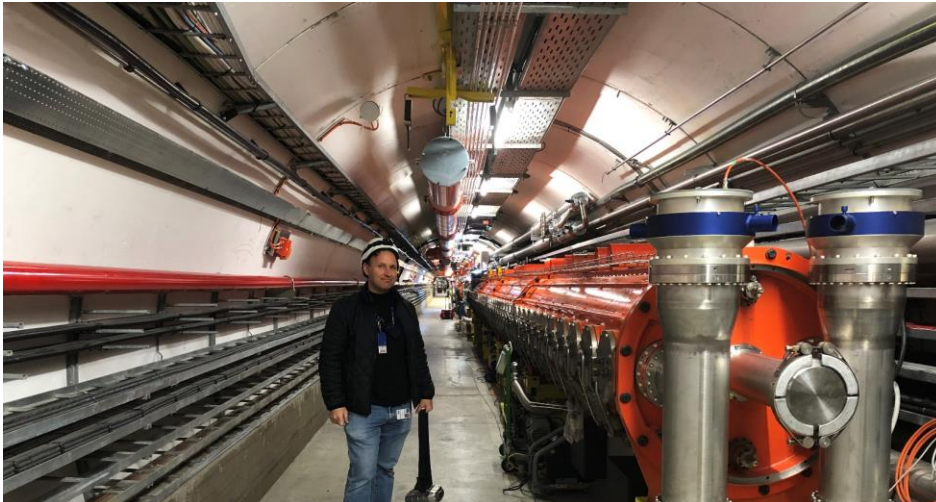
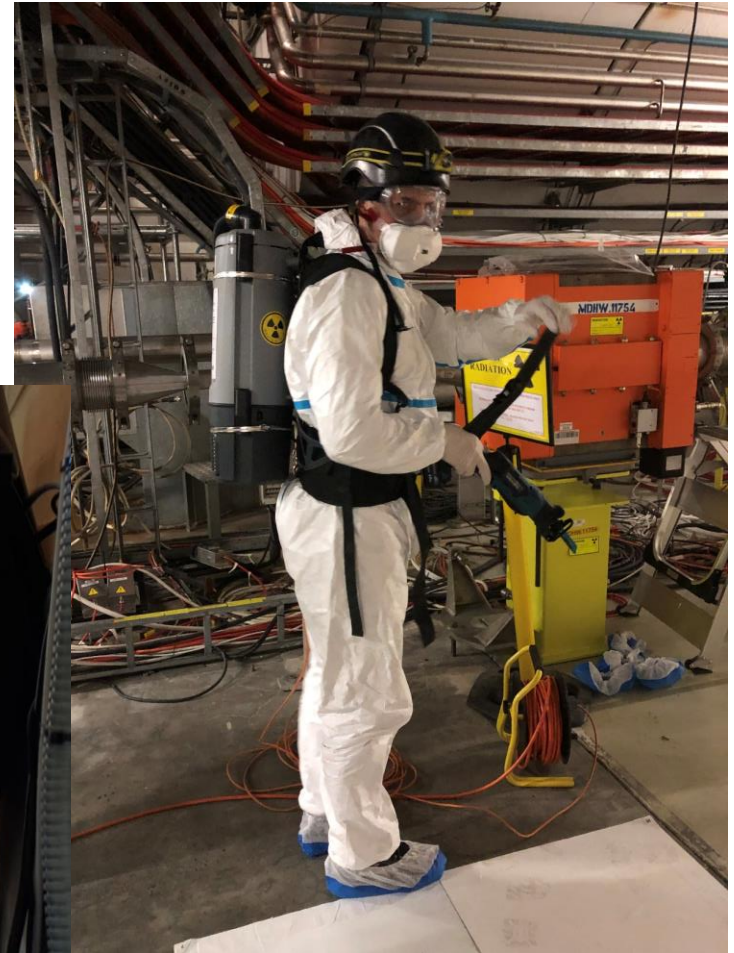
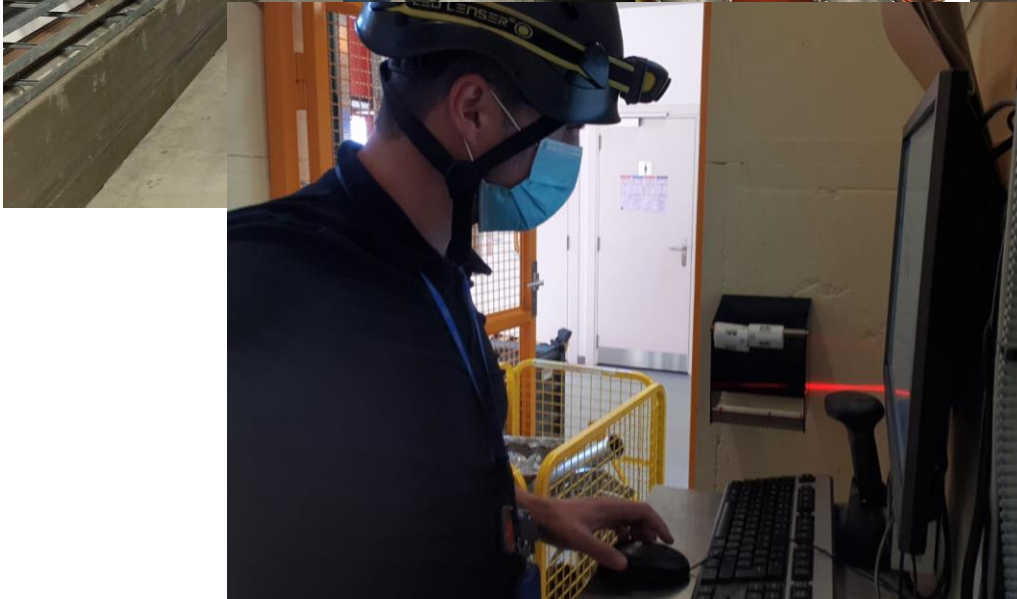
# Few pics.. From LSS1 and LSS3

Pre & post Lockdown

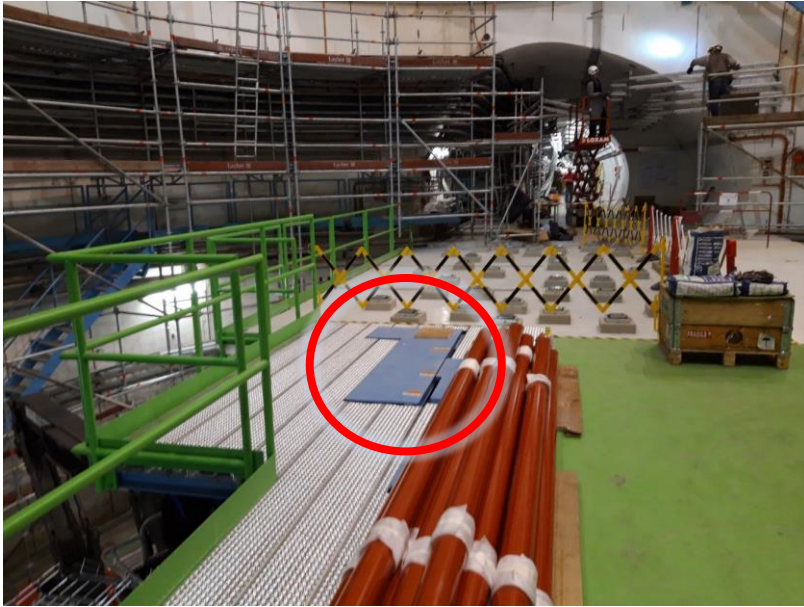
# LSS5

- LSS5: layout checks –few issues with the support integration on the bridge. The bridge is installed with a longitudinal and a transversal mismatch of few cm wrt the 3D beamline integration. It shows a slope as well, it goes downward towards the dump.
- Issue being checked with integration, SMB (contact with the contractor of the bridge) and EN/ACE for the bridge modifications.
- UA9 readiness: might miss the installation date during LS2, a temporary layout will be needed.

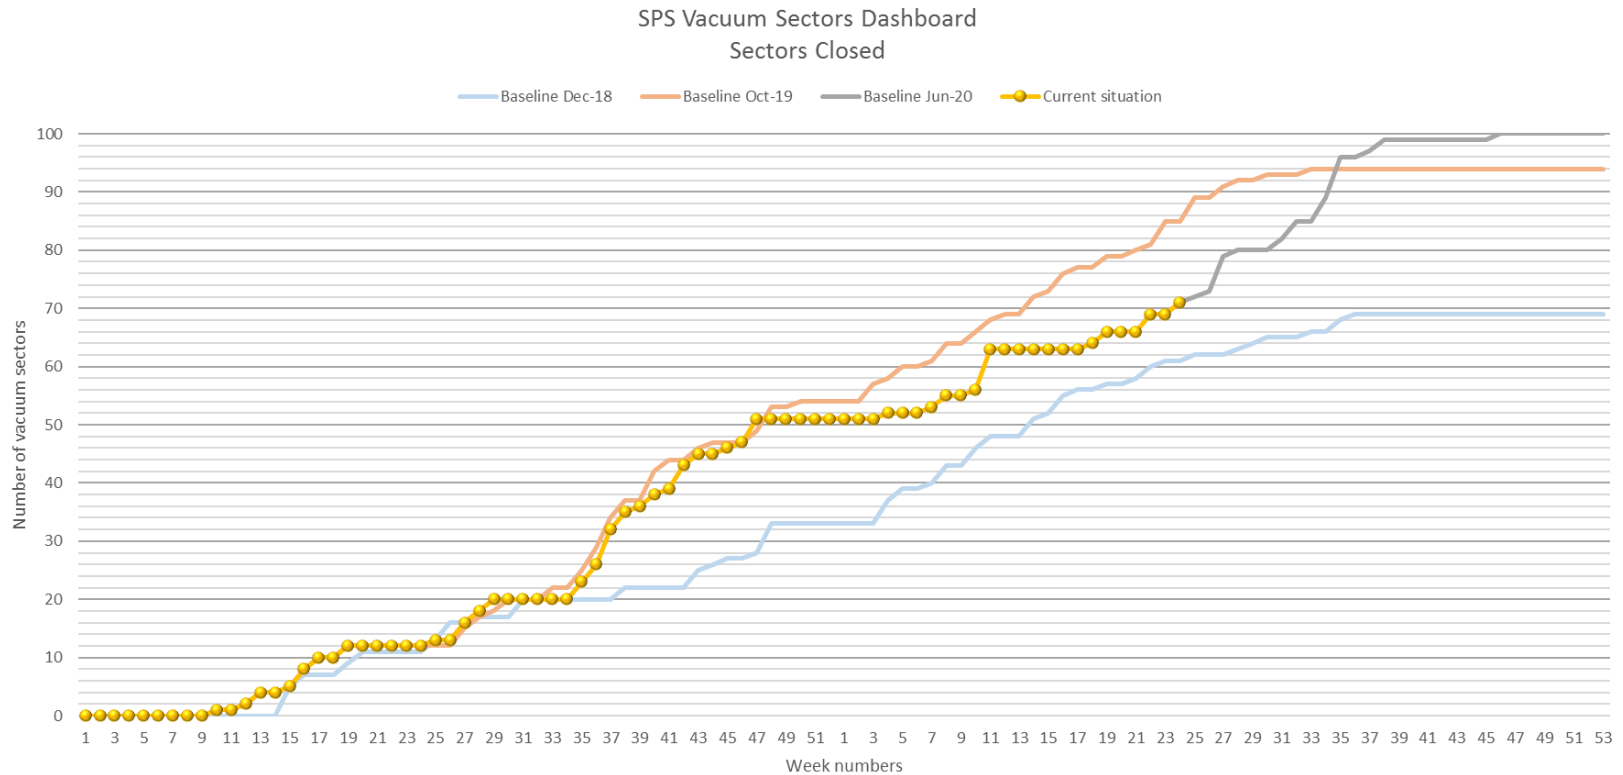
# DASHBOARDS - 2020

Courtesy of A. Grande
