# CMS LS2 Beam-pipe upgrade Status update meeting 24/06/2020

## Central beryllium chamber HCVC5C0038-MN000001

## Forward aluminium chambers VC5F Forward chambers HCVC5F0010-CR\*

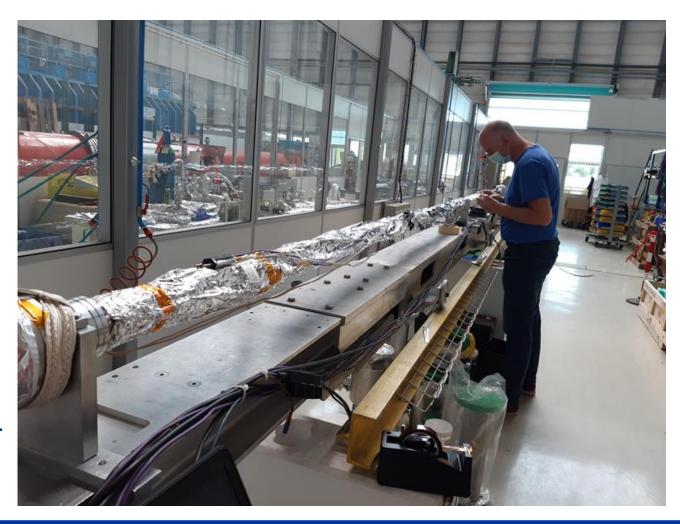
- Central chamber NEG coated;
- NEG performance tests;
- Expected "Ready for Installation" by July.

- No equipment related issues for the moment.
- Process (handling) issues during the NEG coating.
- Seals new series of seals is being tested; we have reliable solution with older type of seal.

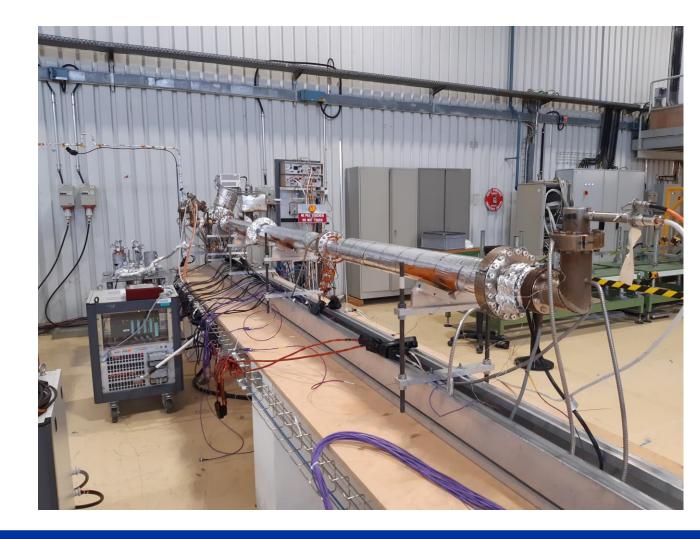
- 3 chambers NEG coated and accepted;
- Ready for installation now.

- Short circuit on one of the heaters during NEG performance test.
- Faulty segment replaced by spare heater.

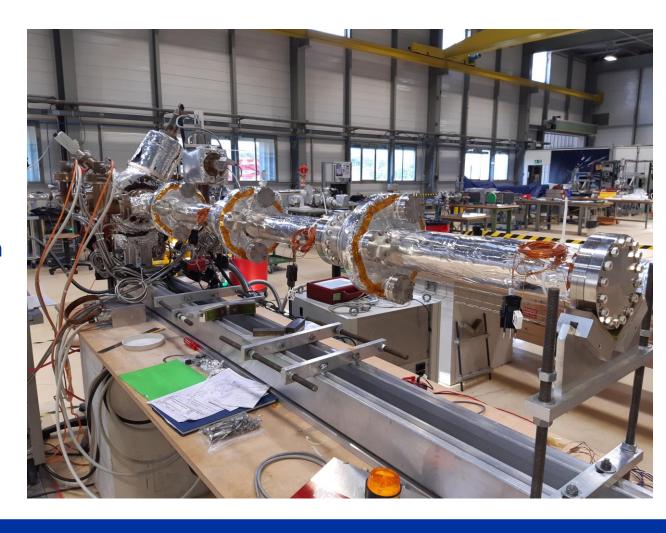
## Forward aluminium chambers VC5FP Forward pumping chambers HCVC5FP002-CR\*

- 3 chambers vacuum acceptance ongoing;
- 3 chambers NEG coating by next two weeks;
- 3 chambers NEG performance test by mid-July;
- Ready for installation by end of July;

- Mechanical problems with insertion of the RF screen
- Once solved mechanical damage of the screen ☺.

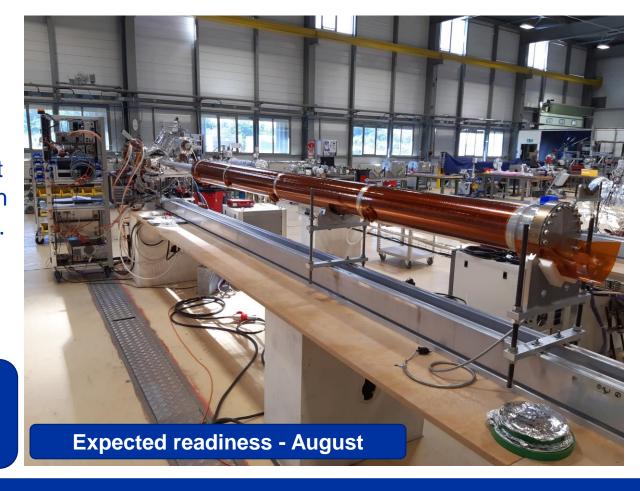
## Forward aluminium chambers HF-CT2 chambers (2+1) HCVC5HFCT1-CR\*

- Chamber #1 vacuum acceptance completed;
- Chamber #2 bake-out wrapping ongoing;
- Chamber #3 stand-by;

- On chamber #1 again short circuit during the bake-out
  - Probably related with the glue within the sandwich
  - We are starting with systematic test of all heaters.
- On chamber 1;3 a slight surface decolorization was observed; RGA spectrum OK; XPS shows sign of elevated silicon on the surface.

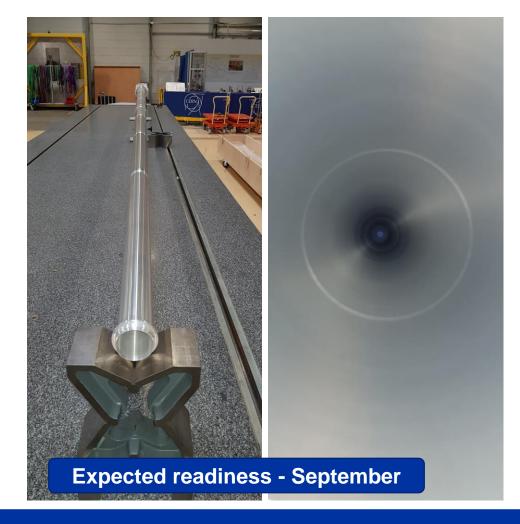
## Forward aluminium chambers End-cap chambers (2+1) HCVC5E0035-CR\*

- Chamber #1 production completed stand-by;
- Chamber #2 production completed stand-by;
- Chamber #3 production completed stand-by;

- No equipment issues observed
- XPS samples from the final cleaning shows similar silicone contamination as for the HF-CT2.

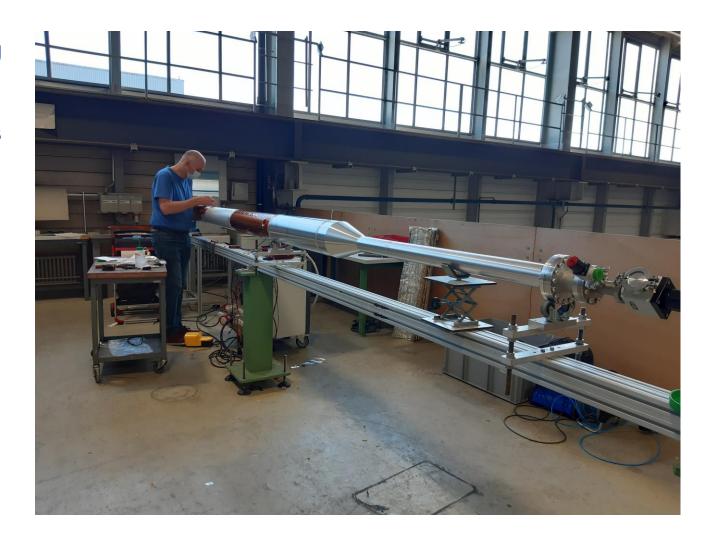
## **Bake-out and fibers**

- Installation of the fibers after the NEG coating
- Please let us know about delivery dates and expected installation availability for all 3 types of chambers (central; HF-CT2; End-cap)
- Position of Lemo connectors TBD.
