Joint COMPASS-AMBER Technical Board 28-September-2021

- **General Communications**
 - Approval of the minutes of the last TB
 - Mandate renovation
 - Dates for 2022 TB
- **HV modules for SciFi**
- **CERN CV preliminary schedule for the winter shutdown**
 - Impact on COMPASS/AMBER operations
- **COMPASS interventions: preliminary scheduling of the activities**
 - Beam Telescope interventions
 - DAQ power lines
 - Polarized target (PT Helium pipe intervention) and He4 pump maintenance
 - Detectors needs → gas availability
- **Amber PRM, scheduling of intervention**
 - Status of the TPC
- **Requirements of space in 891 during YETS**
- **Safety requirements for next year running and future**

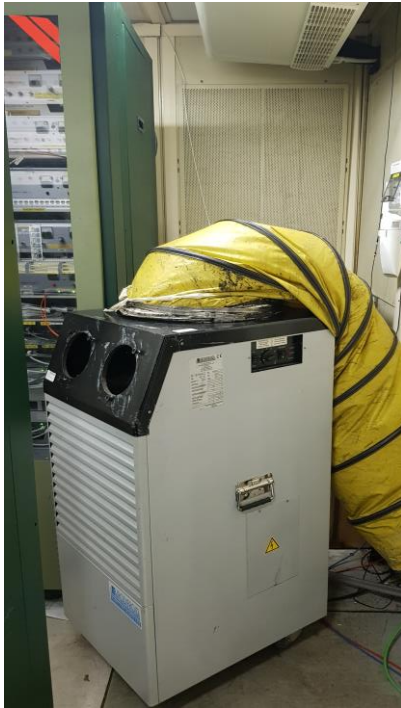
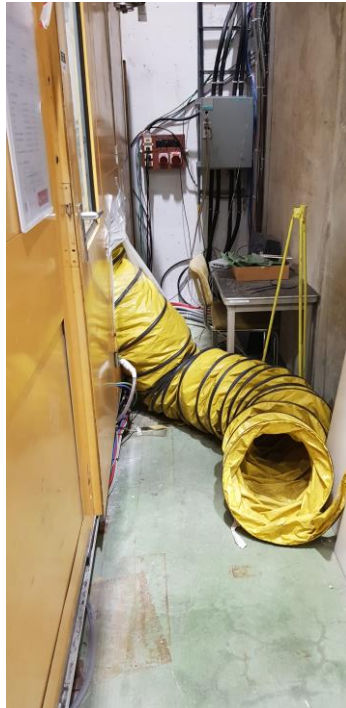
- Few issues with services for the COMPASS spectrometer
 - CV minor interruptions for the cooling water distribution
 - Cooling of the BMS barrack is still an issue, a temporary solution was found, a reliable and appropriate solution is needed: the installed unit is not enough powerful. Fortunately, this year has not been too warm.

At the moment we have $\sim 7 + 4 \sim 11$ kW cooling power, temperature ~ 23 C
To be improved for next year
CV informed

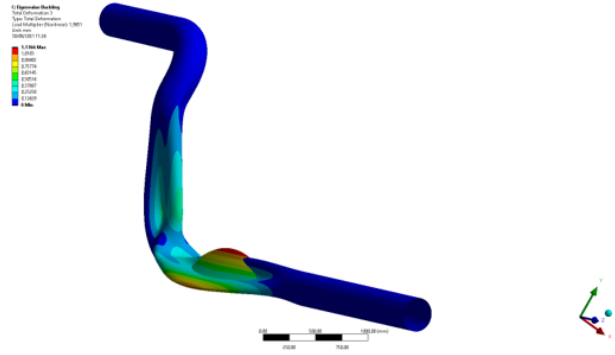
5.1 2mm thickness

Figure 5 shows the deformation due to a buckling of the structure. The collapse of the pipe occurred with a load multiplier of 1.985 meaning that the safety factor of the former design was ~2. As seen in the figure below, the resemblance between the simulation and the real case is significantly high. It can be observed that the buckling appears in the first place in the region where there are no supports nearby as occurred in reality.

Figure 5: Eigenvalue Buckling deformation for 2mm pipe thickness with original supports.

From the results obtained computationally it can be concluded that the main pumping line of the dilution cryostat collapsed due to a buckling caused essentially by a low safety factor, 2, of the structure due to the low thickness of the pipe geometry, 2mm, and the absence of enough supports or stiffeners. In order to increase the safety factor to 8, the minimum recommended in such structures, it has been proposed to **increase the thickness of the pipe to 3mm and to install supports or stiffeners at a maximum distance of 1 meter from each other.** → the safety factor should be increased up to 11.6

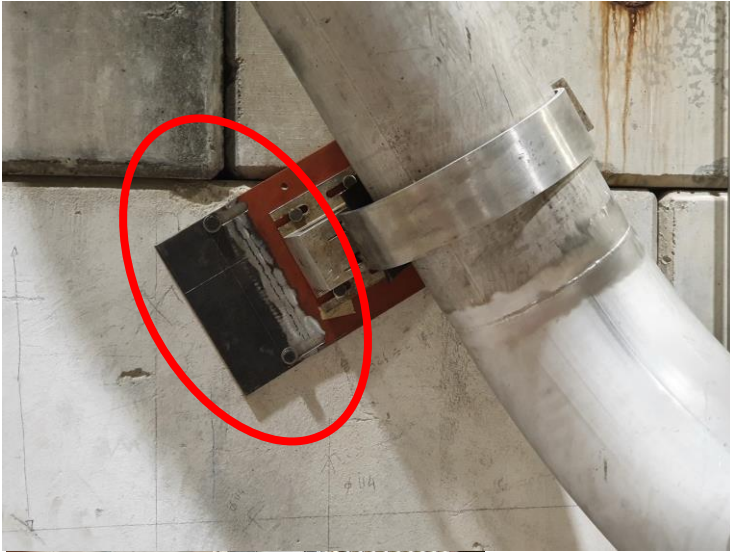
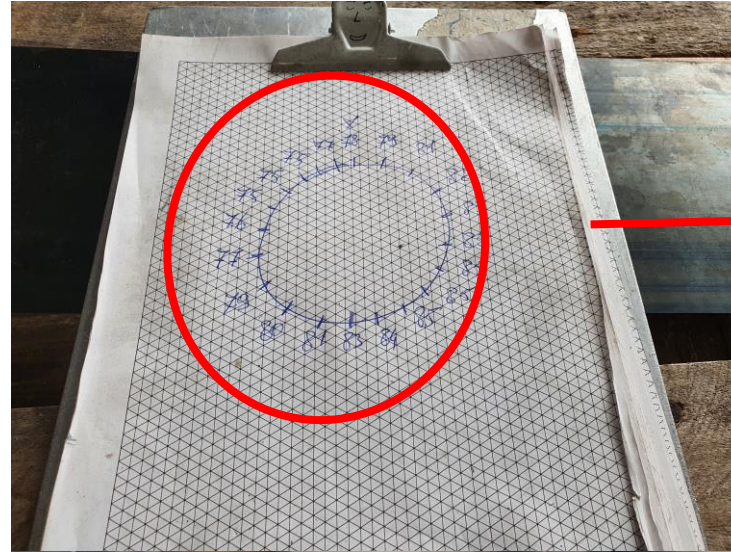
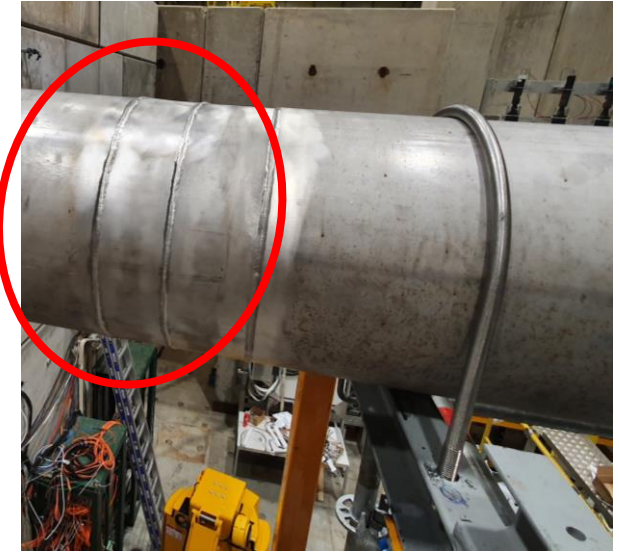
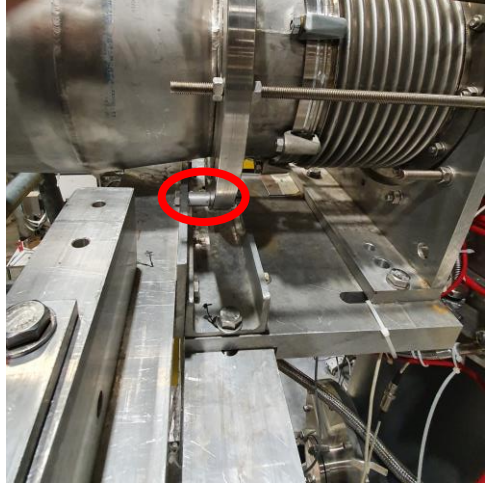
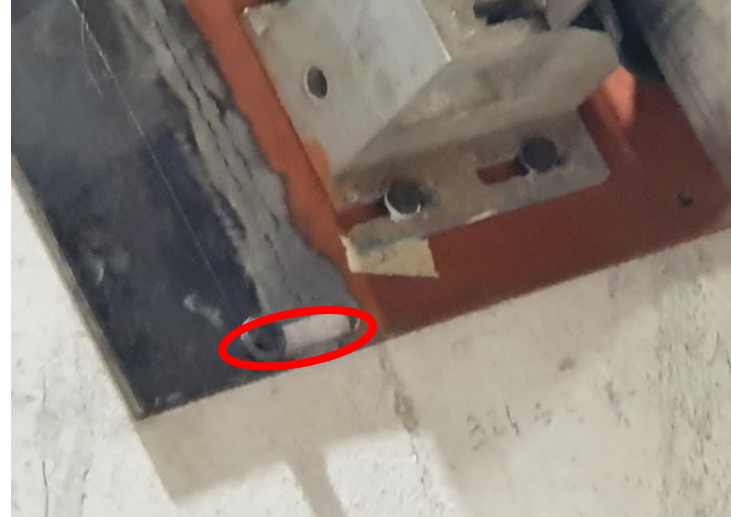
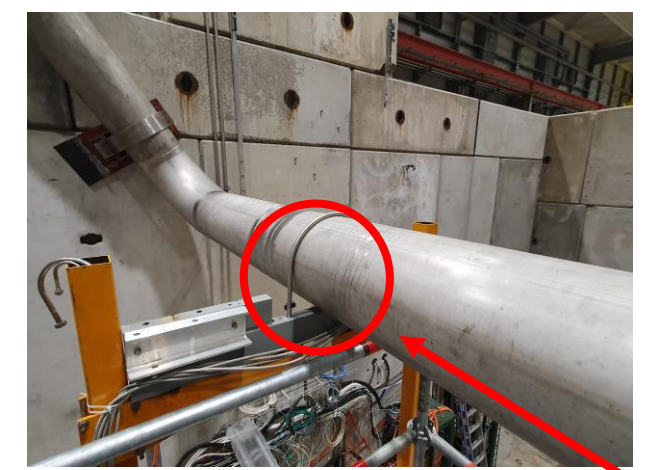
COMPASS, Helium recovery line problem 3rd of July

Later confirmed by the need of modification of the support system, one remark more about the stiffening system

The reason, buckling due pipe thickness DY → SIDIS changeover and missing of the stiffening

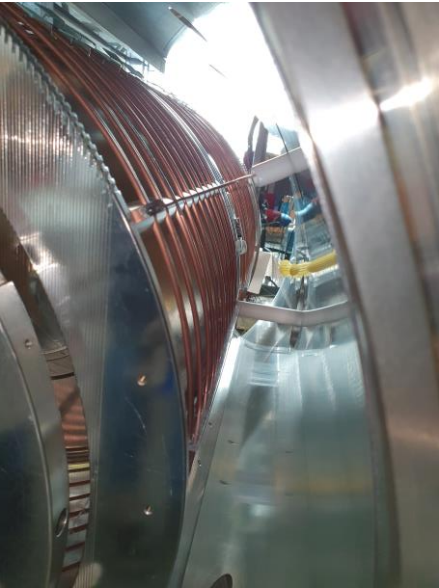
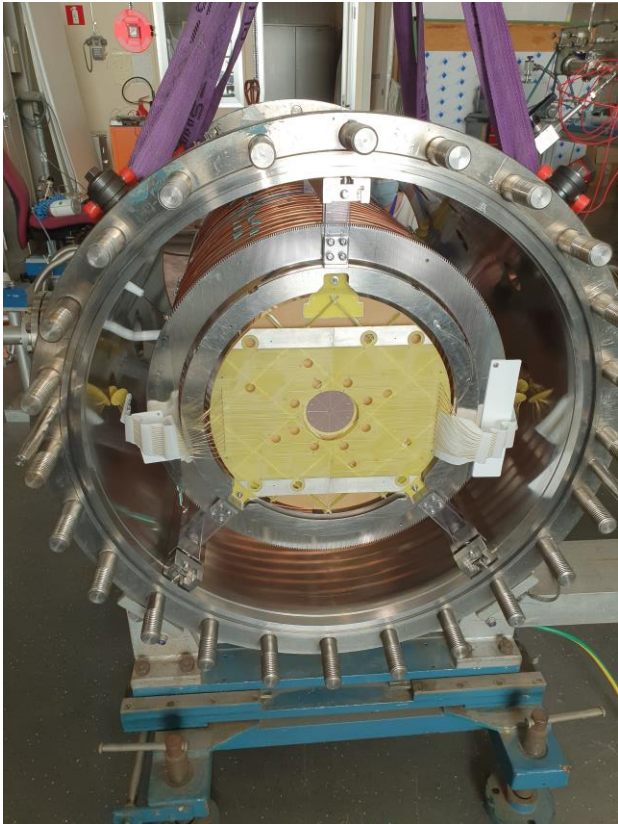
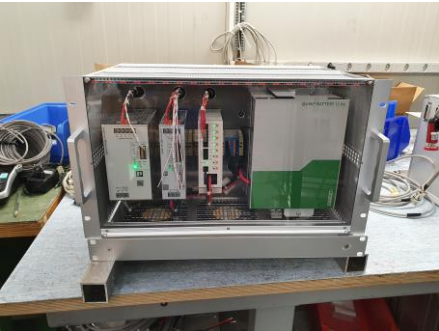
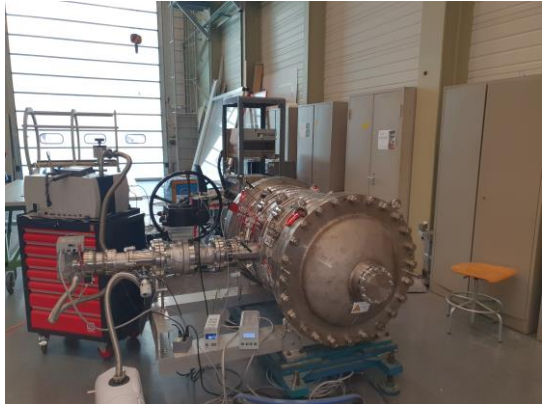
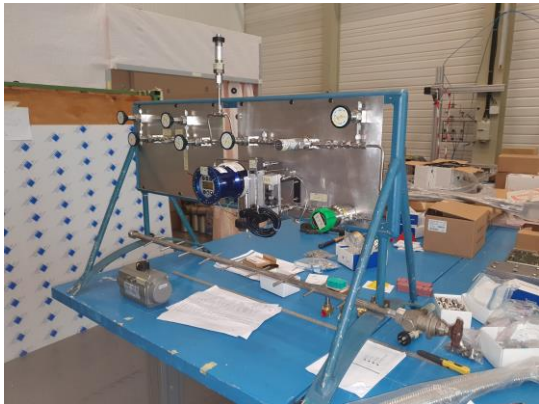
AMBER interventions: TPC status

O Kiselev + colleague @ CERN
last week

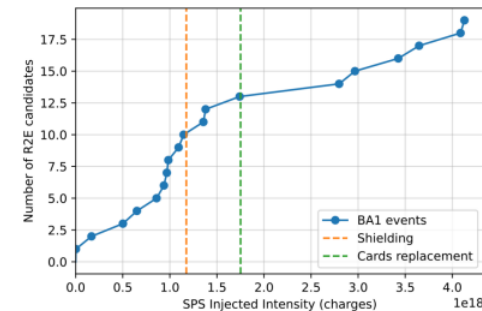
Location	Number of Events	With B4C Shielding	With New Cards
BA1	20	9(6)	6
BA80	7	2	5
BA2	3	1	1
TCC8	2	-	2
TAG41	4	-	2
BA6	1	-	0
BA3	1	-	0
ECN3	1	-	0
	39		16

Y. Aguiar et al, presented at R2E MCWG 7/09/21

- **Failures continue in the intermediate racks located underground in BA1, BA80, BA2, TCC8, TAG41 despite the actions taken already**
 - B4C shielding in BA1, BA2, BA80
 - Exchange of all cards for new ones with ULA conform chip molding
 - > strong suspicion that failures are **radiation induced**
- **Major contributor to SPS downtime**
 - Directly - **a card failure can lead to a Beam Stop** (if cabled to door position or emergency exit contacts)
 - Indirectly – requires reset and re-establishing patrol
- **Short Term Actions**
 - Heavy shielding in BA1
 - Reduce recovery time elsewhere (& more if required)

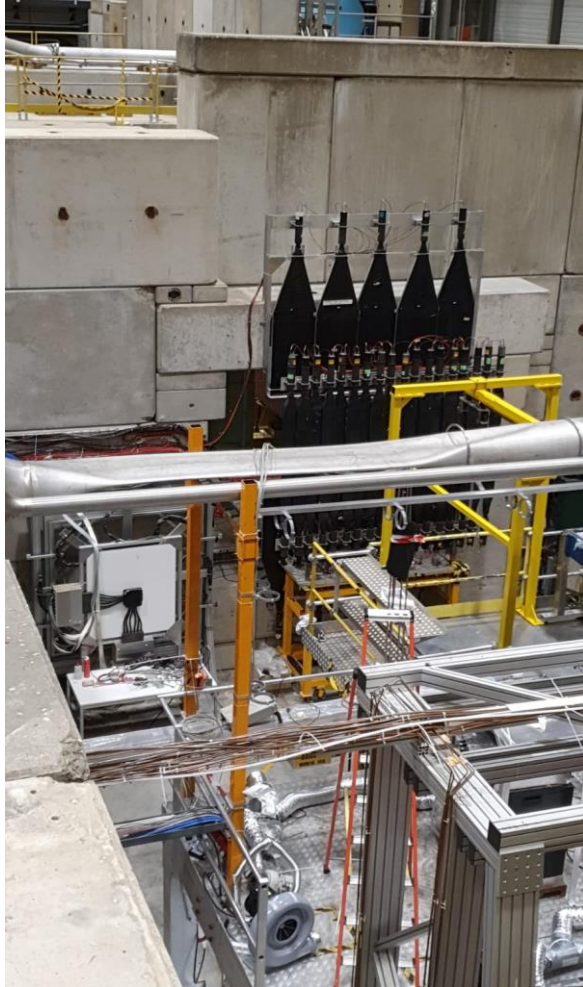
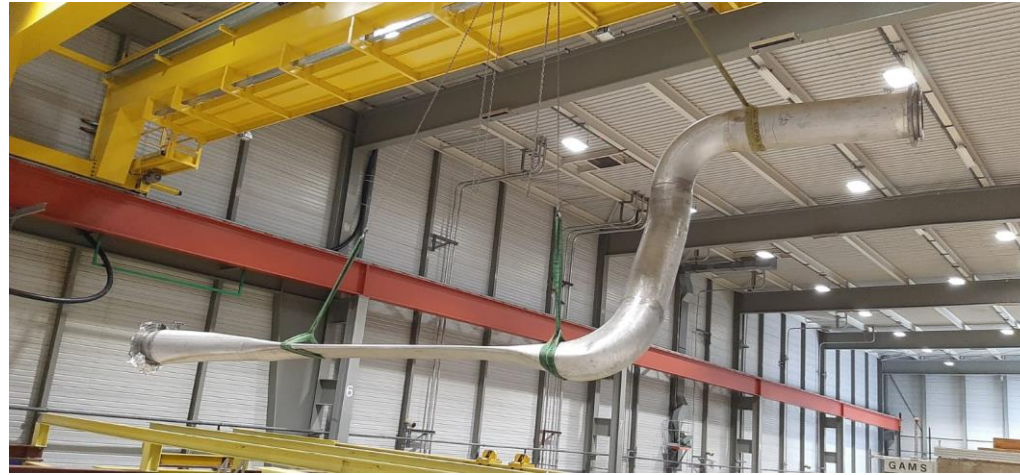
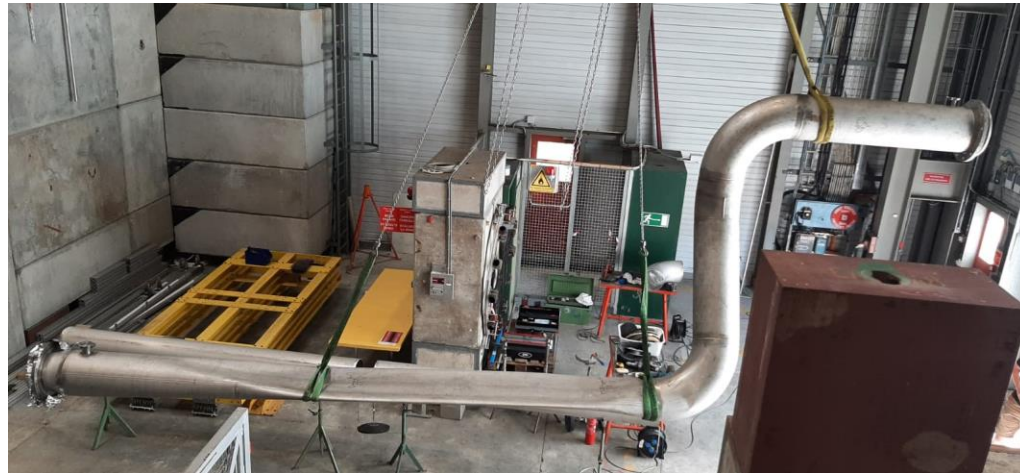
COMPASS, Helium recovery line problem 3rd of July

- Details in Michael talk.

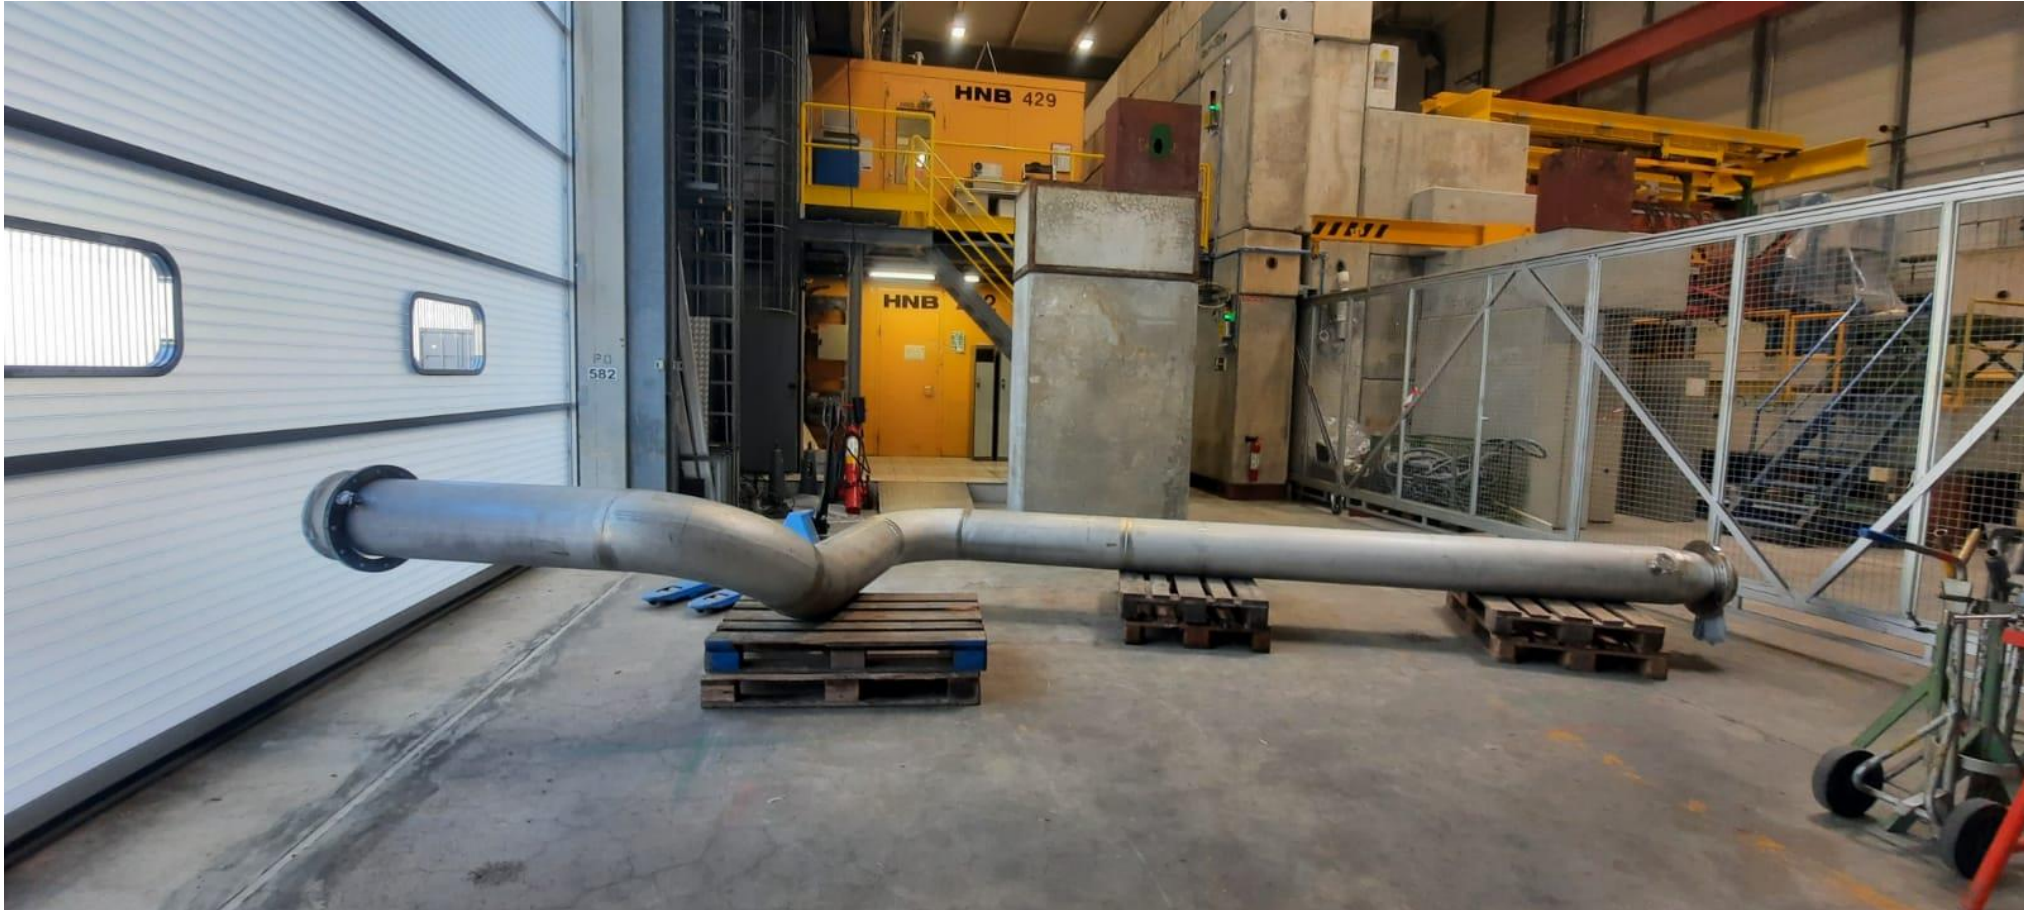
COMPASS, Helium recovery line problem 3rd of July

First trial after unloading the material ~ 1 week after, just replacing the crashed part, unsuccessful → displacement occurred

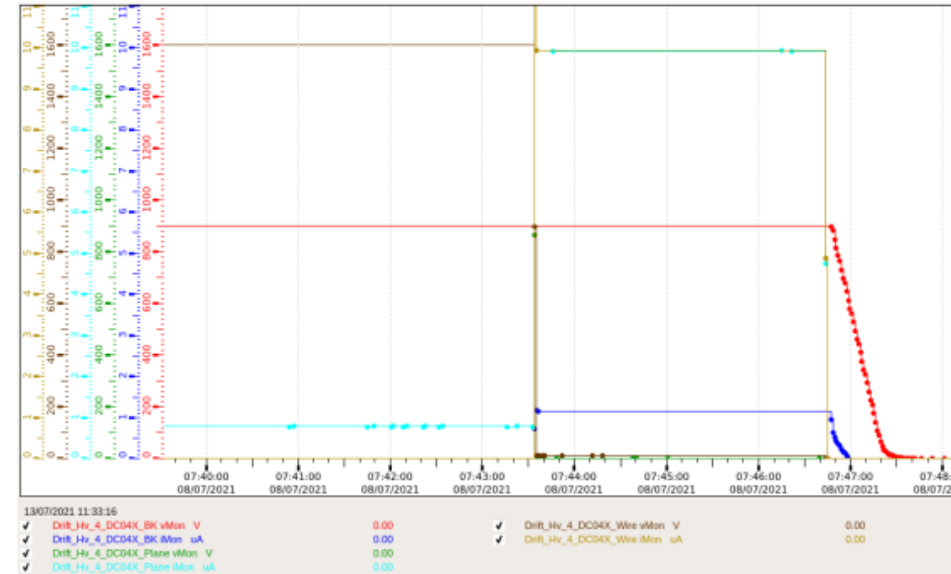
During Commissioning of the DC4 in view of the run a y' wire was suspected to be broken → lack of redundancy in y coordinate

Note: HV mapping mistake, X and Y are swapped

- Not possible to raise the HV
- Measurement with Shuddha:
 - 1Ω to ground for Y' cathode and YY' cathode
 - Beyond accuracy of the device for BKs
 - Beyond accuracy of the device for FWs !?

Next: Localise the potential broken wire (most likely on top)

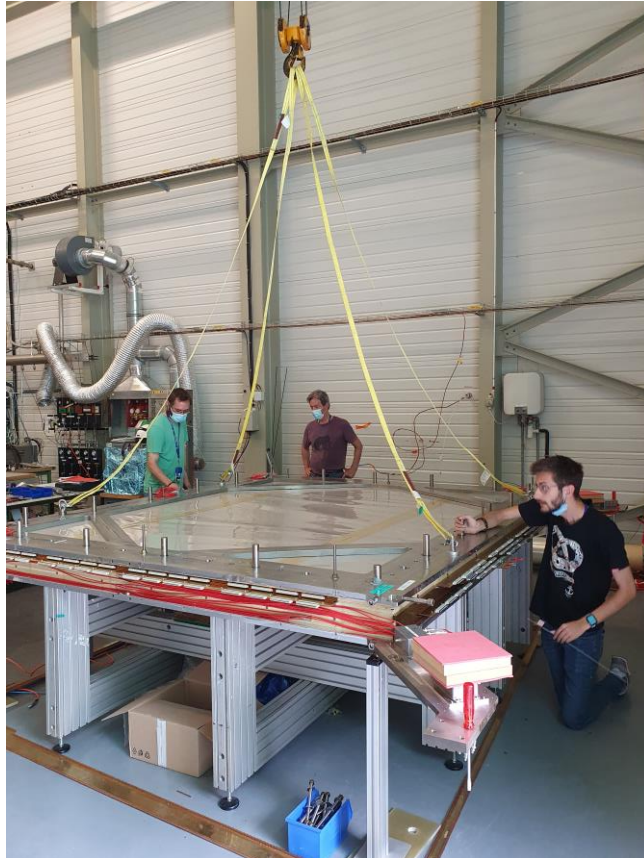
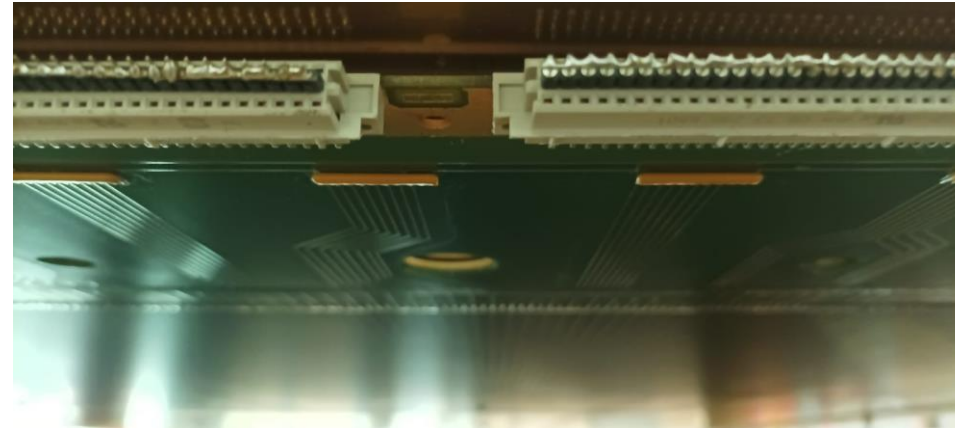
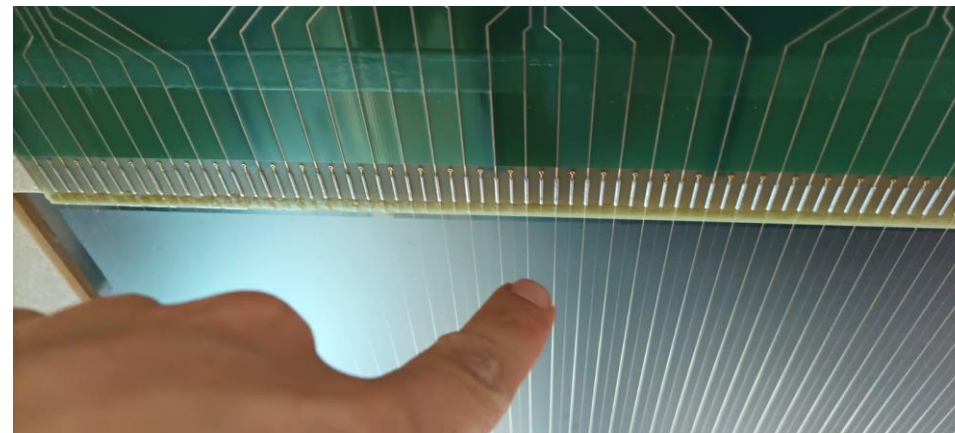
COMPASS, DC4

Decision to go for the repair, Saclay group agreed for the fixation by a local team under the supervision of Vincent
The detector was moved into the clean room on 22nd of July

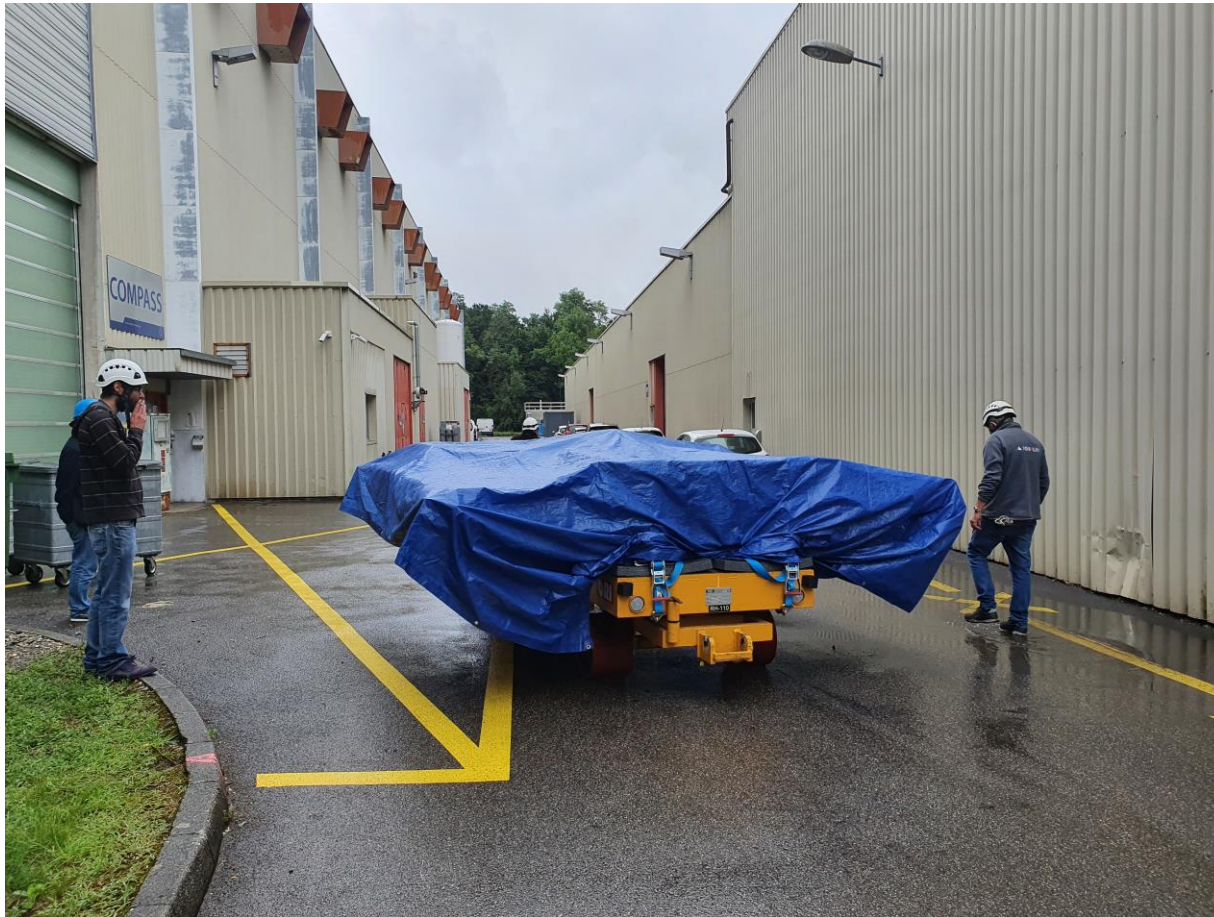
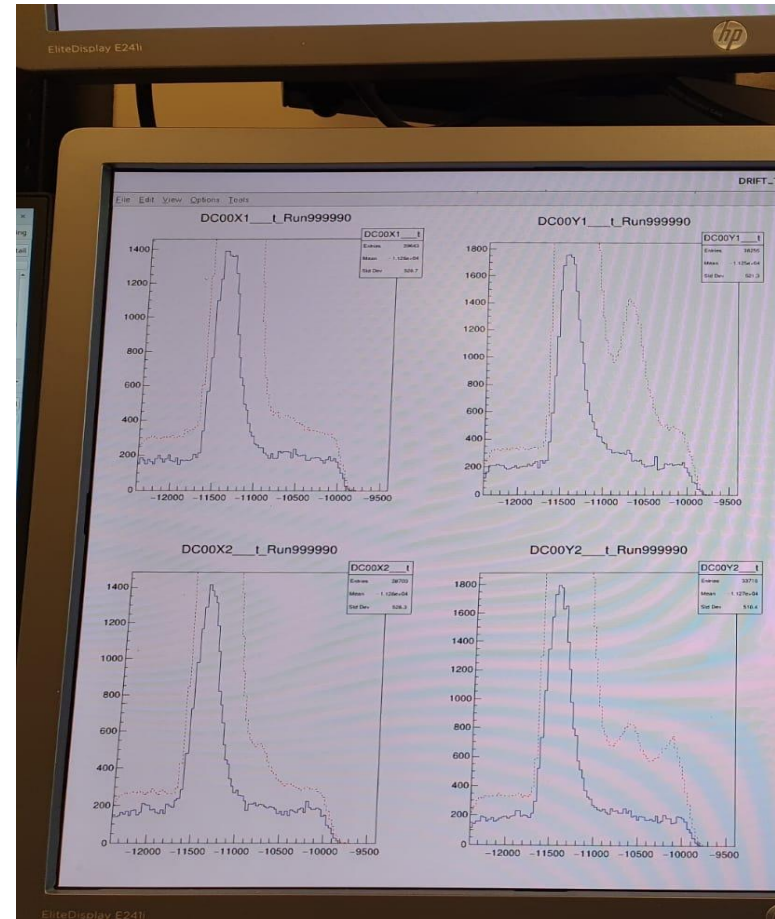
COMPASS, DC4

Successfully fixed and brought back to the hall on 4th of August

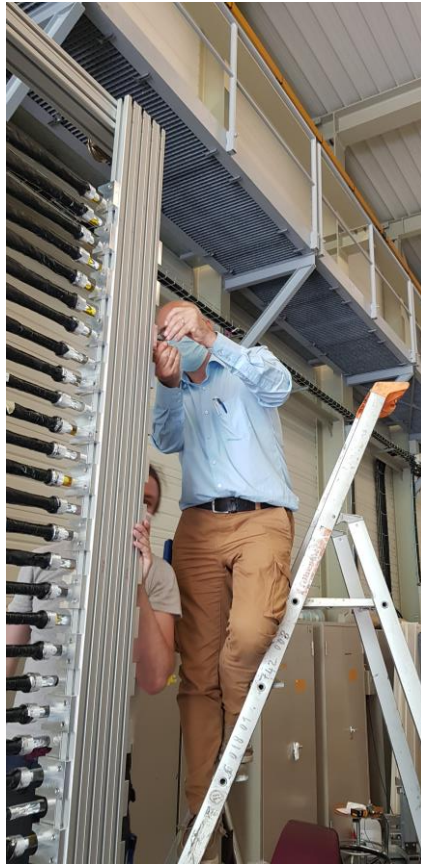
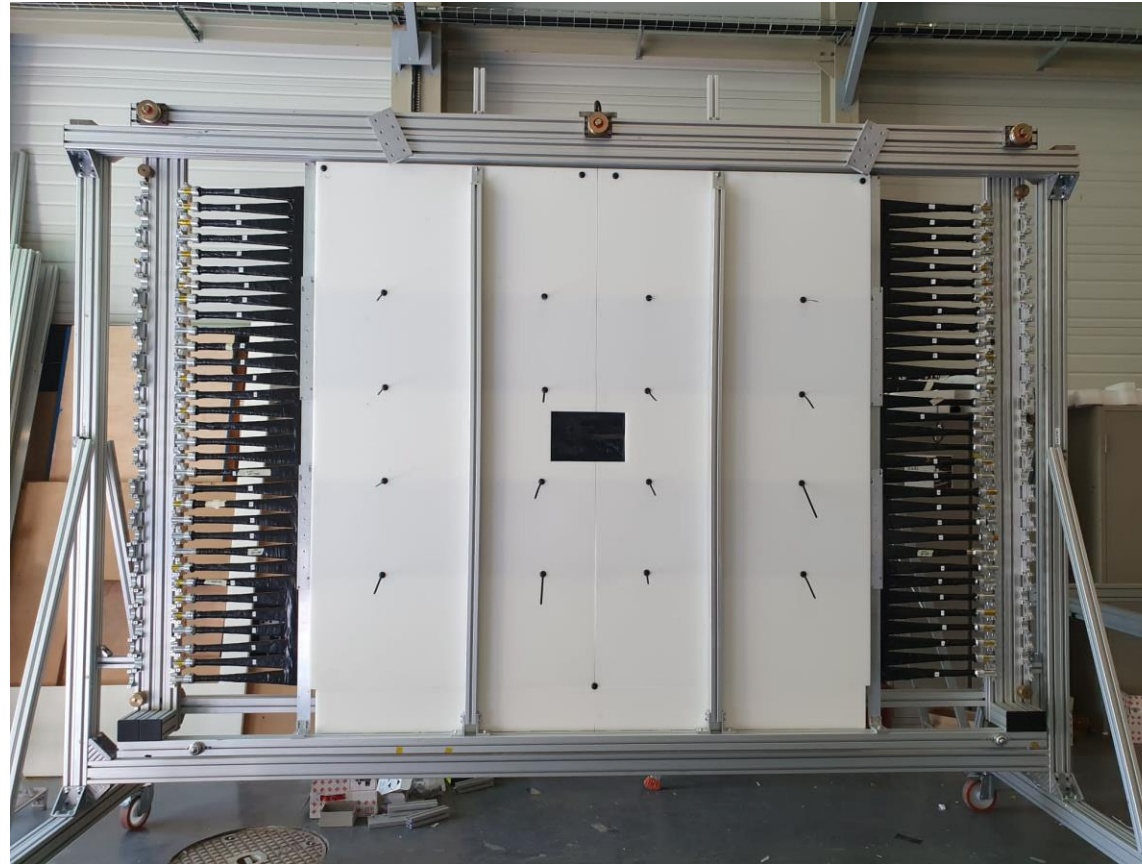
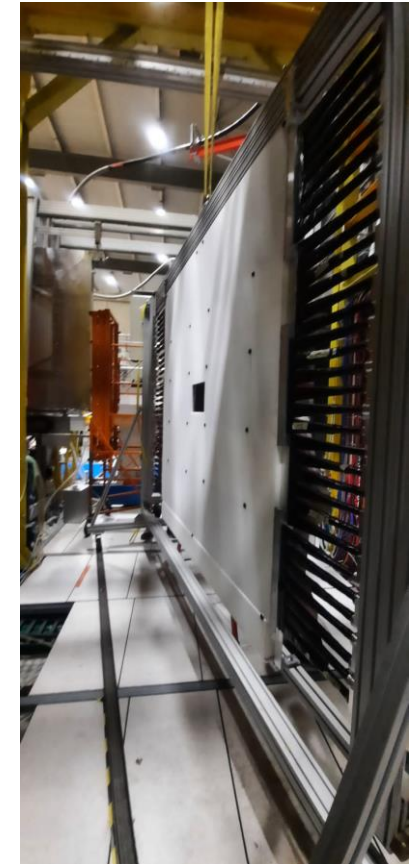
COMPASS, H1

Successfully reinstalled on 11 July with its new Rohacell holding structure, despite a minor issue with the gluing of the last slab of the hodoscope ... a double success

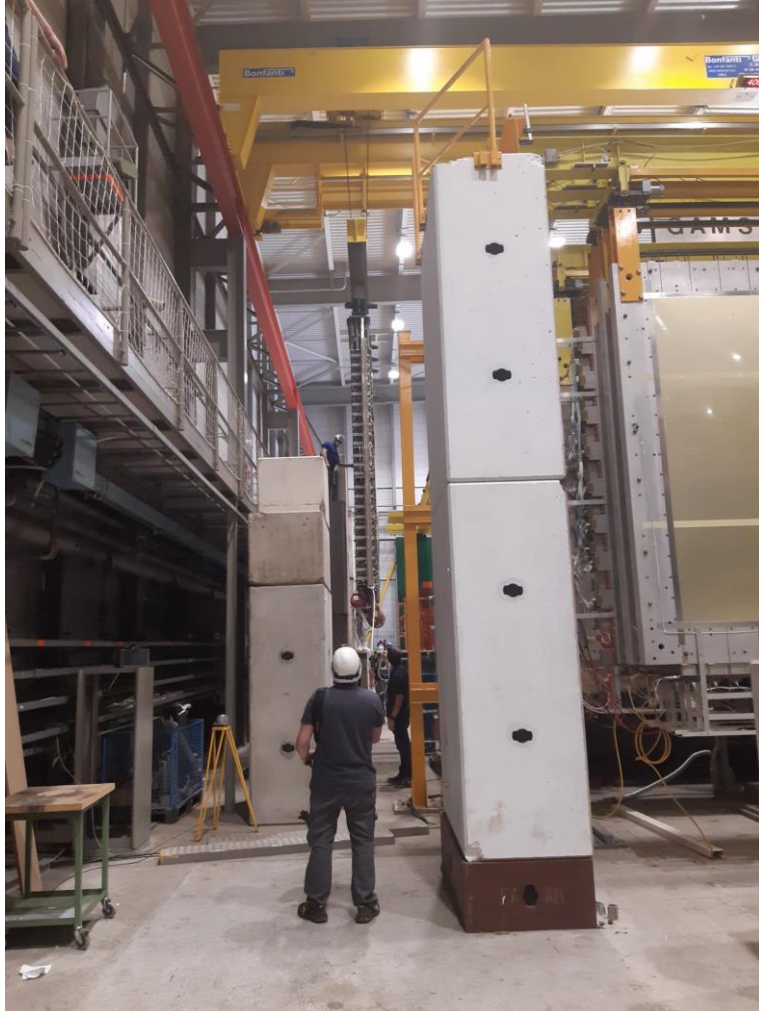
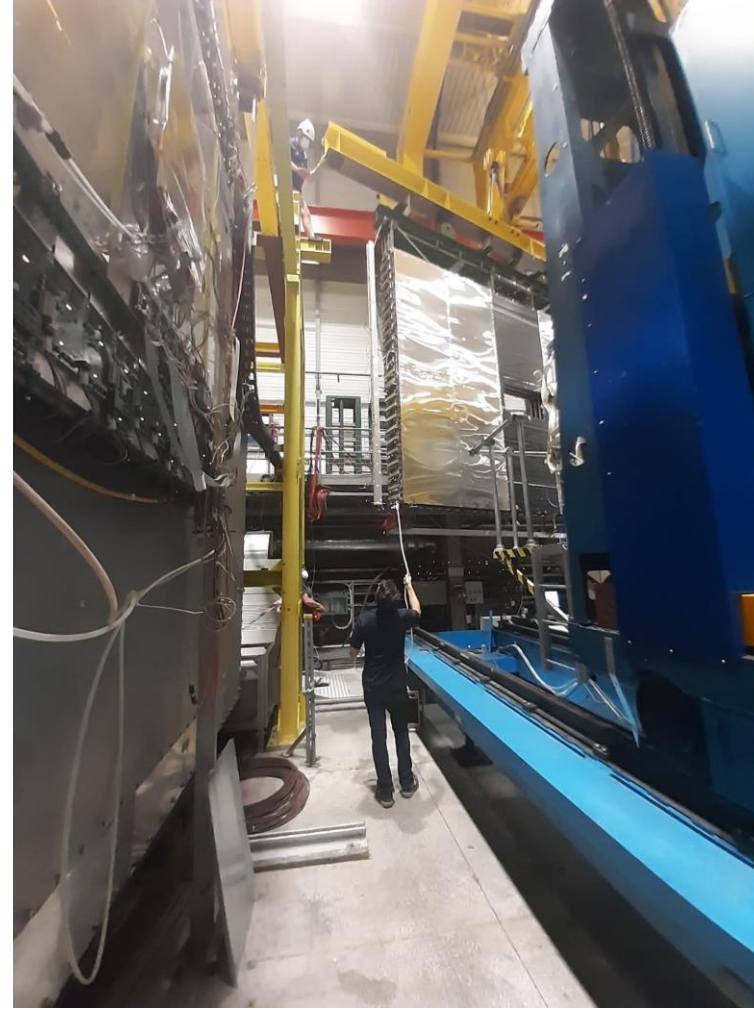
RICH WALL re installation

Successfully reinstalled on 11 July after full MDT system refurbishment

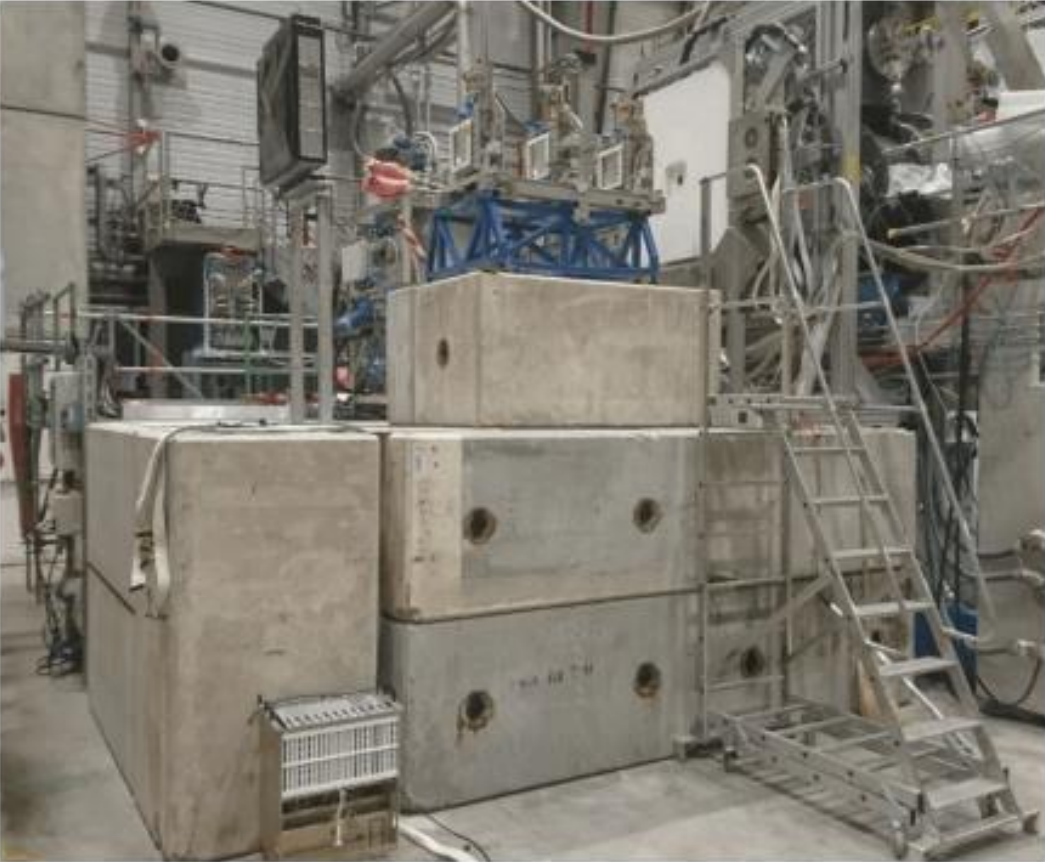
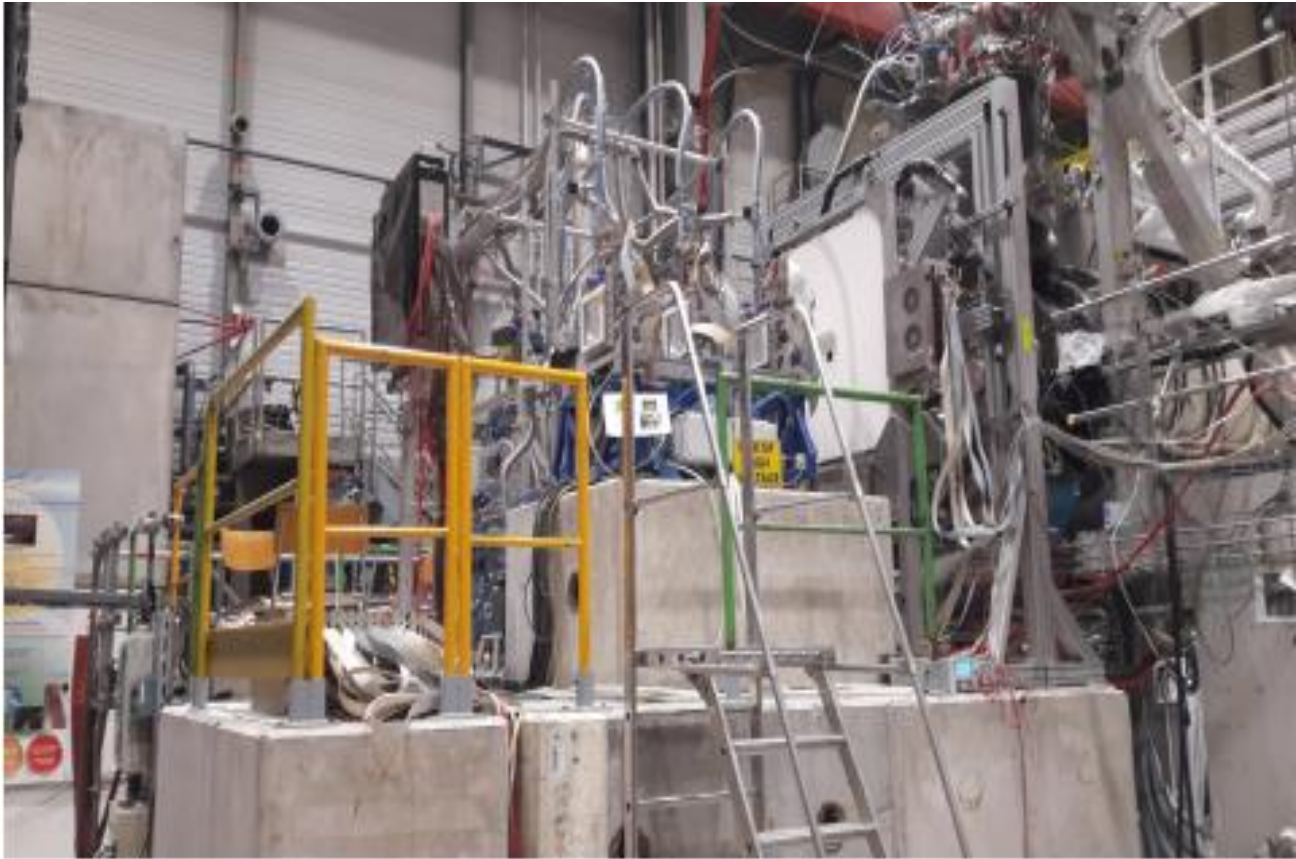
Bram Tracker telescope re installation

Reinstallation started on 13th of August
