Performance and Upgrades of the Advanced Photon Source (APS) 2-MW DC Klystron Power Systems

Gian Trento Accelerator Systems Division Argonne National Laboratory

2MW DC POWER SYSTEM FOR SR & BOOSTER

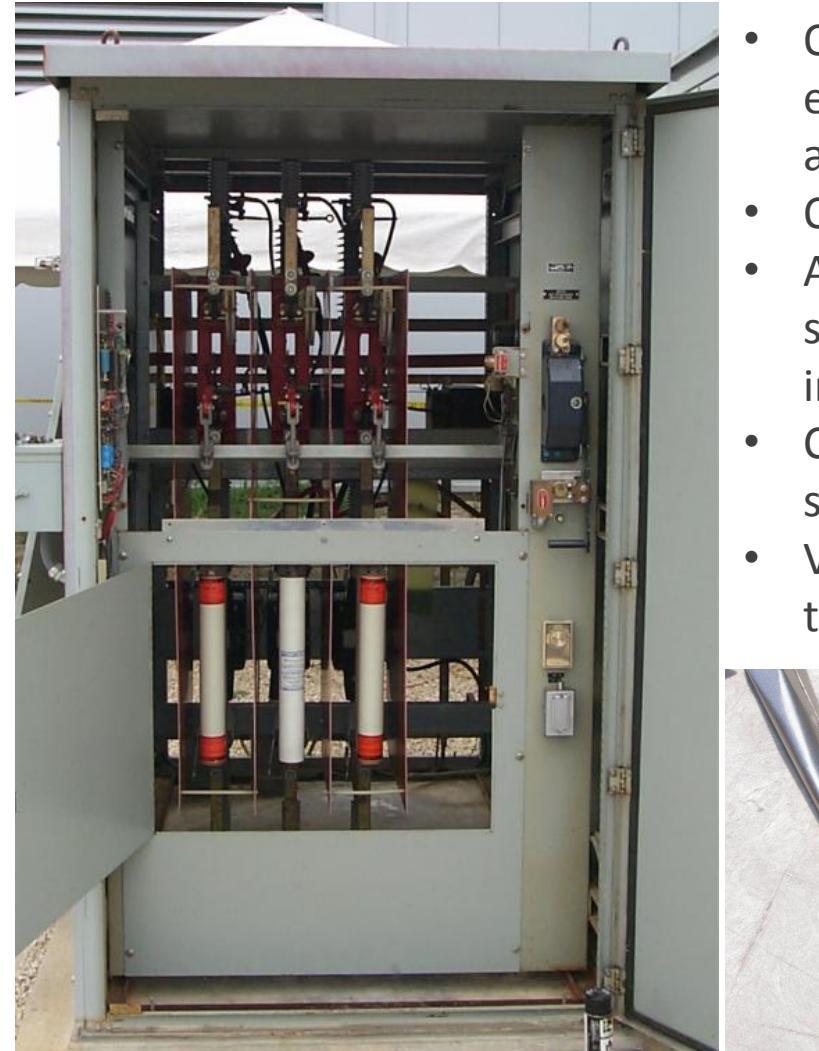
Replaced Motorized Fused Disconnect

- OEM disavowed knowledge of its existence yet sold replacement parts at a premium price.
- Obsolete.
- Averaged 2 failures / year after sacrificial rollers installed. This actually increased reliability!
- Concrete foundation deteriorated and sourced moisture to GPO3.
- Violent open / close action wore out the mechanical components.

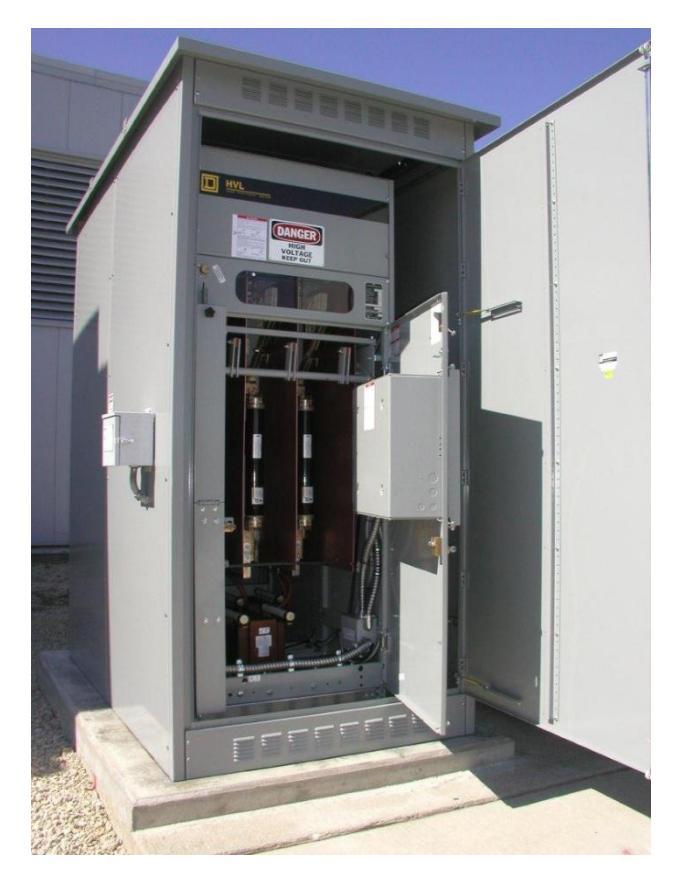
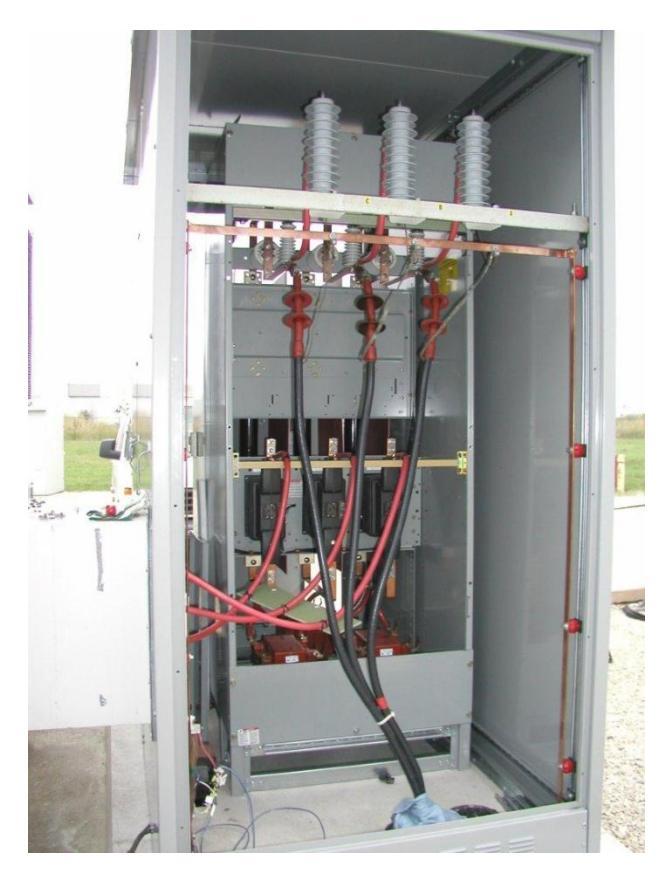
Upgraded MFD

- Specified to operate 750 X prior to maintenance
- Unit and replacement parts available from OEM
- No projectiles during operation!

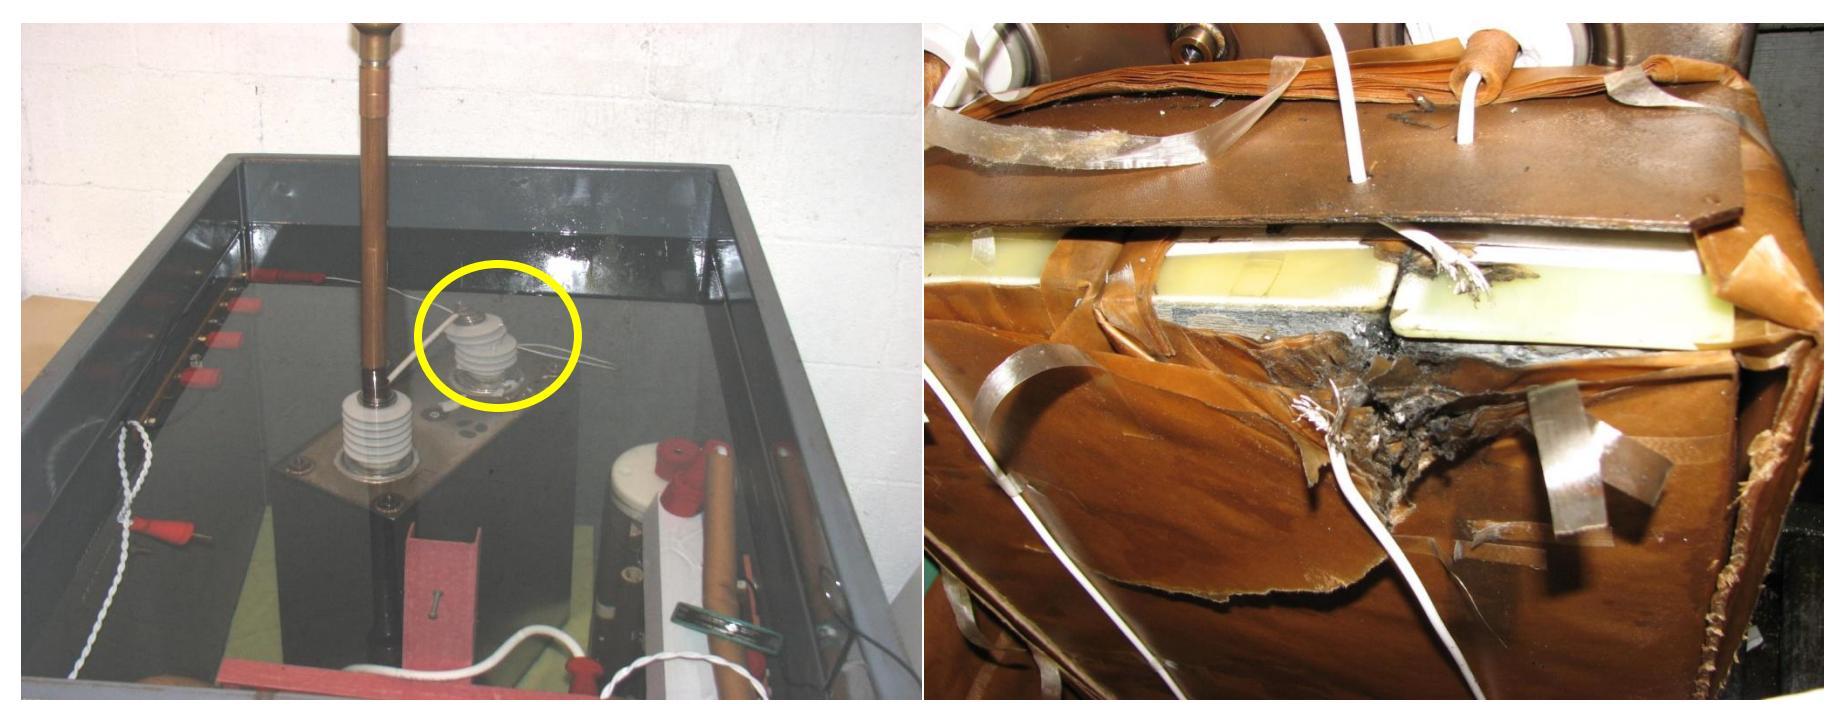
Capacitor Vendor B - Acceptance Testing

Terminal exploded within 15 seconds of high voltage test.

Kraft paper failed to cover edge of cells & can connector wire improperly ran.

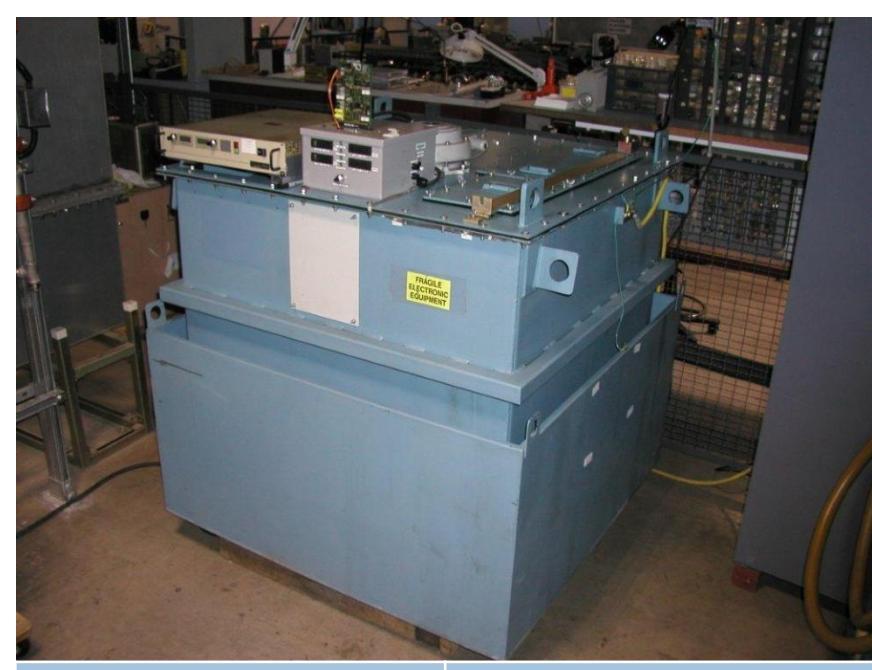
Tetrode Tester

Designation	Description
Source Power	-60kV, 12mA
Screen Voltage	670V
Filament Power	7.5V, 35A nominal
Grid Bias	-500V adjustable
Construction Cost	< \$2k Parts

- Operate a Thomson TH5188 across range of V – I conditions
- Perform QA testing on repaired and new pull-down cage(s)
- Tune control circuitry
- Determine what "shot-gunned" component failed.
- Provided hands-on training for support personnel.

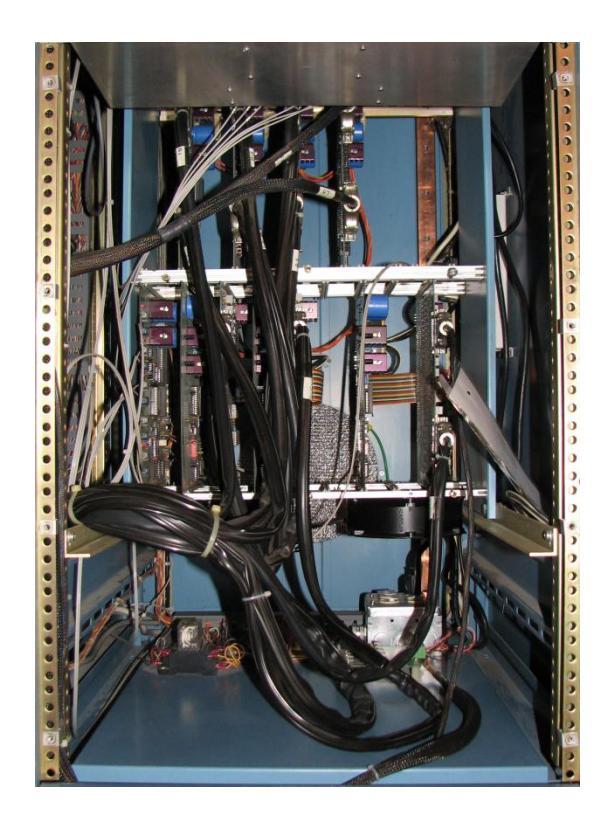
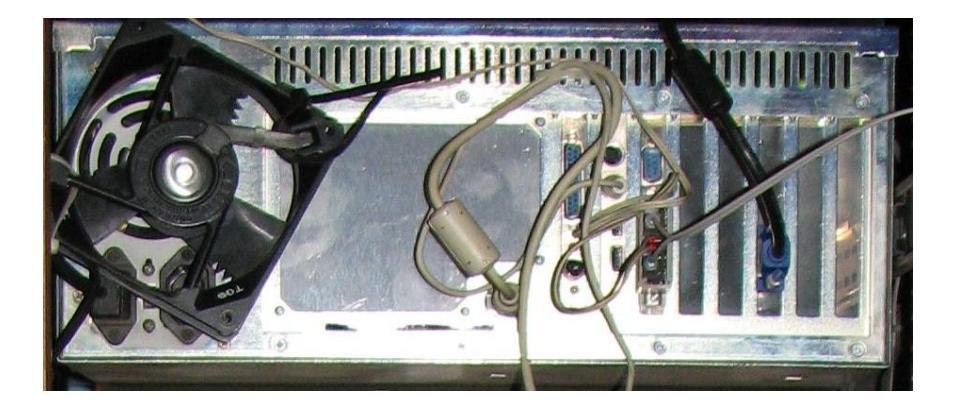
Obsolete Klystron PS Control Interface

- 1. 486 PC running Windows 95 GUI code
- 2. Proprietary E²PROM
- 3. OEM PC Boards and various I.C.s obsolete
- 4. GPIB communication error if left in analog monitoring

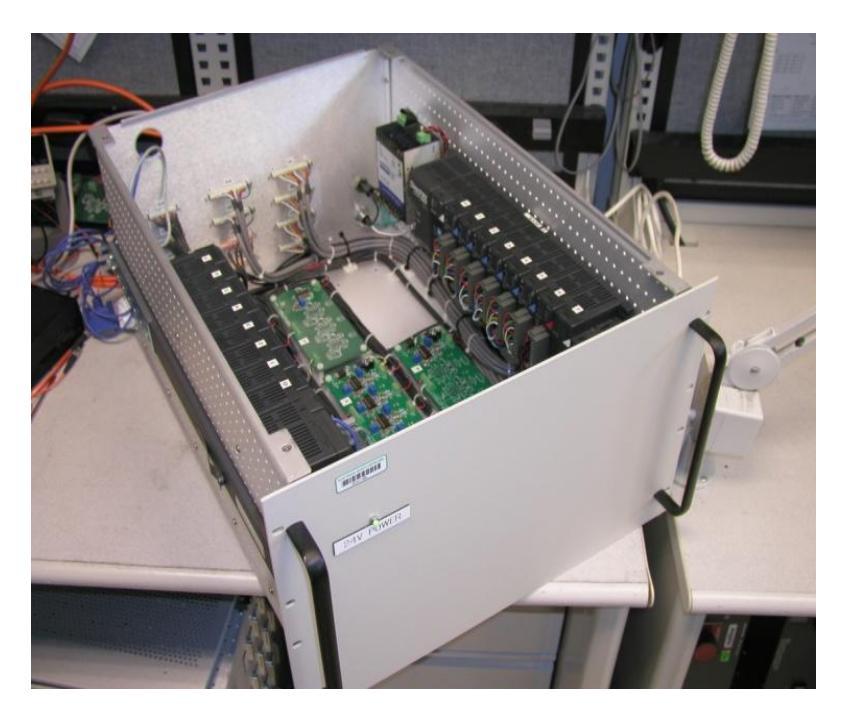
Updated

- Reliable EPICS interface
- Flexible
- Up-to-date software & hardware
- Low \$\$
