AHCAL beam tests

- > AHCAL technological prototype
 - concept
 - production, assembly, QA
- Testbeams at SPS
 - first look into the data

Katja Krüger CLIC Detector and Physics Collaboration meeting 29. August 2018

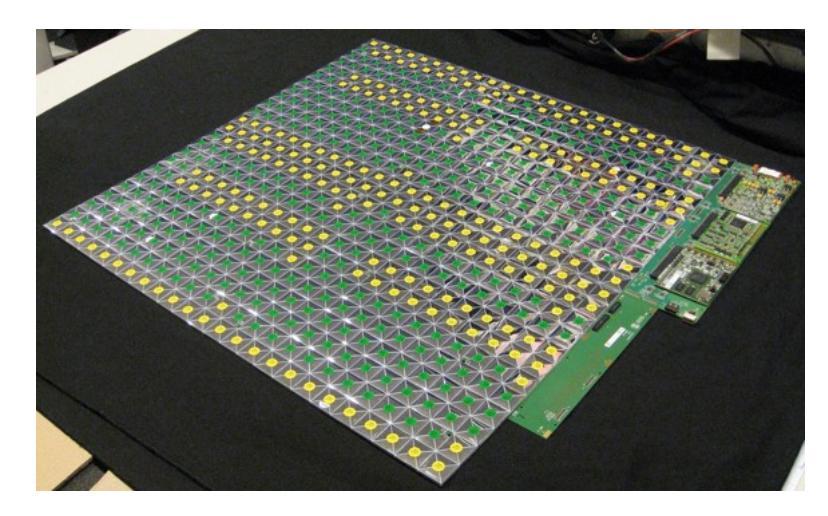
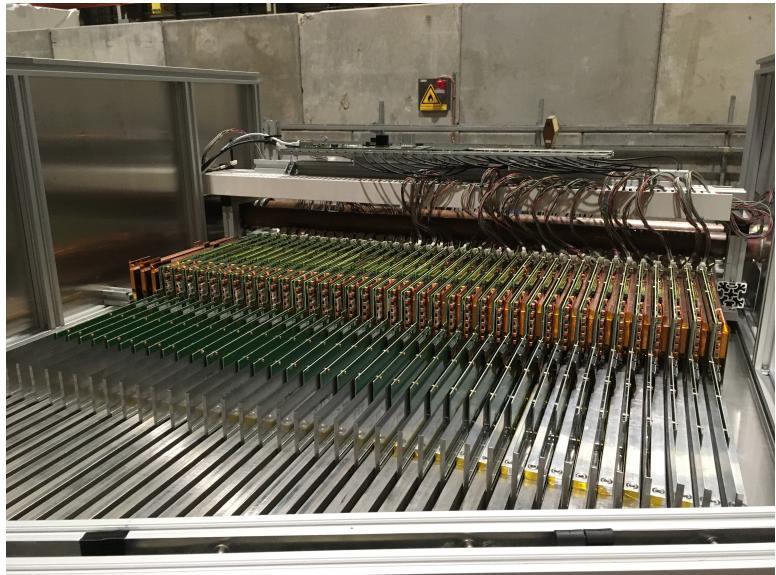
AHCAL active layers for testbeam

- > 38 active layers of 72*72 cm²
- > 4 HBUs per module
 - 16 ASICs, 576 channels
 - in total: 608 ASICs, ~22000 channels
- > all modules with surface-mount MPPCs
 - S13360-1325PE
 - 2668 pixels
 - operated at 5V overvoltage
 - nominal operation voltage within 200mV in a module -> use same voltage
- all modules are interchangeable, so positioning in stack according to quality (worst modules in the back)

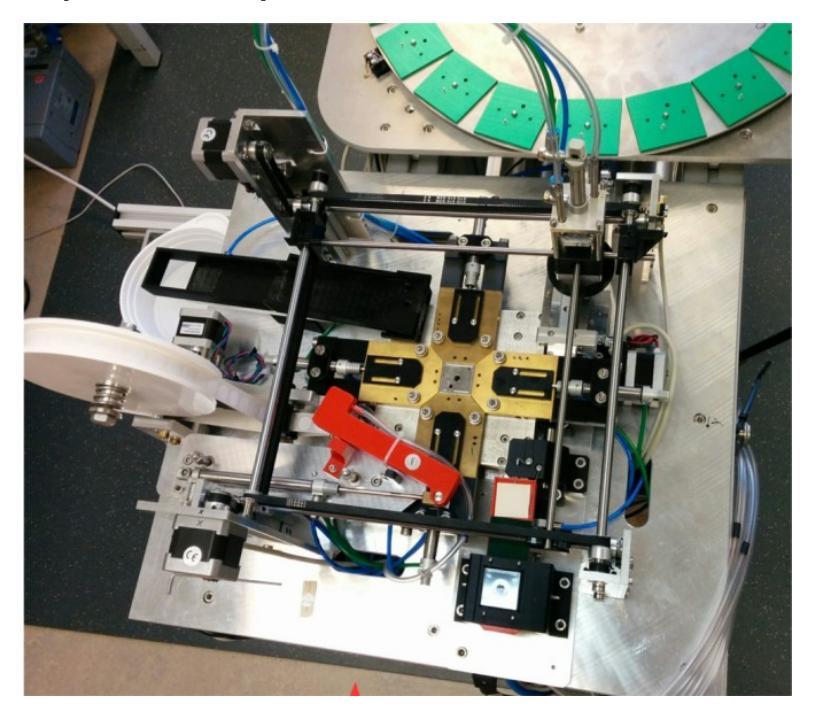
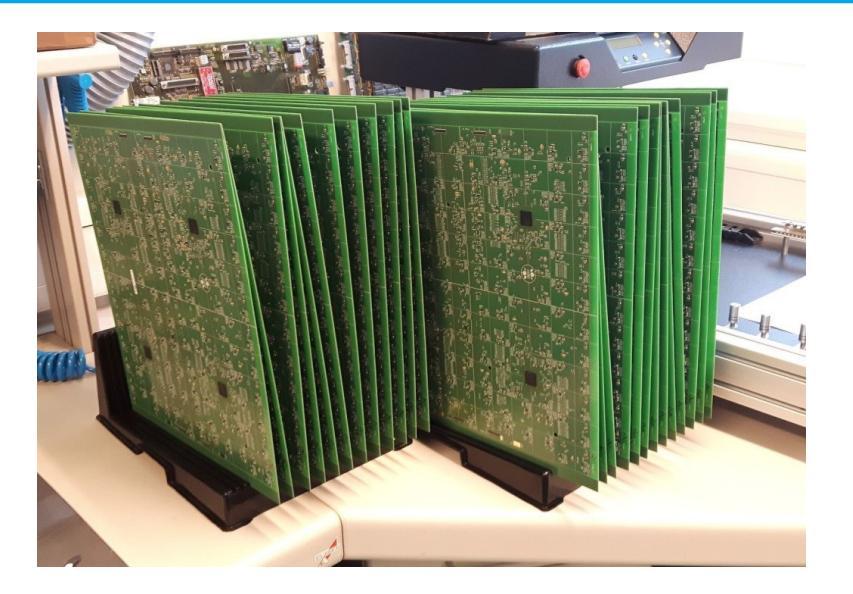
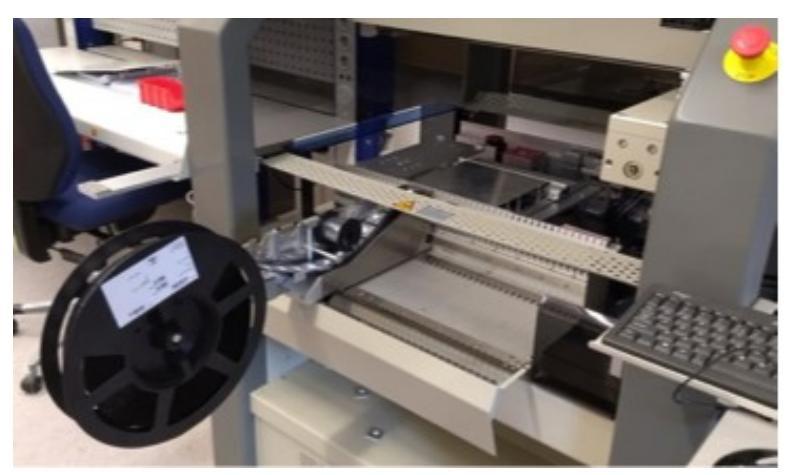
Mass production

- > design optimized for mass production
 - SMD SiPMs soldered automatically
 - injection-moulded polystyrene tiles, no further surface treatment
 - automatic wrapping in ESR reflector foil
 - glueing of tiles with screen printer and pick-and-place machine

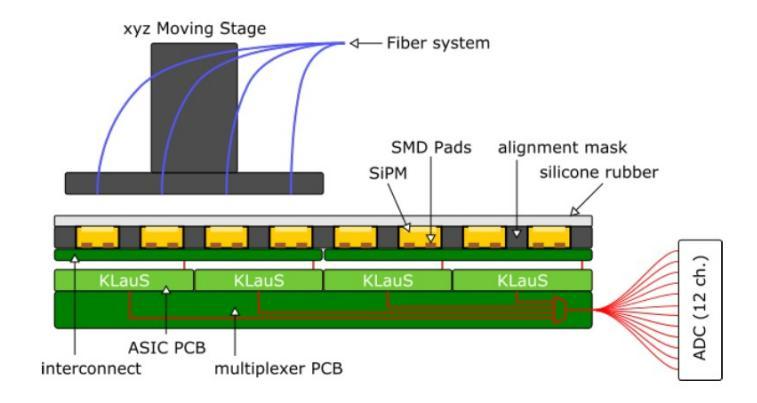
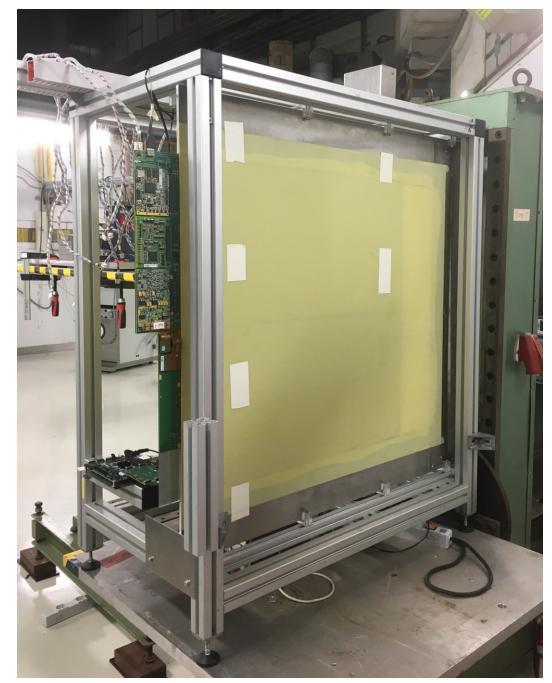
Quality assurance and calibration

- > SiPM sample tests
- tile sample tests
- test of all ASICs
- > all individual HBUs tested and calibrated with LEDs and cosmics
- > all modules (2*2 HBUs) tested with cosmics
- all modules calibrated with LEDs and DESY beam (3 GeV electrons as MIPs)
 - calibrate 4 modules in parallel, ~1 day per set
 - automated scan with automated control of the moving stage
 - many technical tests: gain switching, ...
- result: overall quality very good

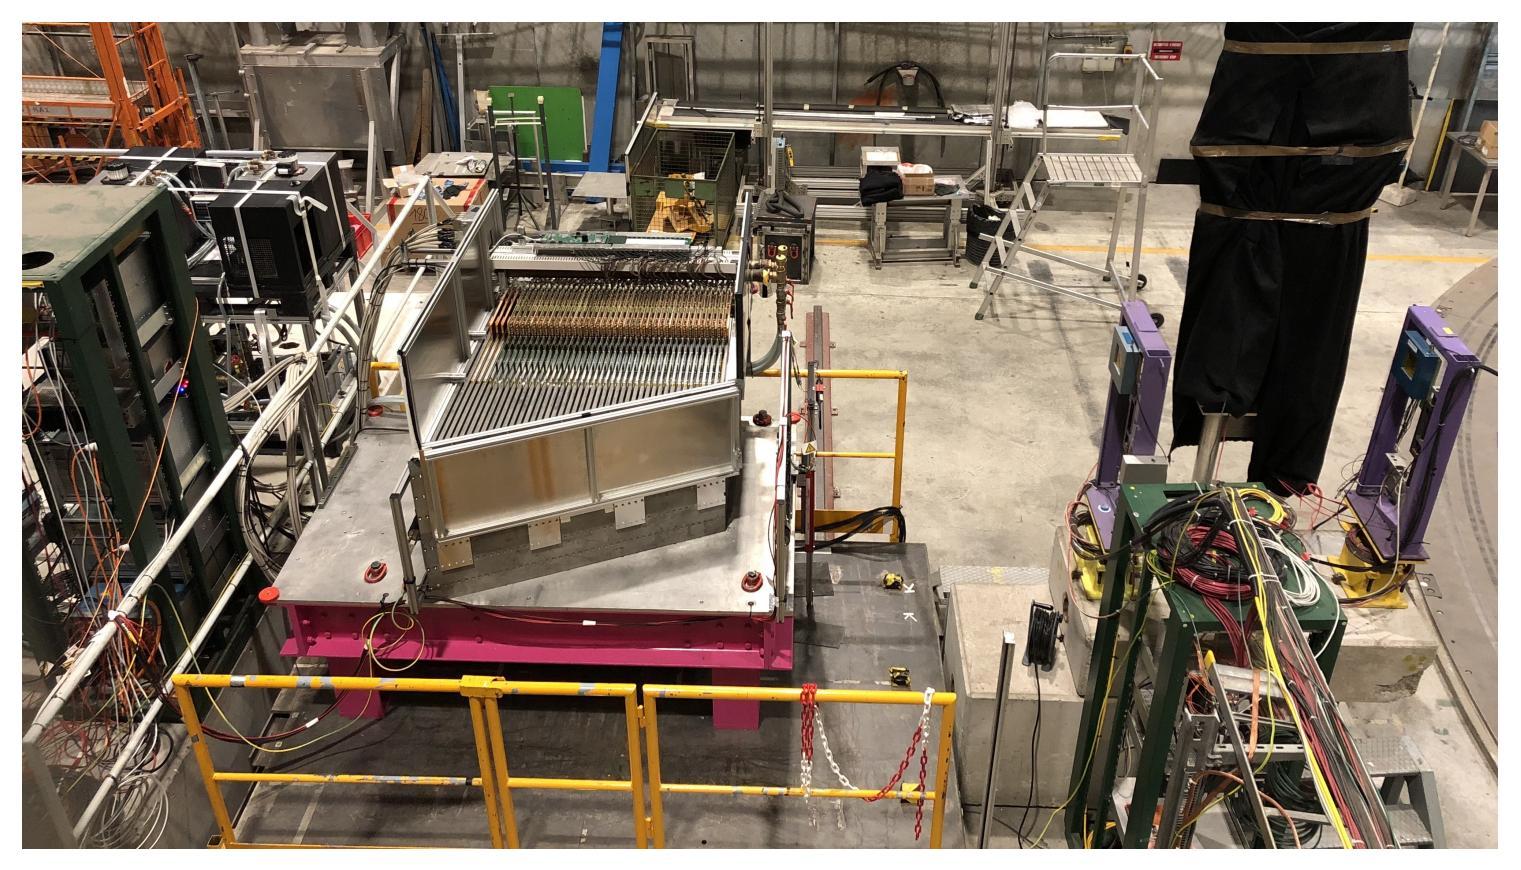
Testbeam setup 9. – 23. May 2018 in H2 at SPS

> 38 active layers of 72*72 cm² in steel absorber with 1.7 cm layer thickness (~4 λ)

- > mounted on the movable platform ("scissors table") in H2
- beam instrumentation: wire chambers, trigger scintillators, Cherenkov detector

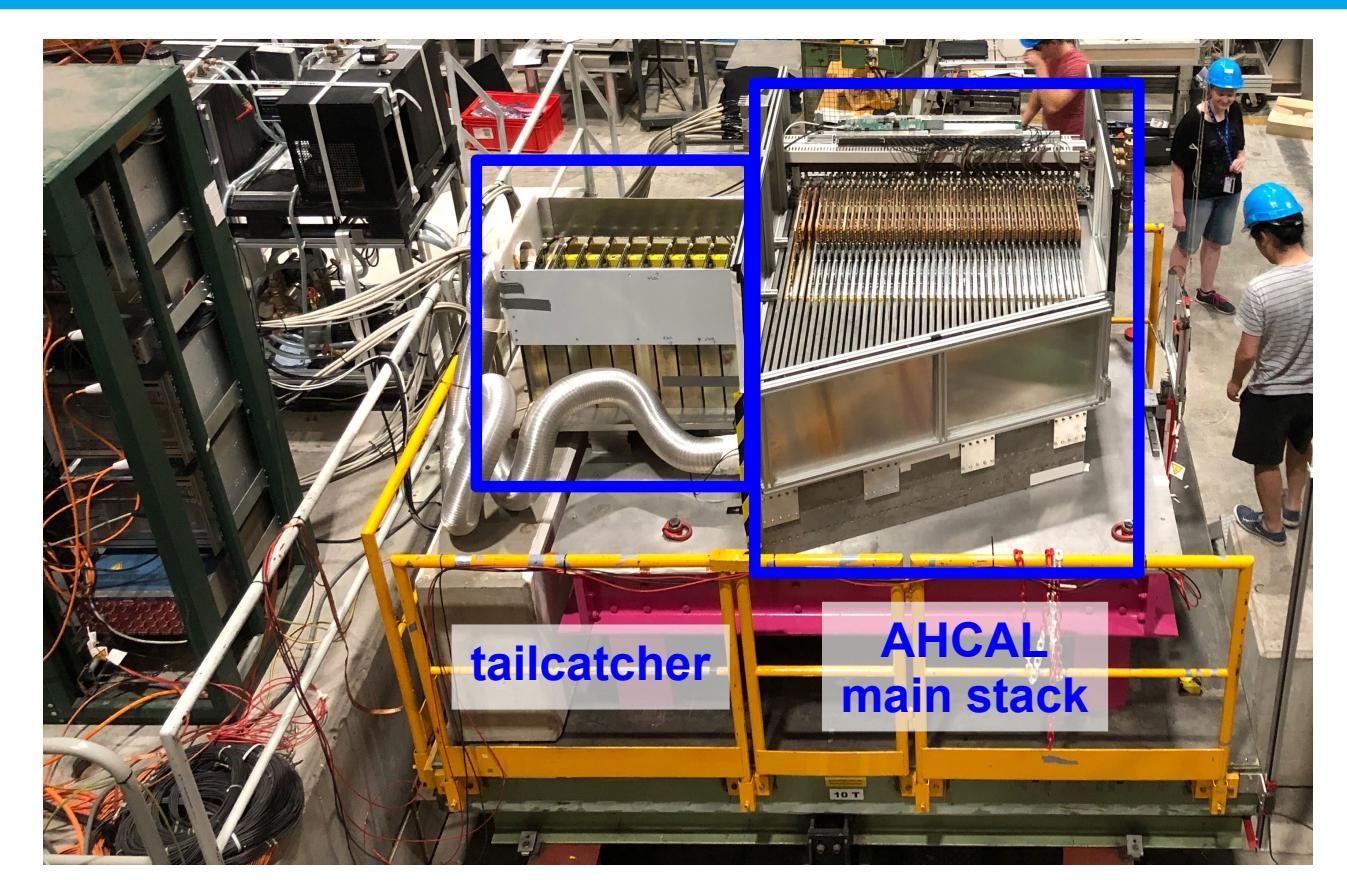
Testbeam setup 27. June – 4. July 2018 in H2 at SPS

> as in May, plus:

- added one module with 6*6 cm2 tiles
- added CMS HGCAL "thick stack" (12 layers of 1 HBU, 7.4 cm steel absorber) as tailcatcher
- added single HBU in front of absorber as "pre-shower" detector

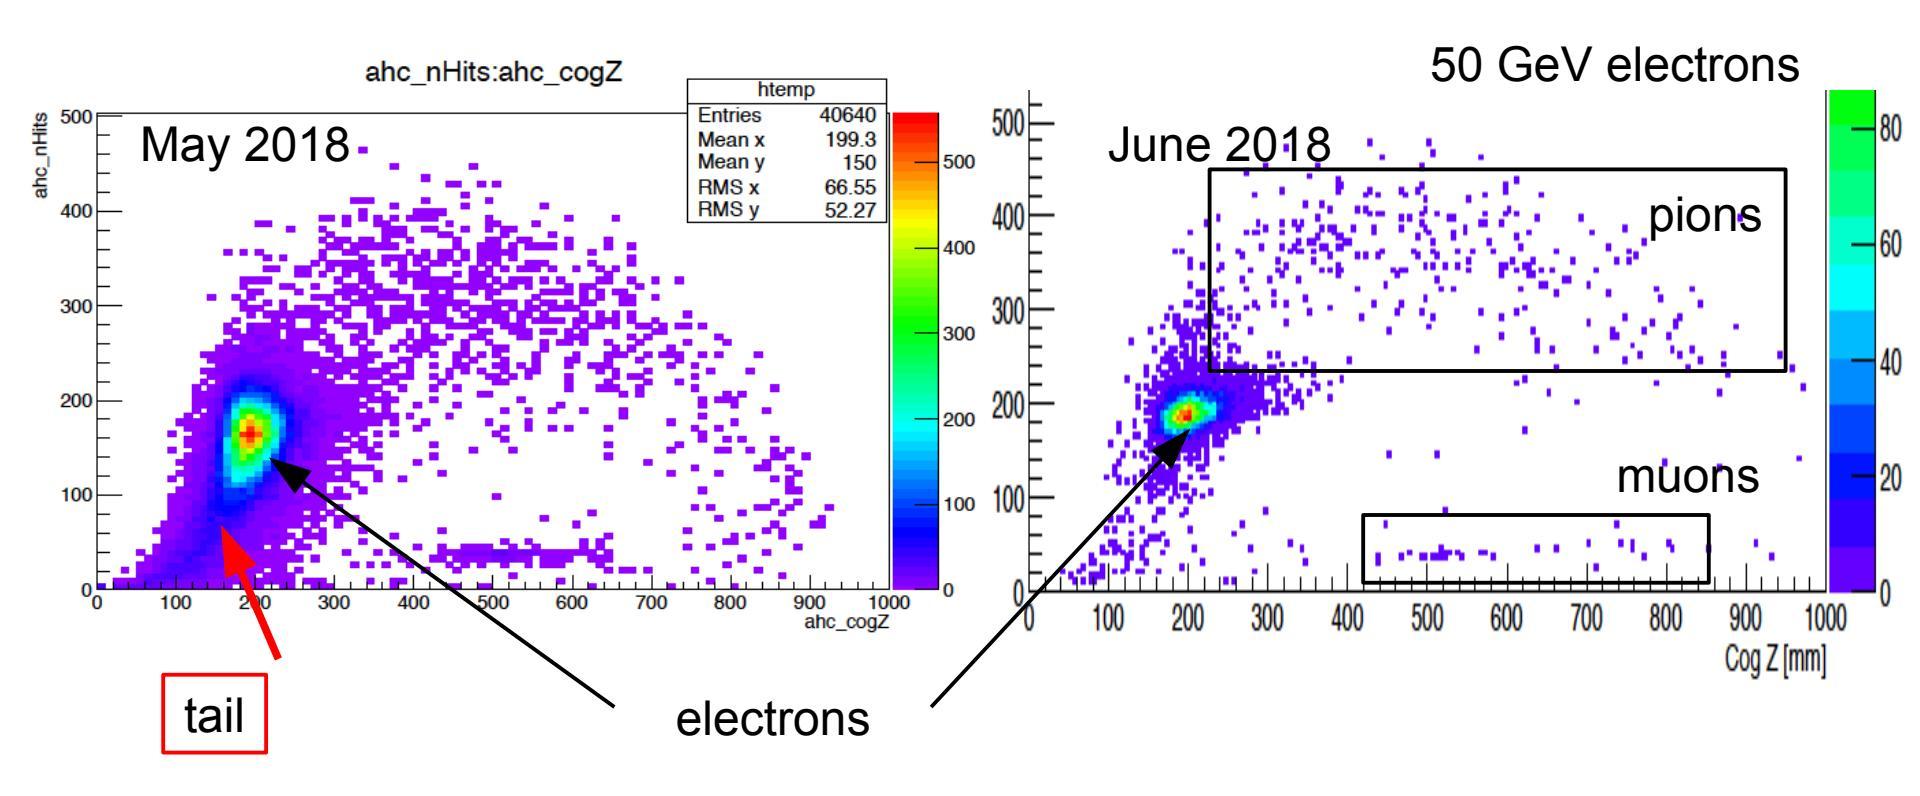
Very first look into electron data

> May:

- clear tail to smaller number of hits and earlier center-of-gravity
- present for all electron energies

- > June:
 - changed beam steering
 - tail gone, nice and narrow energy distributions

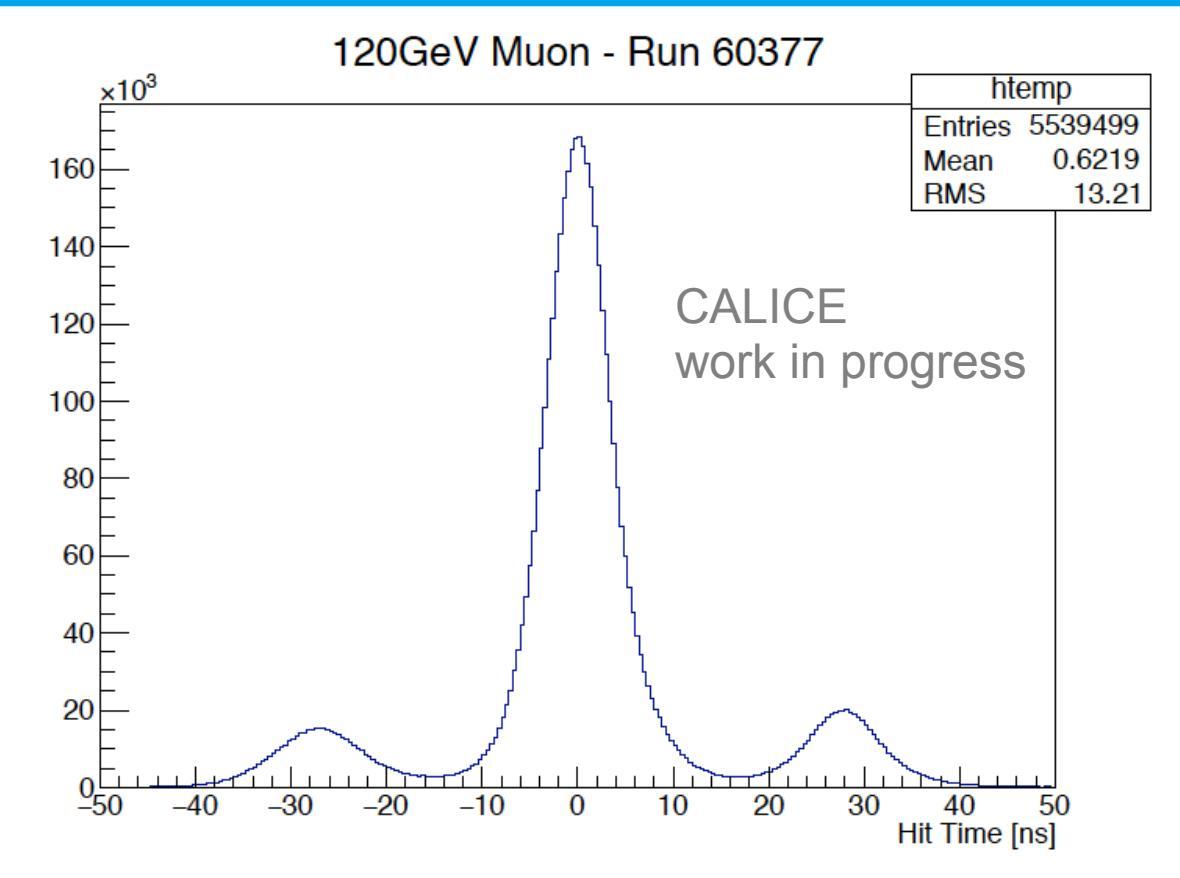
Timing analysis

> first attempt of calibration of the hit time measurement

- promising resolution in core (~8 ns FWHM, with slow testbeam clock)
- > additional peaks at ~28 ns under study
 - probably the whole event is shifted, so can be corrected in reconstruction

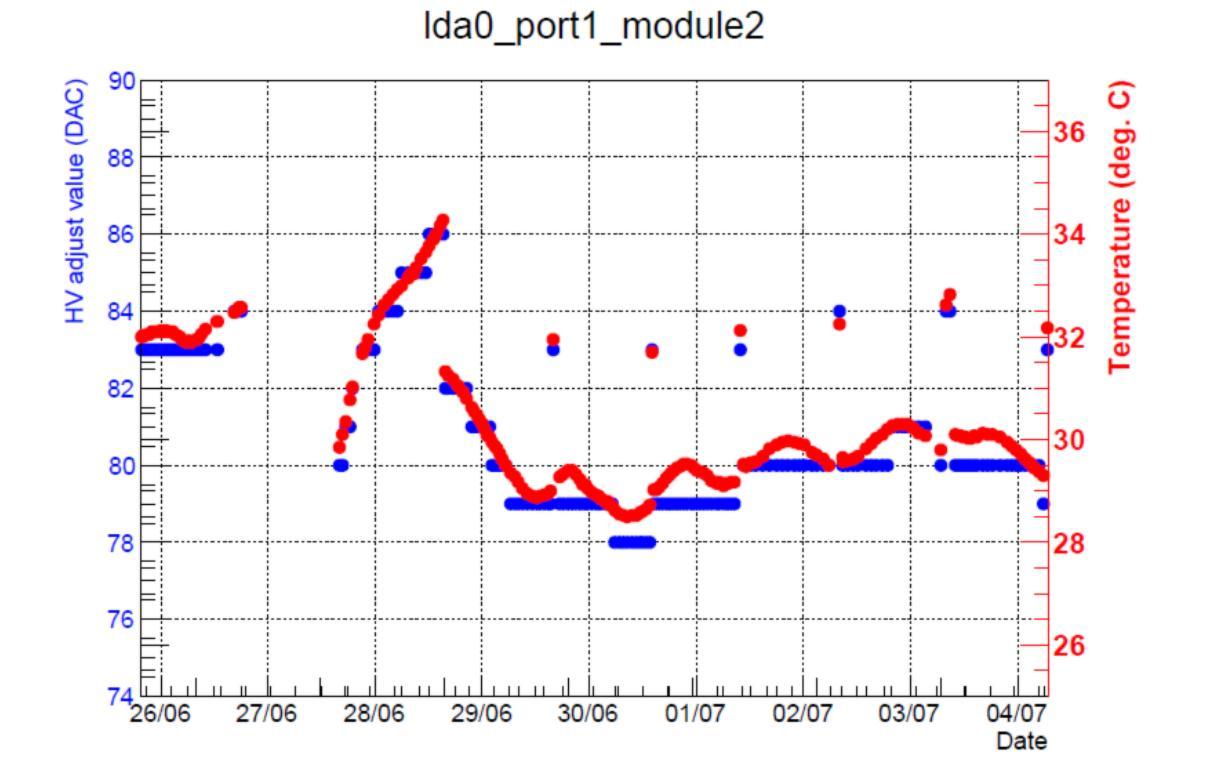
Temperature compensation

gain and photon detection efficiency of SiPMs depend on temperature
can avoid changes by stabilizing temperature or adapting bias voltage (HV)

temperature compensation: use mean temperature in a layer to adjust HV

used routinely, HV changes as expected, gain stays stable

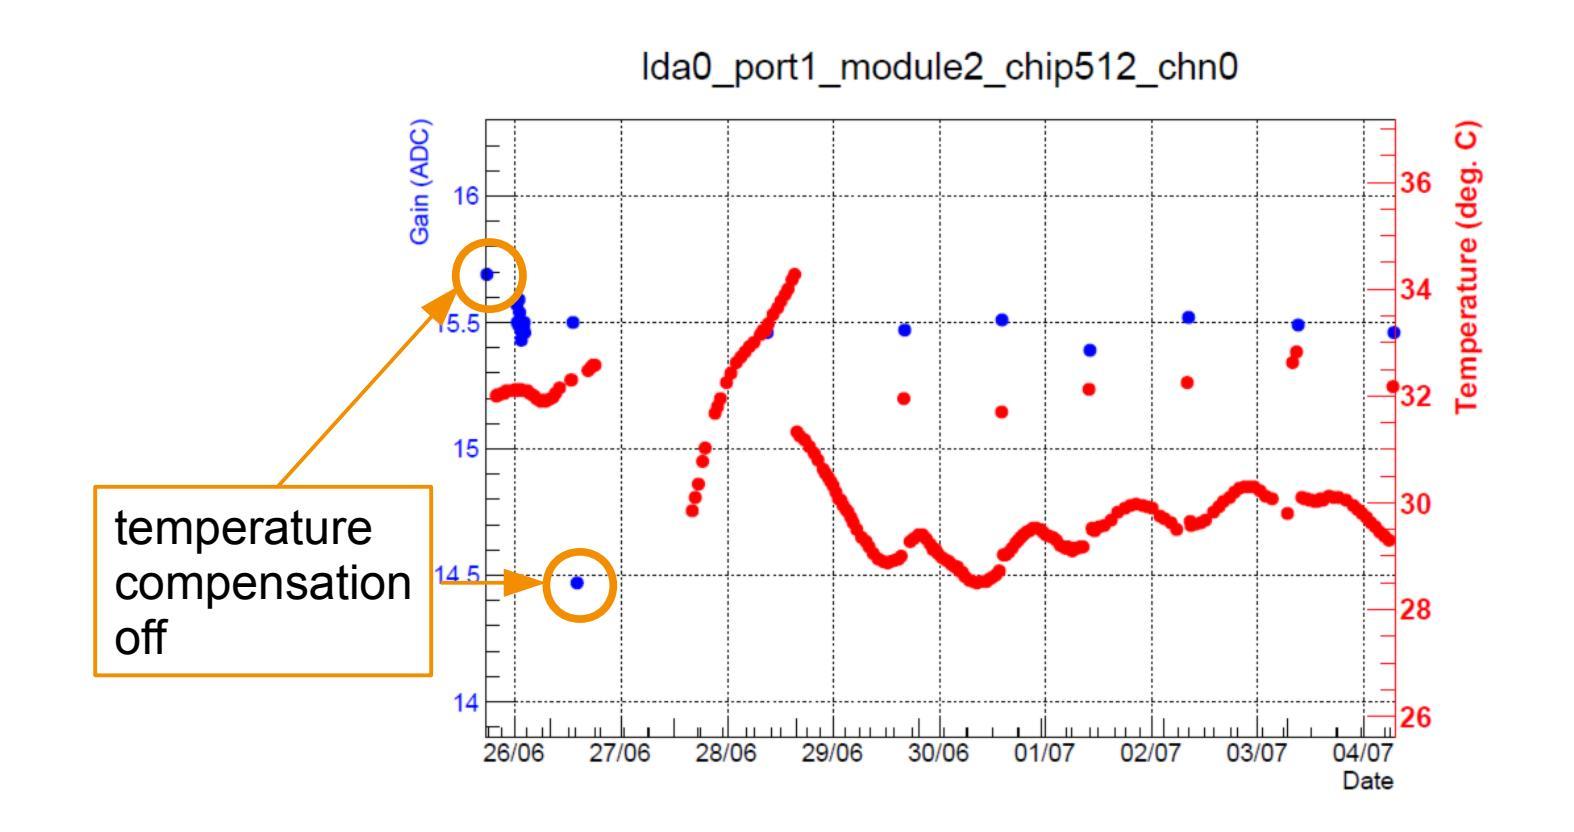
Temperature compensation

gain and photon detection efficiency of SiPMs depend on temperature
can avoid changes by stabilizing temperature or adapting bias voltage (HV)

temperature compensation: use mean temperature in a layer to adjust HV

used routinely, HV changes as expected, gain stays stable

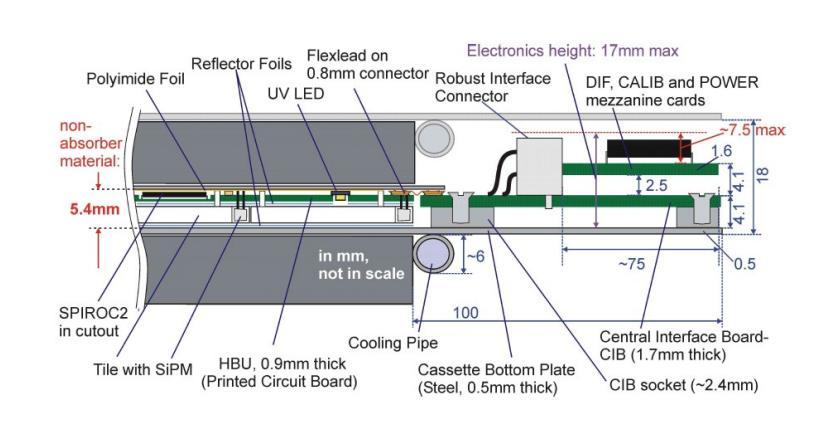
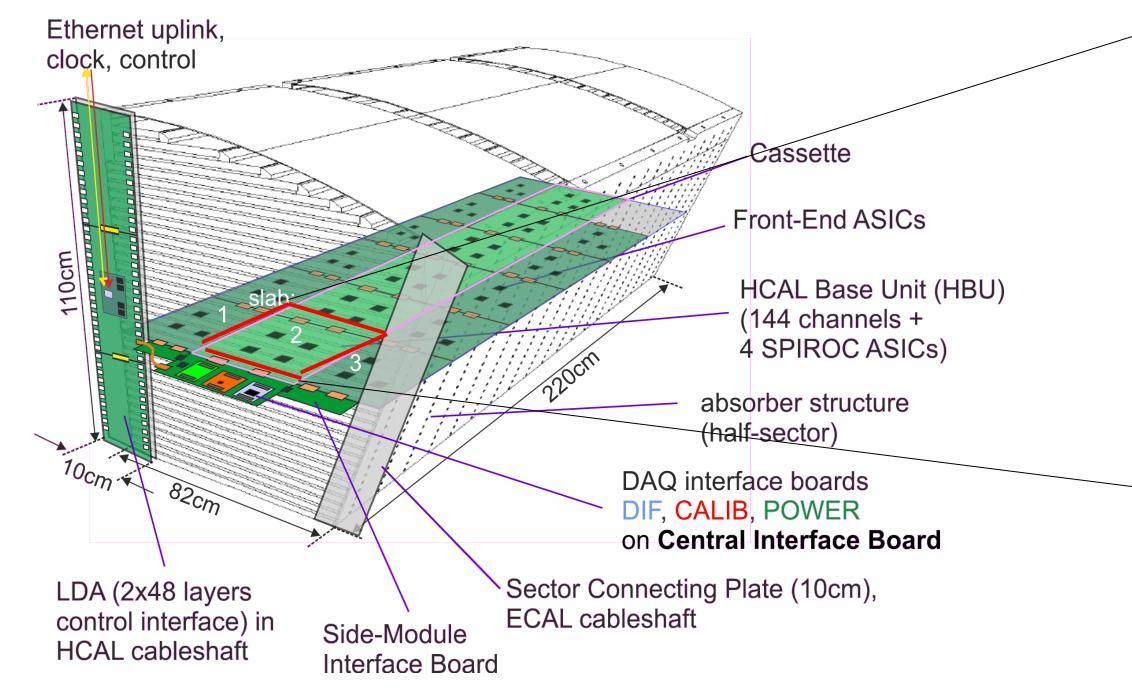
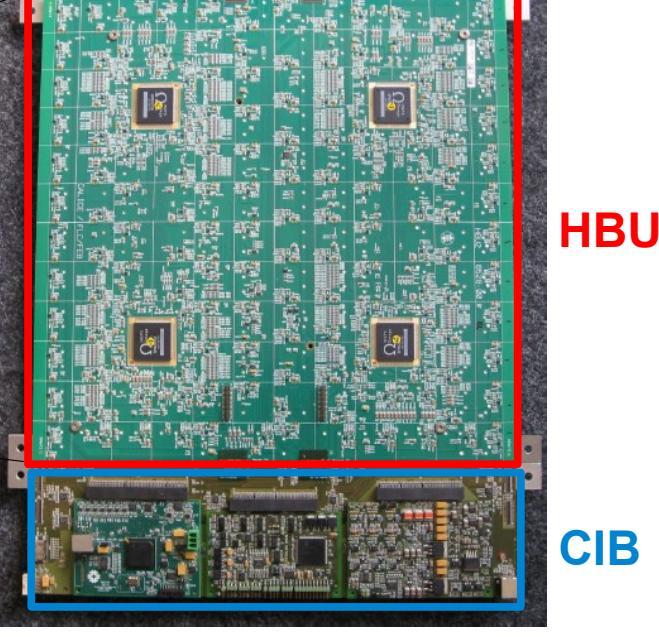
AHCAL technological prototype: Integrated Electronics

- HCAL Base Unit: 36*36 cm², 144 tiles, 4 SPIROC2 readout ASICs
- Central Interface Board: DIF, Calibration, Power for 1 layer
- > 5.4 mm active layer thickness
- 1 layer has up to 3*6 HBUs

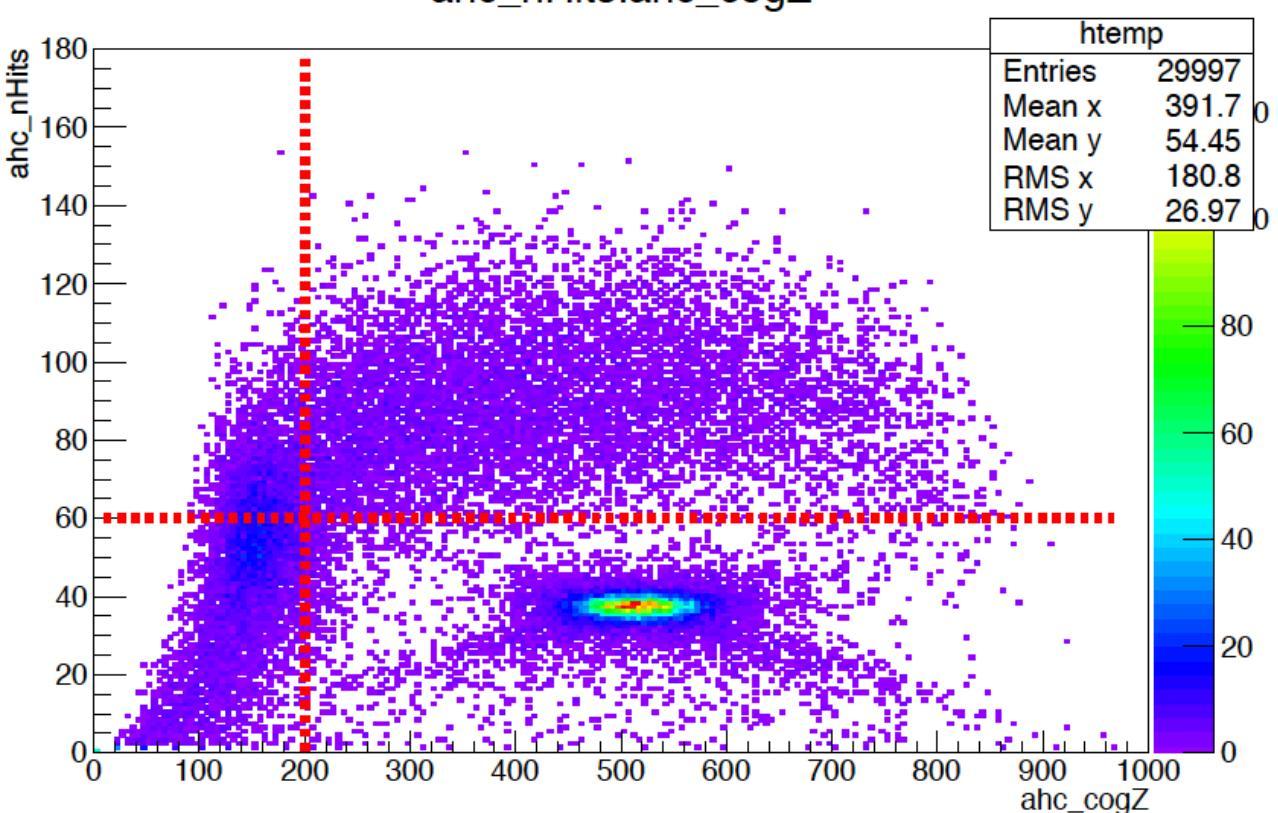
Contamination in low energy pions

ahc_nHits:ahc_cogZ

- beam rate for 10 and 15 GeV pions rather low (few hundred Hz)
- > clear contamination with electrons and muons (~30% pions)
- > attempts to clean the beam with absorber did not work
