Production, calibration and performance of the layer 1 replacement modules for the CMS pixel detector

Vertex 2020 October 6, 2020

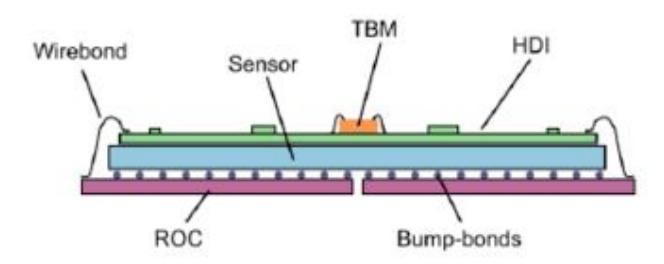
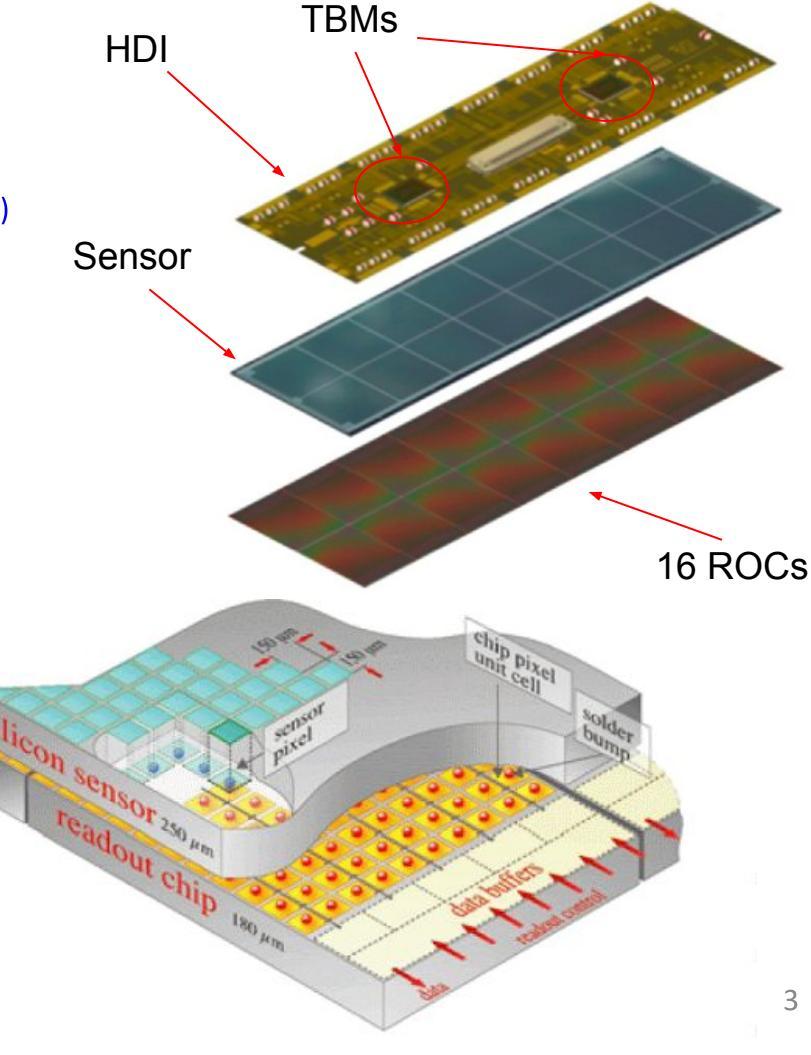
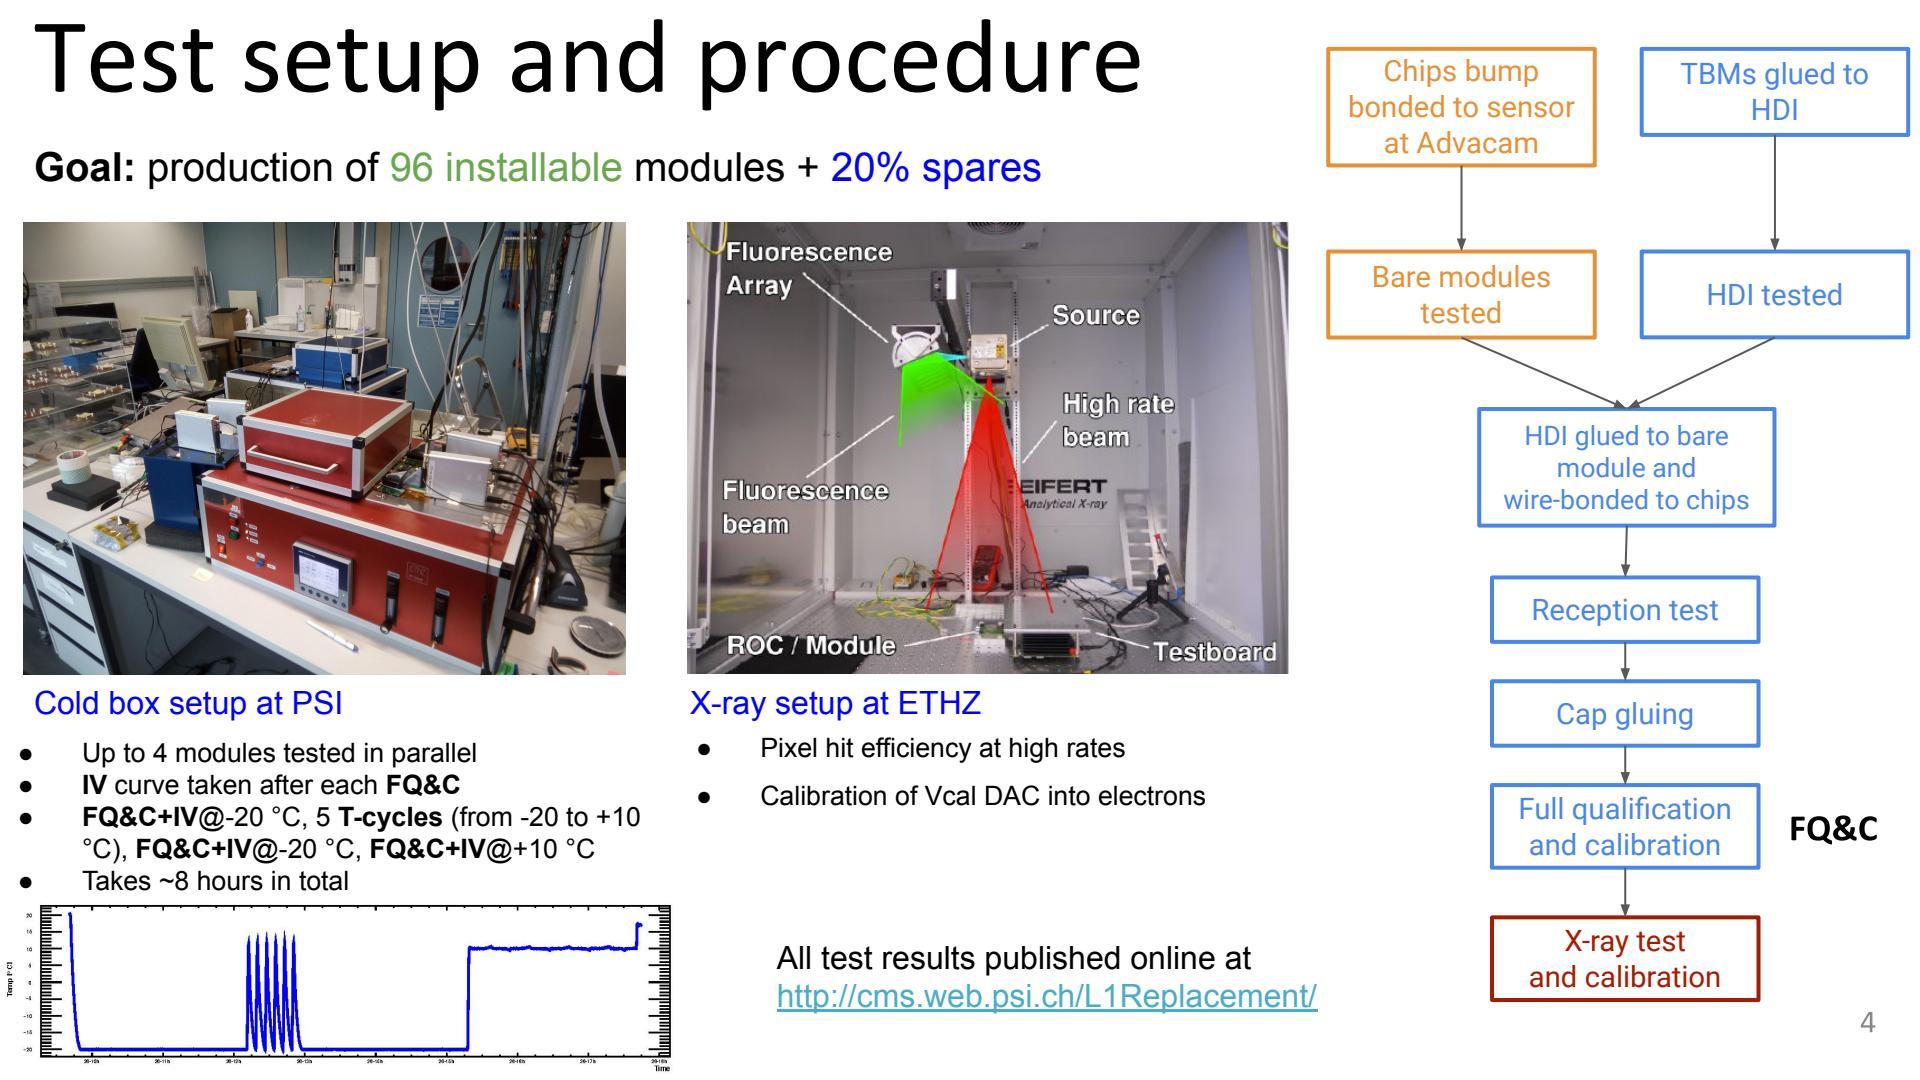
L1 module overview

- High-density interconnect (HDI10d)
 - Glued on top of the sensor and wire-bonded to readout chips (ROCs)
 - Routes control and data signals between ROCs and token bit manager chips (TBMs)
 - Routes high-voltage to the sensor
- Sensor
 - "Sandwiched" between HDI and ROCs
 - Connected with ROCs through bump-bonds (bottom image)
- Read-out chips (PROC600 v4)
 - 16 chips at the bottom of the module
 - "Reads" signals from sensor, processes them and sends to TBM

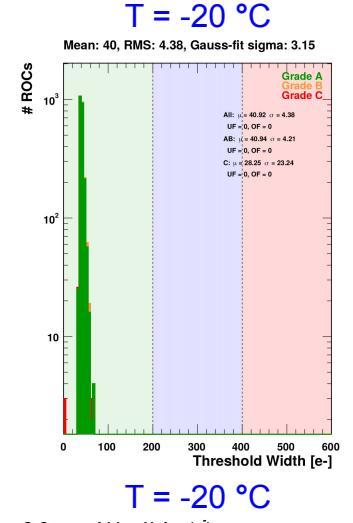
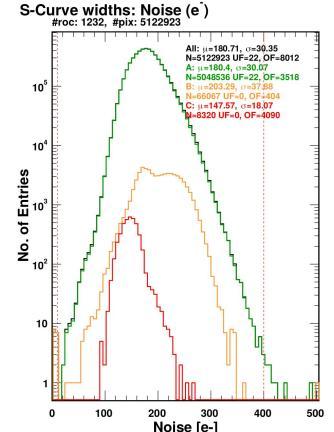
Threshold trimming

- Trimming to about 2000 e⁻
- Thresholds uniform within about 40 e⁻

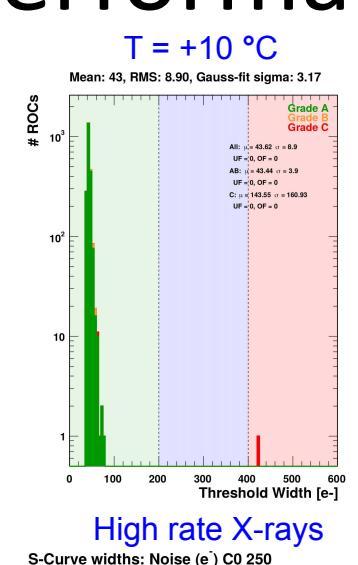
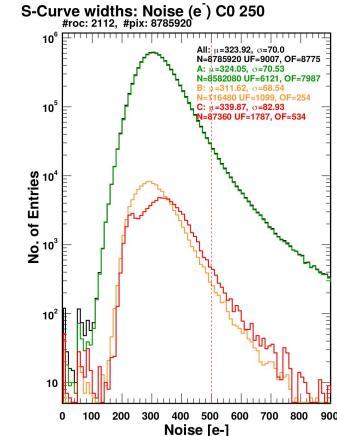
Noise per pixel

- Mean of about 200 e⁻ and small tail
- Under X-rays, higher noise with longer tail, rate of noisy pixels still low (~1-2%)

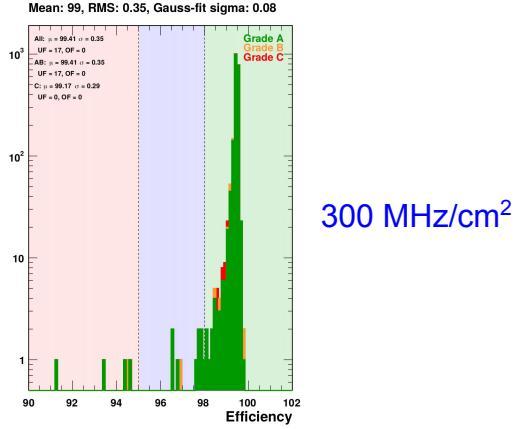
High rate efficiency

- 300 MHz/cm² X-ray rate corresponds the expected hit rate on L1 at the LHC
- Modules not installable if hit efficiency <95%
- Great majority of ROCs have hit efficiency above 98% (target for PROC600)

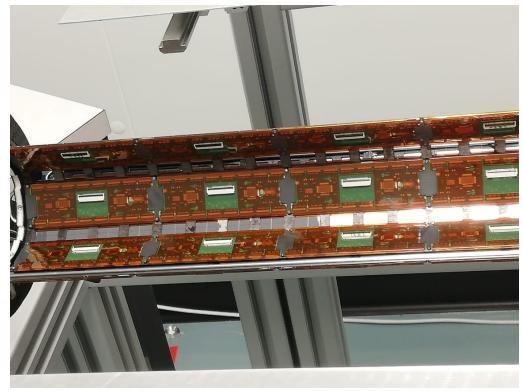
Mounted L1 modules

Cumulative production graph Grade A+B Grade C incomplete # modules 60 40 20 03-01 01-31 03-31 04-30 05-30 06-29 07-29 08-28 2020 2020 2020 2020 2020 2020 2020 2020
