# High Power Test Results of X-Band Dielectric Disk Accelerating Structures

Ben Freemire for Euclid Beamlabs & Argonne Wakefield Accelerator

International Workshop on Breakdown Science and High Gradient Technology 19 May 2022

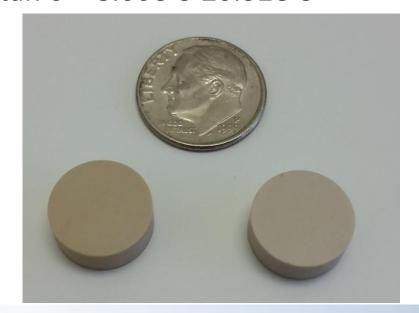
- Prototype I & II:
- BaTiO<sub>x</sub> ceramic (D-50) from Skyworks (Trans-Tech)
- 10 coupons measured (4 GHz):
  - $-\epsilon_r = 50.14 \pm 0.35$
  - $-\tan \delta = 8.00e-5 \pm 0.32e-5$

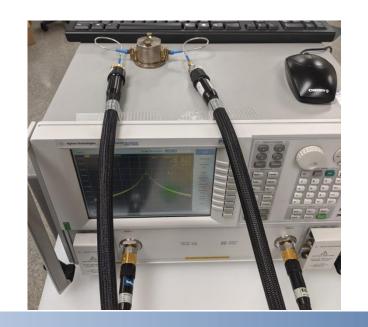
- Prototype III:
- Ca<sub>v</sub>Ti<sub>w</sub>La<sub>x</sub>Al<sub>v</sub>O<sub>z</sub> ceramic (D-47) from Keramika
- 3 coupons measured (3.8-7.4 GHz), extrapolated to 11.7 GHz
  - $\epsilon_{\rm r} = 47.7$
  - tan  $\delta = 3.44e-4$

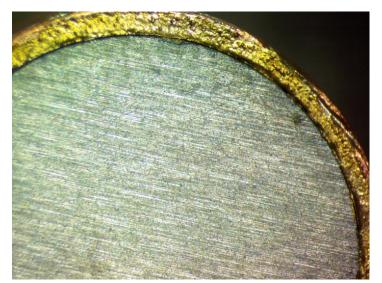
- High temperature InCuSil-ABA @835°C in vacuum furnace
- Hermetic seal successful; ceramic became lossy
- Post-braze bake in air reduced RF loss
- Oxygen escapes in vacuum at high temperature but can be reintroduced

Temp.	Time	ε <sub>r</sub>	tan δ
Original	-	-	50.2	8.15e-5
Post-Braze	835	N/A	49.7	1.43e-2
Post-Bake 1	800	60 min.	49.3	7.17e-4
Post-Bake 2	800	60 min.	49.3	1.03e-4

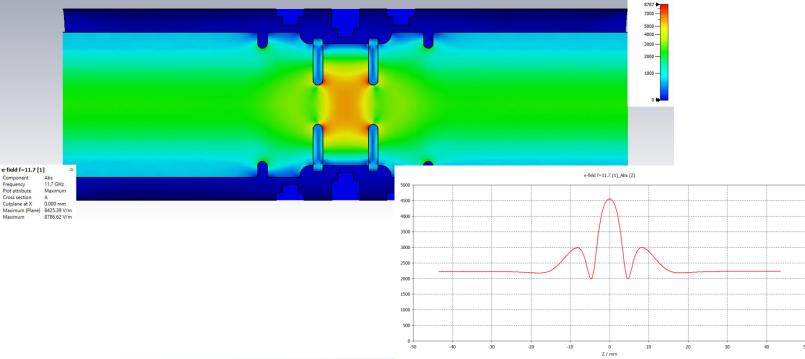
- 1 Dielectric cell (2 disks) + 2 matching cells
- f = 11.7 GHz, three sets of 4 tuners each allow
  ±3 MHz range

Dielectric constant	50.1			
	Loss tangent	8e-5			
	Q	10,300			
	Shunt impedance	176 MΩ/m			
	Group velocity	0.345c			
-	Phase advance	2π/3			
	E <sub>acc</sub> (P <sub>in</sub> )	100 MV/m (280 MW)			
50	E <sub>max</sub> / E <sub>acc</sub>	1.84

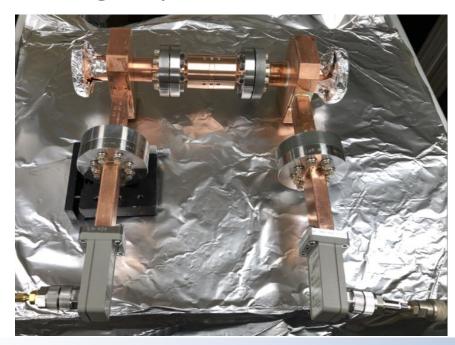
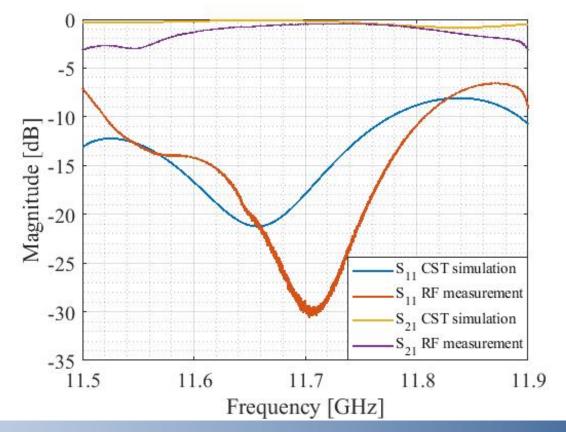
- Measured  $S_{21} = -0.50 \text{ dB \& } S_{11} \text{ 10 dB BW} = 290 \text{ MHz}$
- Differences attributable to discrepancies in machined dimensions/dielectric constant
  - Couplers included in simulation
- No tuning required

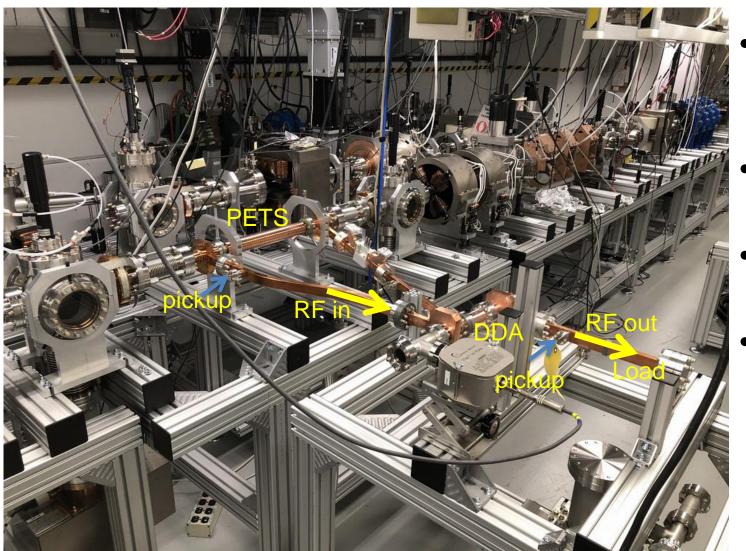
- Power provided by Power Extraction and Transport Structure (PETS)
- ICTs measure beam current for power generation
- Directional couplers at DDA input & output
- Instrumentation to look for multipacting/breakdown
  - Ion pump & vacuum gauge
  - Cameras on both ends of DDA

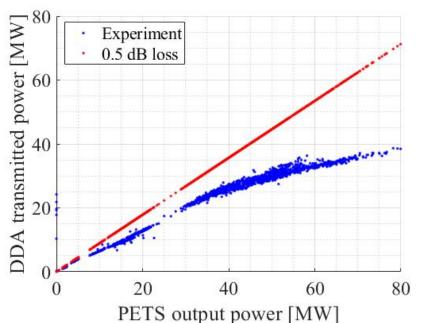
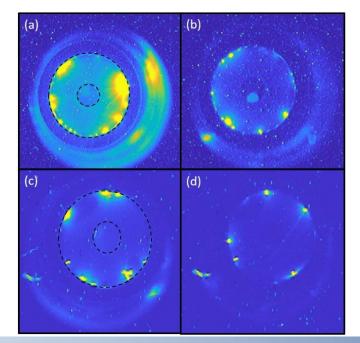
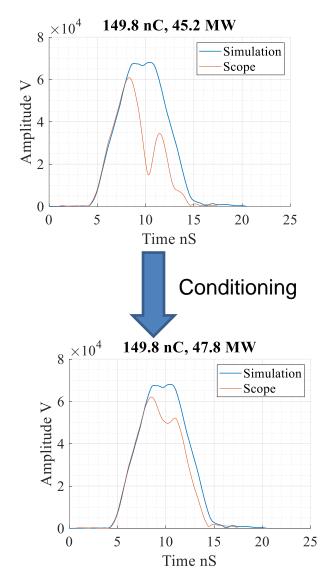
- Significant multipactor/breakdown activity observed
- Light emission from circumference of both ceramic disks
  - No light visible from irises
- Conditioning improved power transmission & light emission somewhat; never eliminated
- Run aborted at 80 MW input power

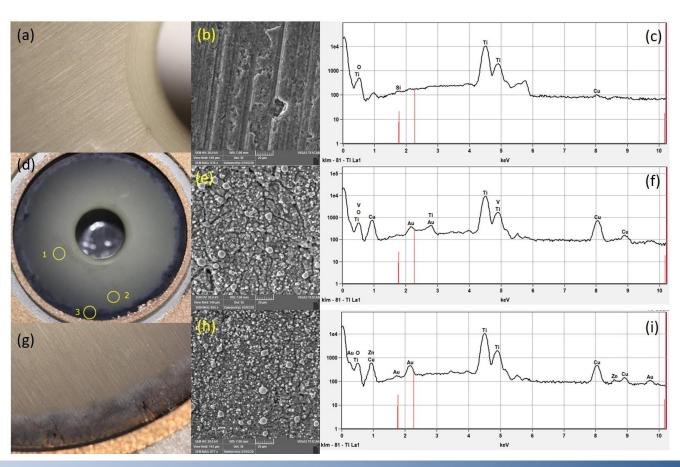
Damage around ceramic circumference

SEM & EDX results reveal pitting and presence of gold (braze alloy) and

copper near outer radius of disks

Iris & surrounding area free from damage or contamination

Breakdown/ multipactor confined to triple junction

region

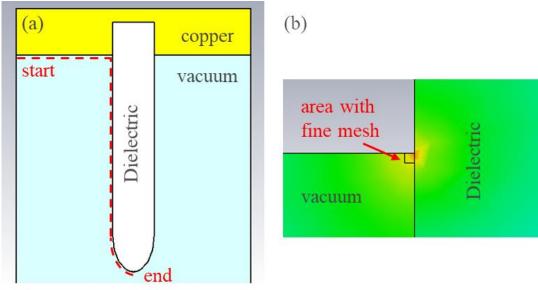
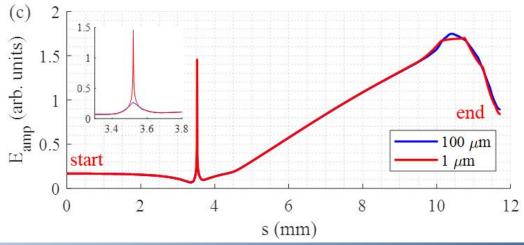
- Finer mesh revealed field enhancement at triple junction
- No evidence of problems stemming from iris or ceramic material
- Engineering challenge to overcome, not fundamental

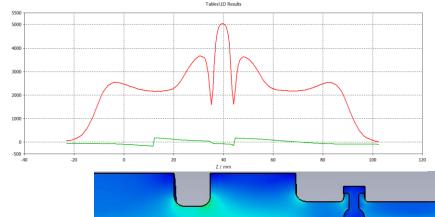
- Triple junction redesigned to minimize E-field
- Elliptic rounding added to copper and ceramic

Dielectric constant	47.7
Loss tangent	3.4e-5
Q	8,500
Shunt impedance	174 MΩ/m
Group velocity	0.27c
Phase advance	2π/3
E <sub>acc</sub> (308 MW)	100 MV/m
E <sub>max</sub> / E <sub>acc</sub>	1.44

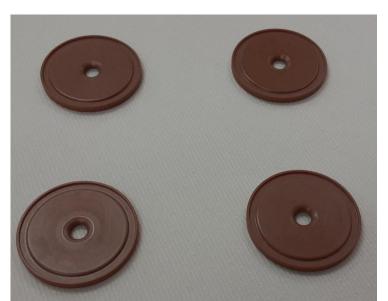
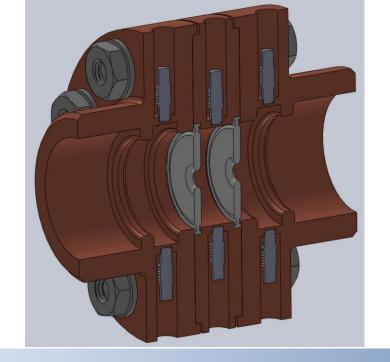
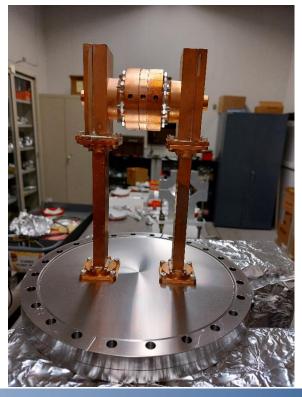
- Potential problem associated with braze alloy avoided
- No vacuum seal (tested in vacuum chamber)
- Outer edge of ceramic disks bite into annealed copper parts

Ceramic design more difficult to machine

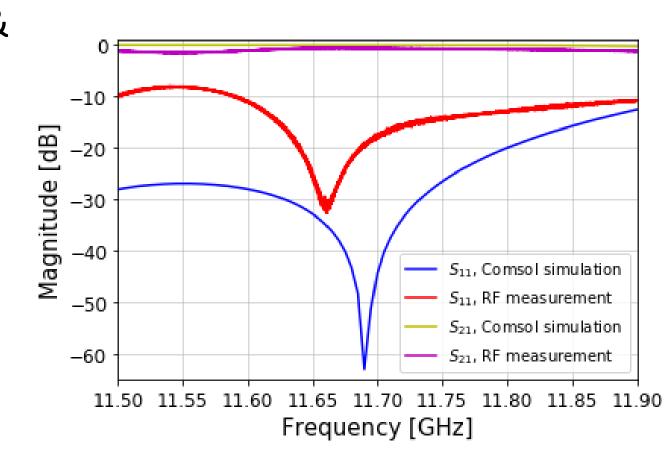
- Measured  $S_{21} = -0.652 \text{ dB } \&$  $S_{11} \text{ 10 dB BW} = >640 \text{ MHz}$
- Differences attributable to discrepancies in machined dimensions/dielectric constant
  - Couplers included in simulation
- No tuning required

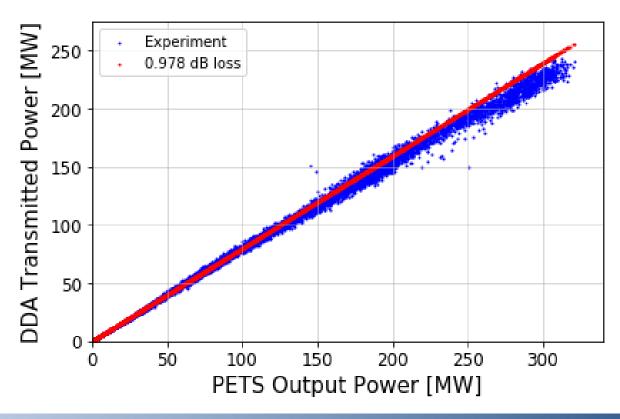
- No evidence (RF or light) of breakdown or multipacting
- Brief period of faint light from interior of structure at highest power conditioned away
- Transmitted power agrees very well with measured transmission loss from DDA+waveguide
- Limited by available input power!

320.9 MW input power = 102.3 MV/m accelerating gradient

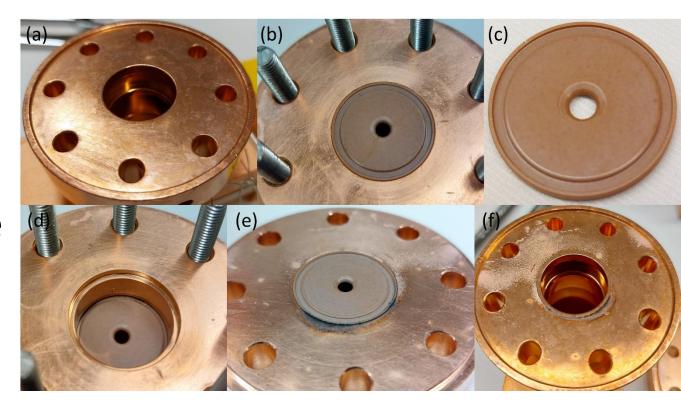
- No damage on ceramic or copper in RF volume
- Damage on copper surface and ceramic circumference in one cell due to RF leakage caused by inconsistent clamping force
  - May have been source of brief light during high power test
