Field emission seeded multipactor

Very early in conditioning of 400 Hz S-band photoinjector we see this:

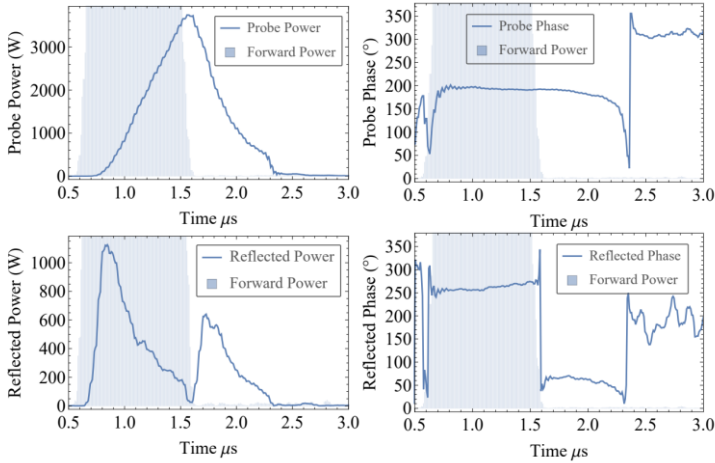
Caught as a breakdown- but occurs on every pulse in certain *forward* power ranges. Multipactor?

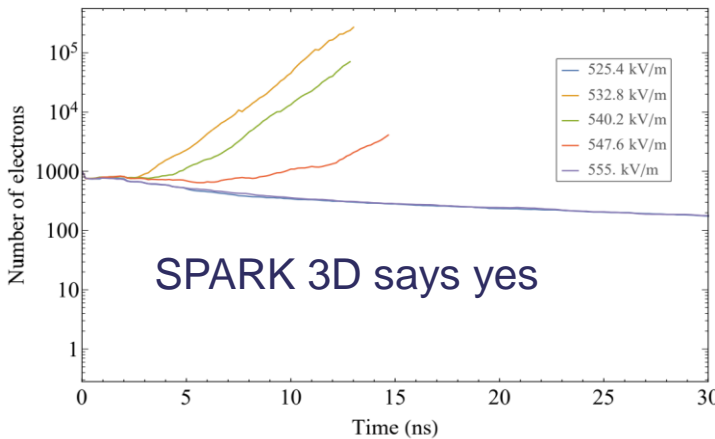
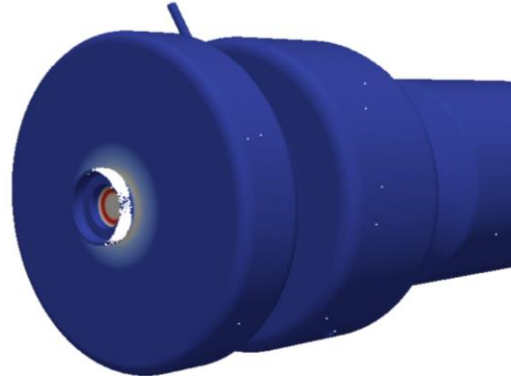
Multipactor is in the cathode plug region. Ok great. But...

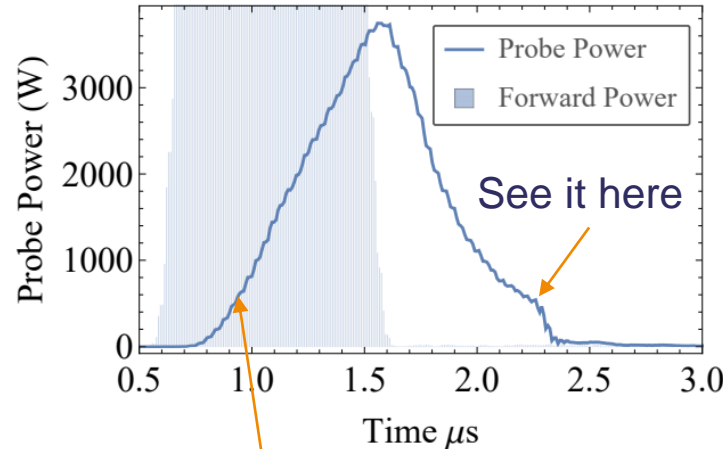
Why not here? It's the same gradient. Maybe because the time spent in the multipactor band is not long enough? Also why do we only see it at certain *forward power* ranges? The structure will always empty, and always pass through this gradient range as it does.

Field emission from earlier into the pulse seeds the multipactor in the decay. Estimating from the exponential growth rate and the power loss, a seed current of 3.88 μA is required.

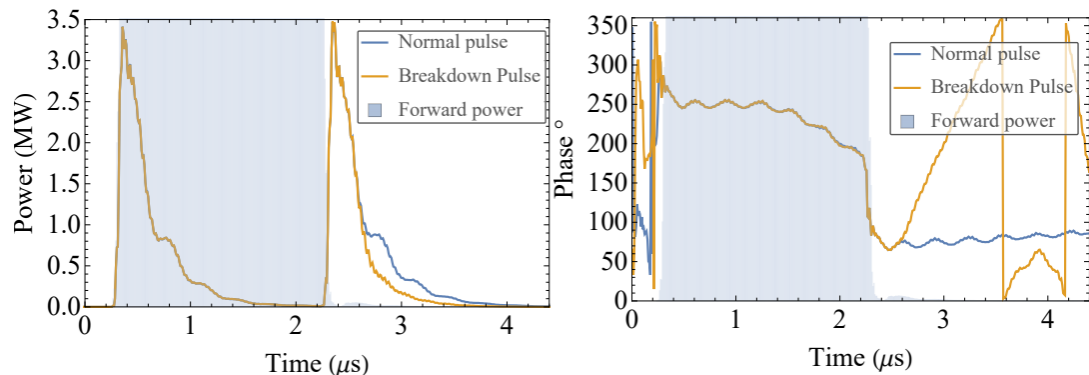
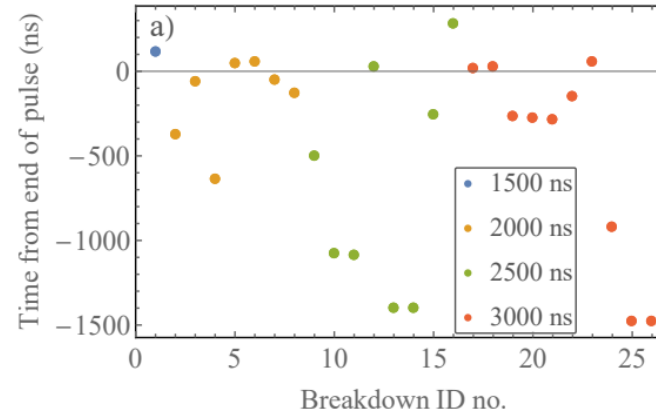
But also a surprising number of breakdowns that are just after the end of the pulse

The time of the breakdown from the end of the forward RF pulse here shown as scatter plot in chronological order and histogram with 100 ns bins.

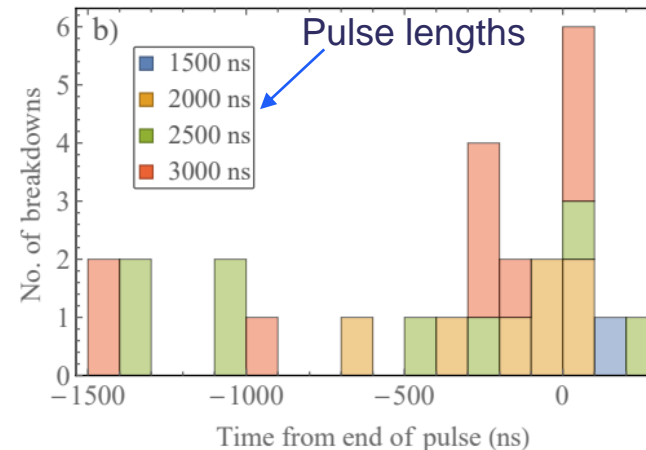
Low statistics, but there seems to be a cluster just after the end of the pulse. **Hypothesis: power flow effect.**

The gradient in the cavity is high just before the end of the pulse, but there is no/low power flow as tends towards steady state.

Immediately after the end of the forward power pulse the cavity starts to empty and the power flow is high, but so is the gradient.

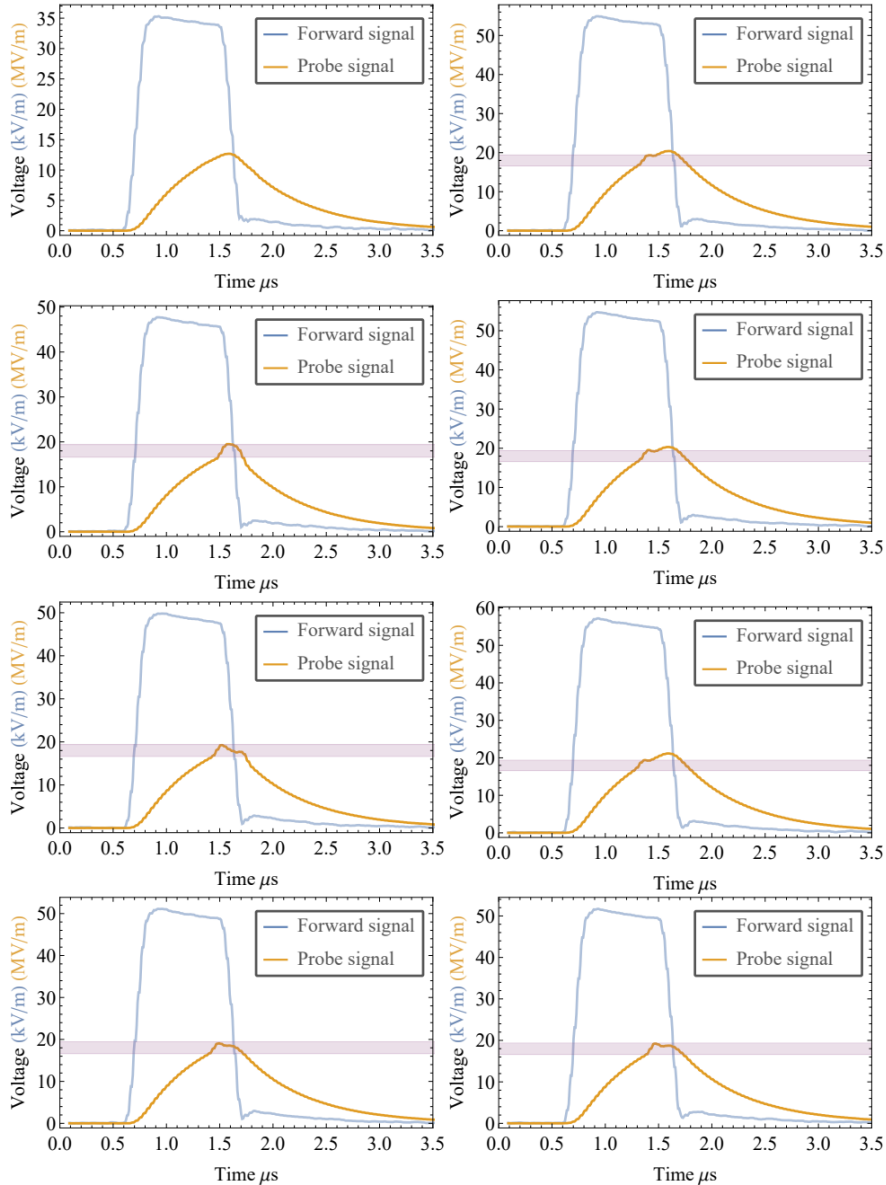
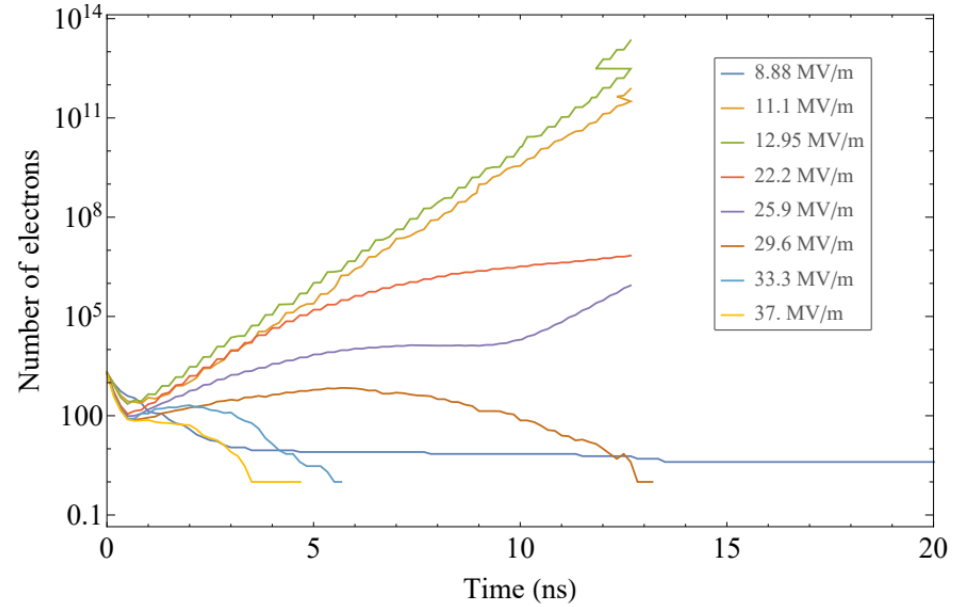
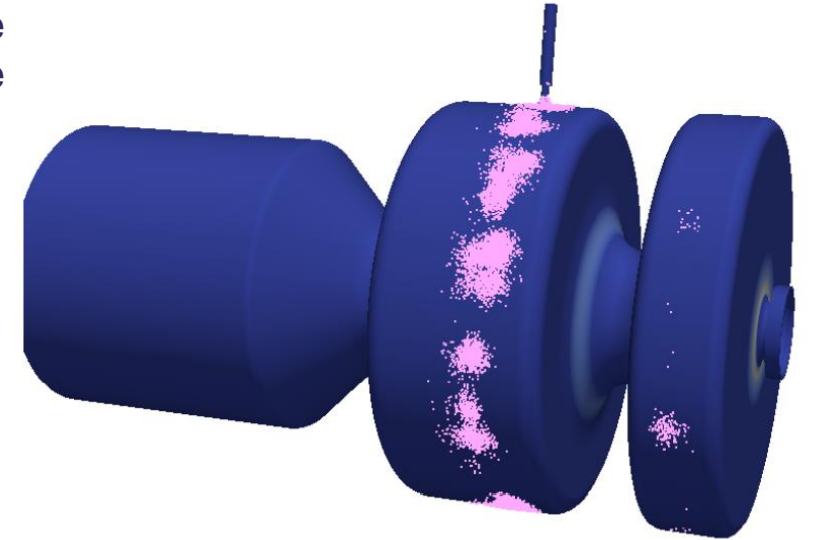
Weird signals on the probe measurement. Turned out to be multipactor electrons hitting the probe!
