Injection Kicker MKI-D Field Breakdown

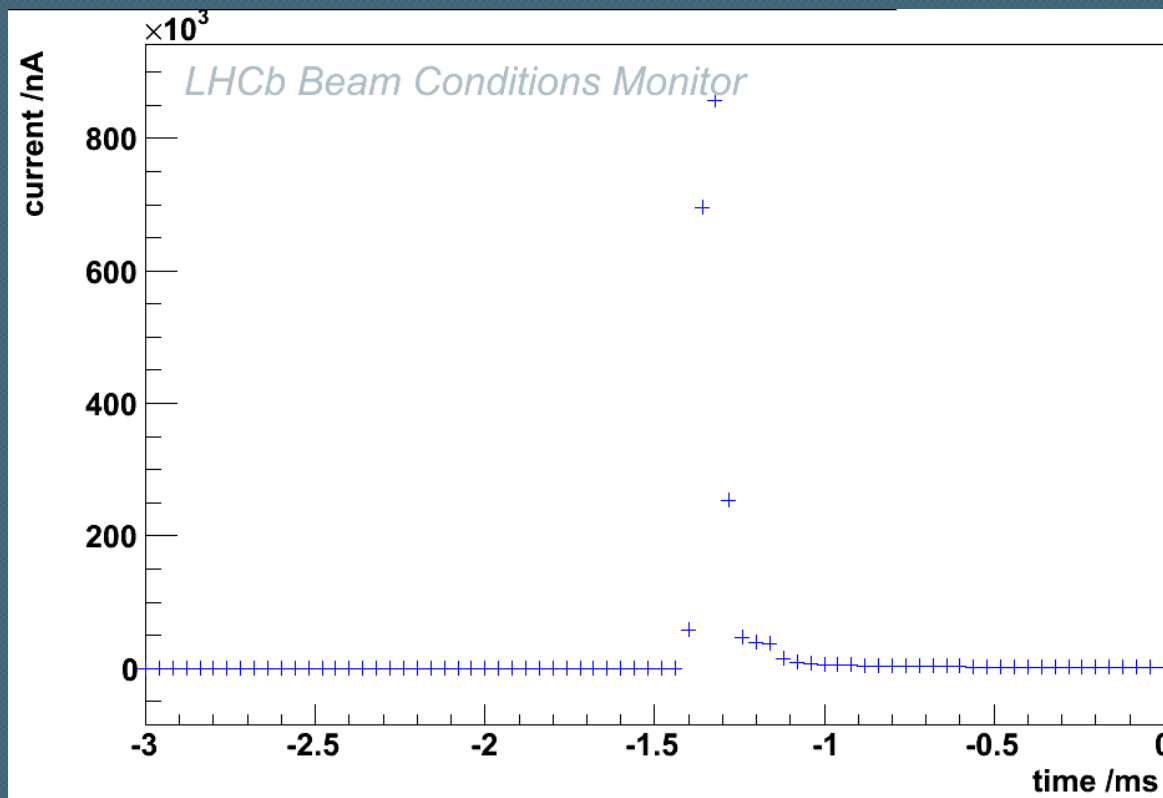
- April 15, 04:47: Injection failure
 - Appears oscillations on partially kicked train was worst on second turn
 - **BCM : Equivalent to 3×10^7 MIPs / cm^2 !! (centre of shower)**
 - 144 bunches on TDI lead to equivalent of 2×10^5 MIPs / cm^2 (April 18)
 - **Factor 100 above dump threshold at injection**
 - A problem with the TDI alignment is a major worry
