X-Box Summary

27.11.2024

X-Box 2 TD31 N3 N4: Structure B

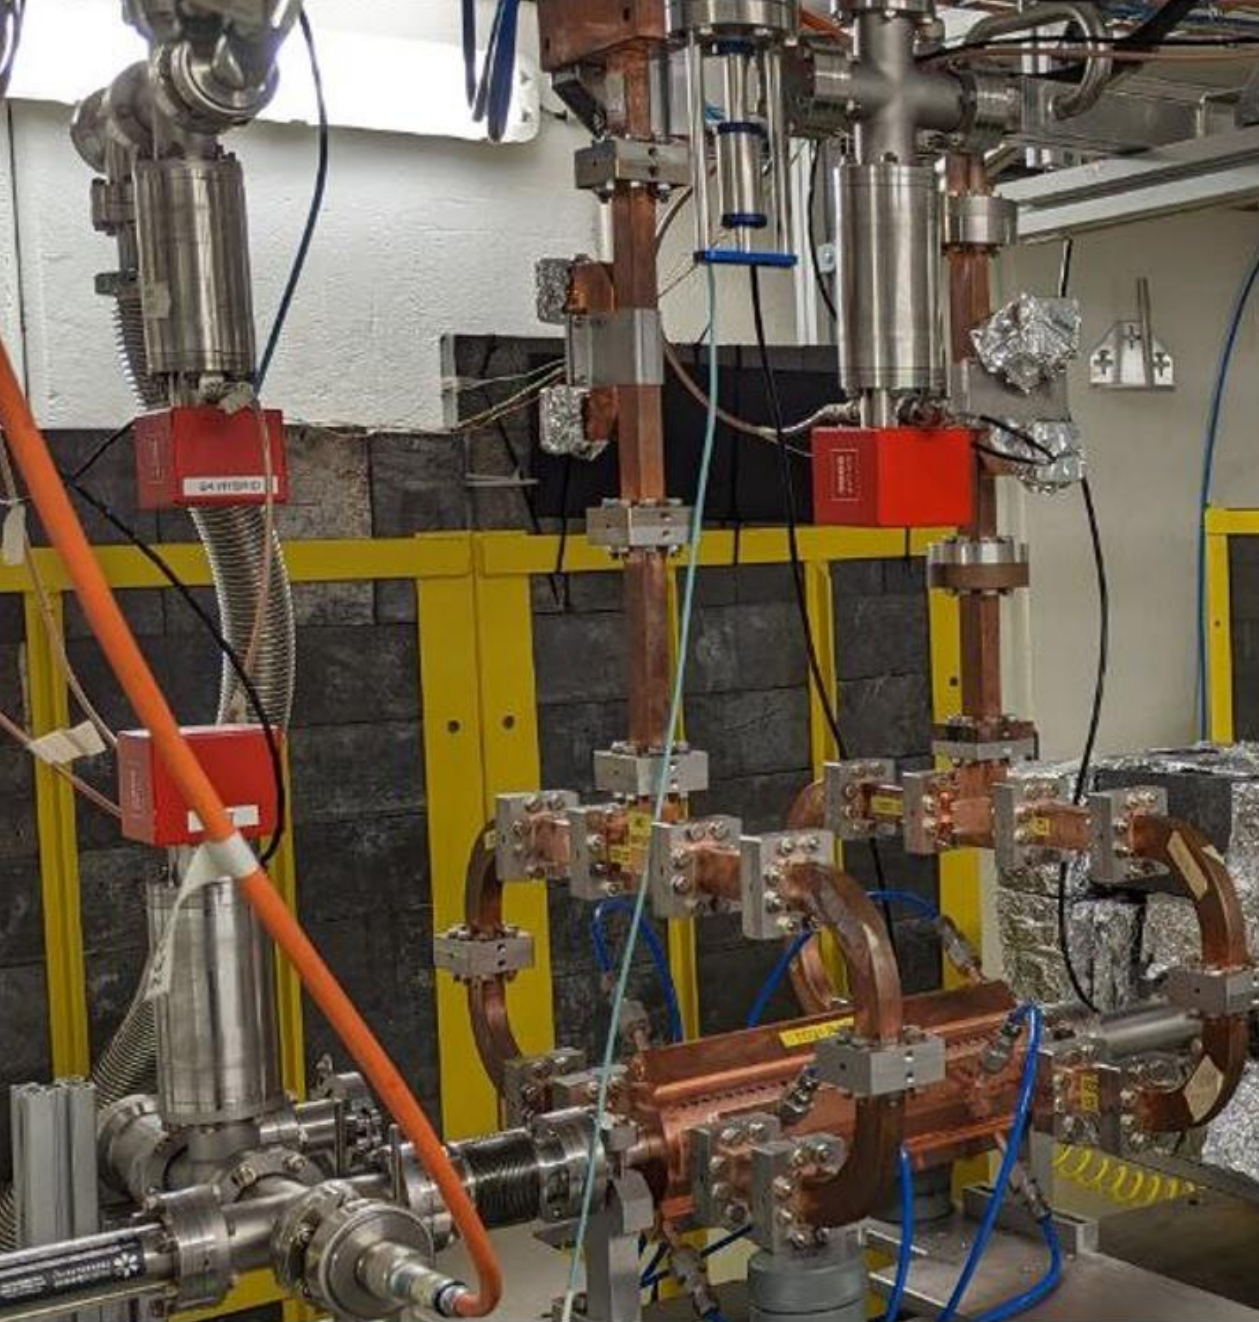
- **Restarted after visit 18.10.2024**
- 100:1 ratio, all power to Structure B
- Pulse width 100ns
- **Changed pulse shape (Igor's request)**
- **Fixed problem with pulse counter**
 - Saved old and corrected TDMS files
 - Corrected PXI Pulse count.txt too
- **Running flat 50MW**
 - BDR 1e-5
- **Stopped – SU6 broken**

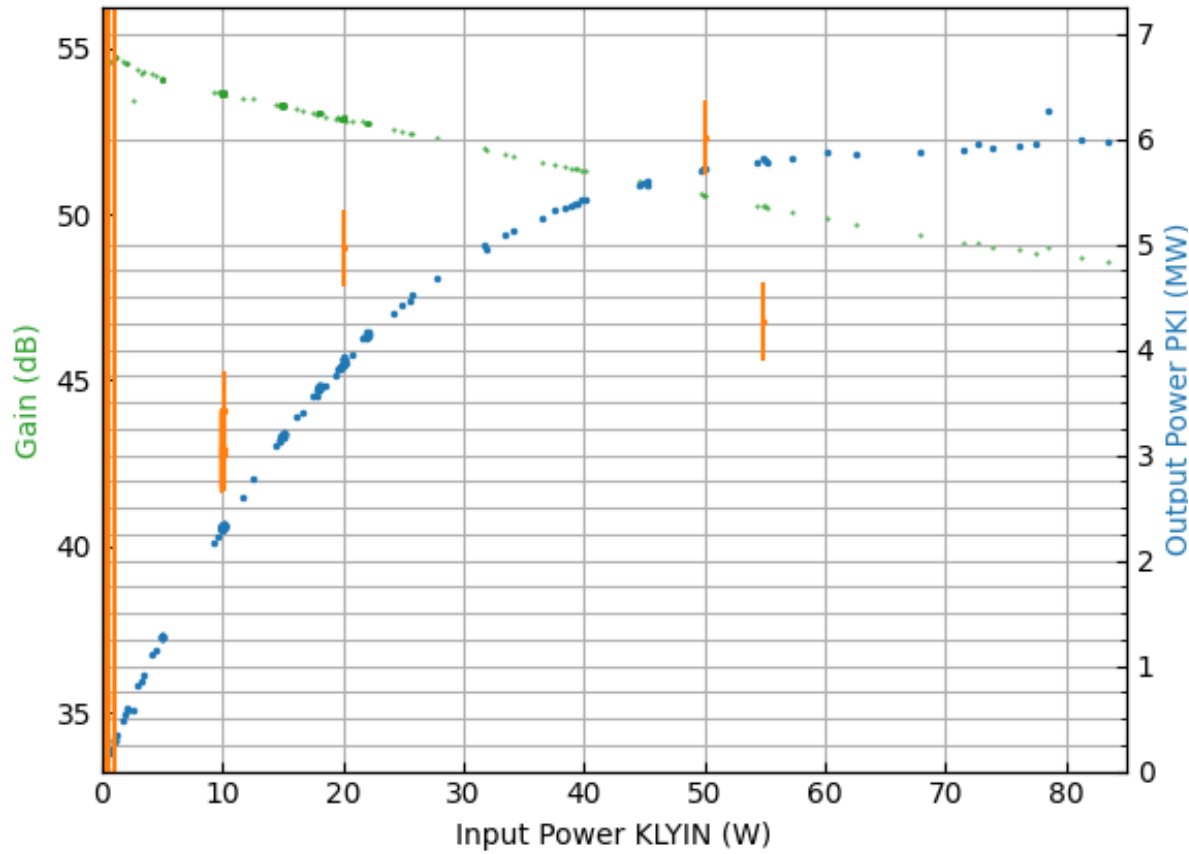
Freq. shift 0MHz

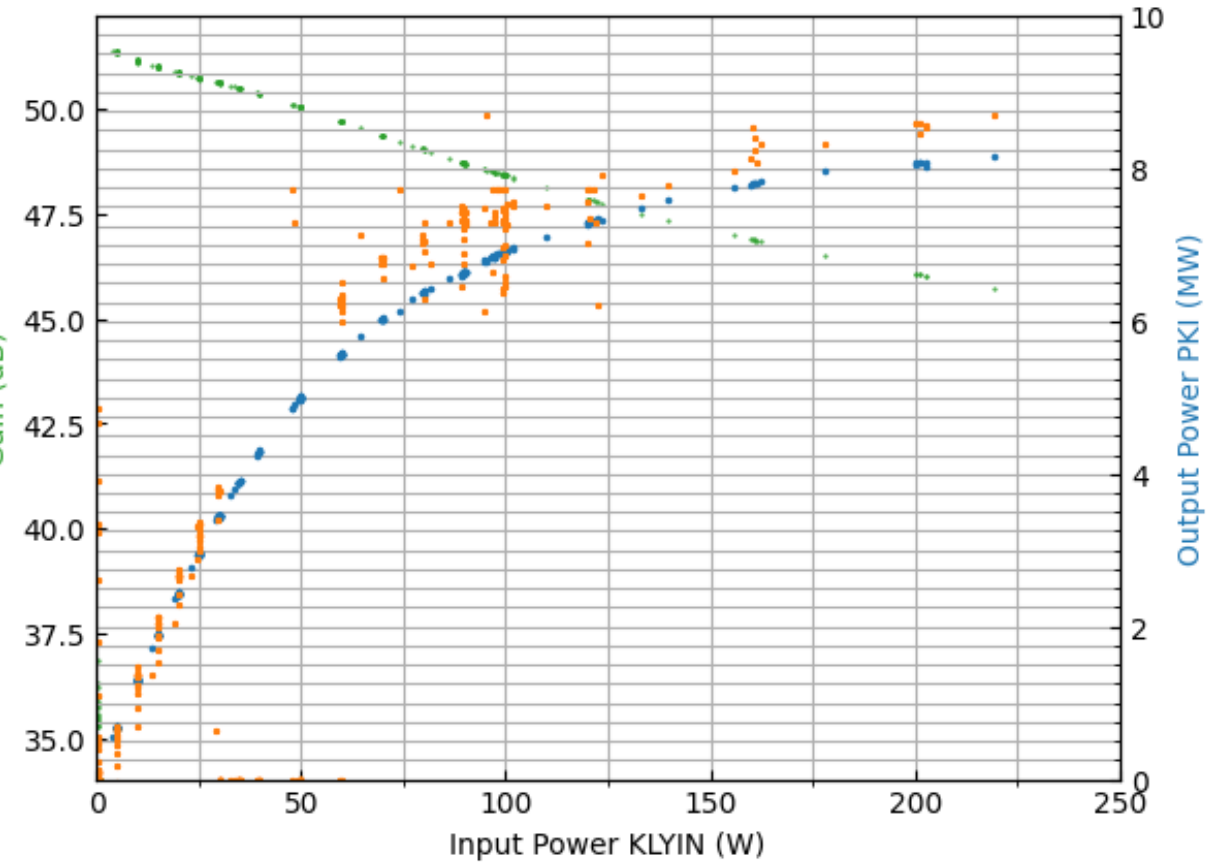
Freq. shift -20MHz

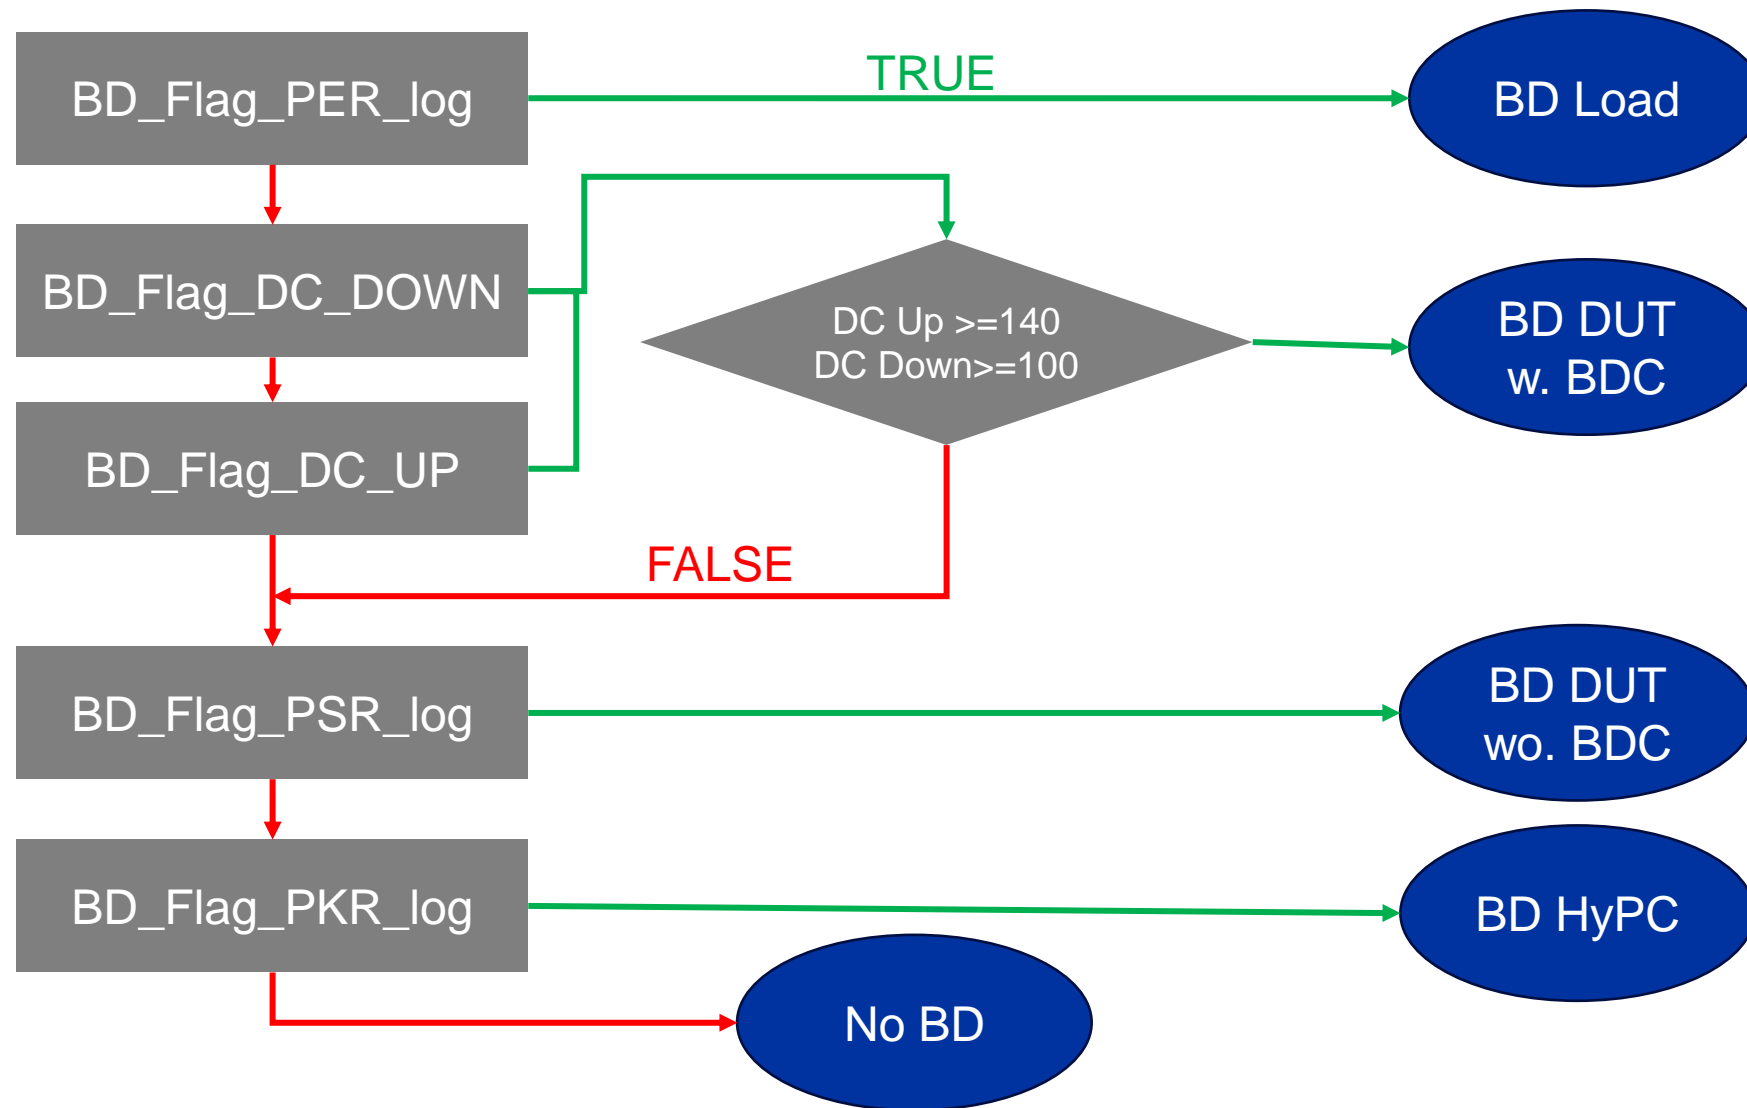
X-Box 2: Reminder on BD classification
