HI-ECN3 – EN-HE ongoing activities for WP5

HI-ECN3 WP5 coordination meeting #1 – R. Rinaldesi – EN-HE

2024-12-10

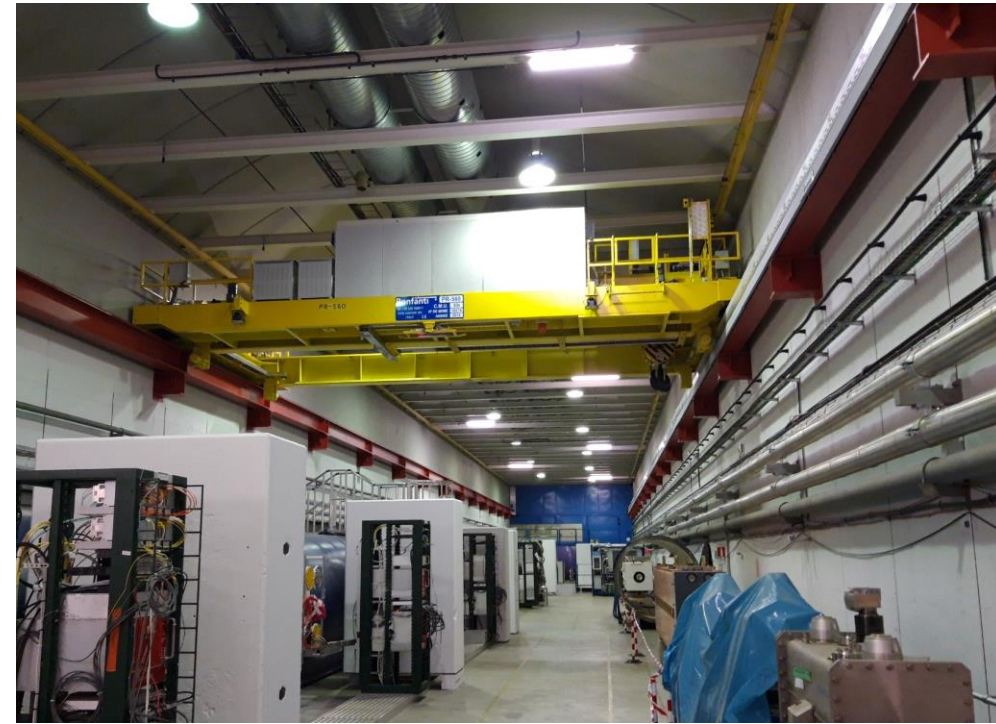
Overhead crane in TCC8

- Crane installed in 1978 and refurbished in 2014
- Generally in good conditions
- **Upgrade is needed to meet the future needs of the project:**
 - Remotely controlled operations
 - No electronic components on-board
 - Emergency brake
- **Replacement is preferred to another refurbishment because:**
 - Cost will be similar
 - Overall duration of the on-site intervention much shorter (procedure for paint containing lead...)
 - Design can be optimized for the new needs (addition of an auxiliary hoist)
 - Possibility to test the entire crane at the contractor's facility
 - Higher number of expected bidders

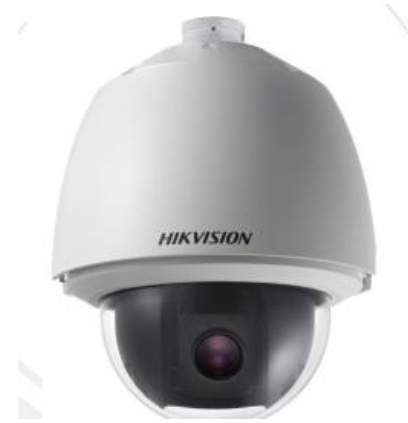
TCC8 crane - Technical features 1/2

Specific aspects of a crane working in a harsh environment:

- **Mechanical redundancies (double motor with differential unit) on all motions**
- **Emergency brake**
- **Remote control panel – no electronic components on-board (except load cell)**
- **Four removable cameras on-board**

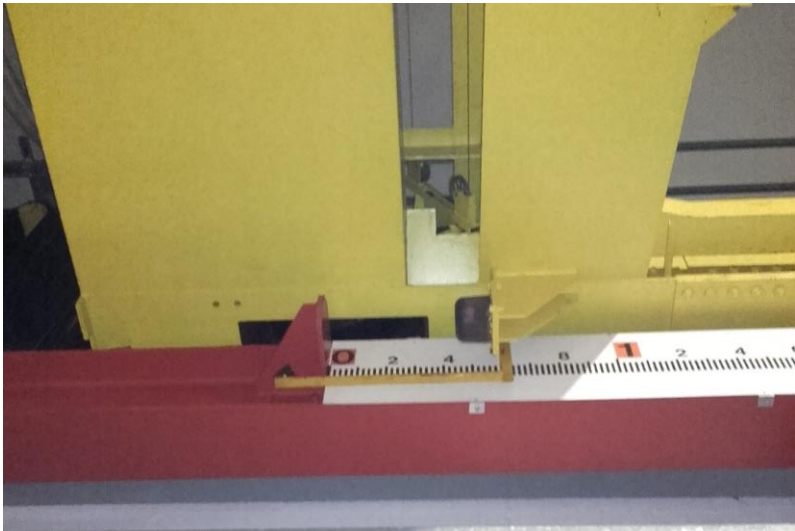
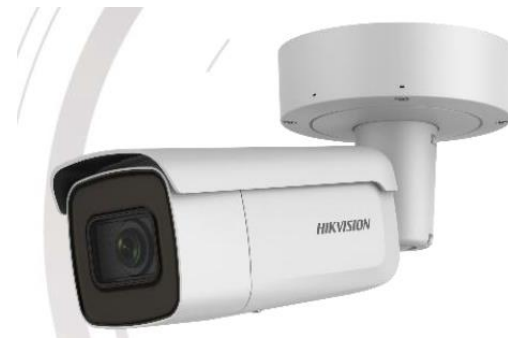
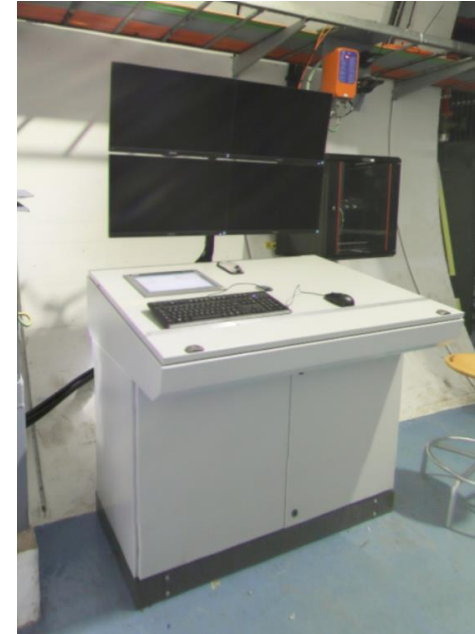
TCC8 crane - Technical features 2/2

- Remote control desk with 4 screens
- Redundant position detection system: cameras+rulers and resolvers

- Cable reel to install a motorized device on the hook

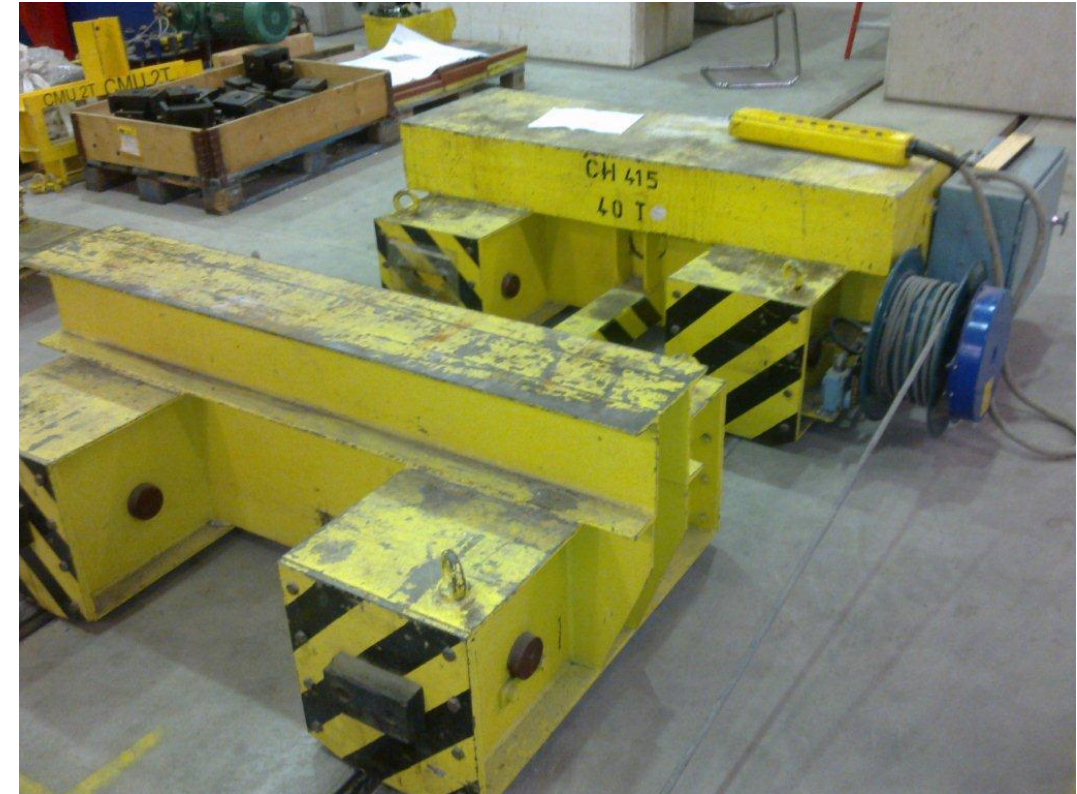
ECN3 transfer tables

- Bogies used to handle material between the bottom of the shaft and ECN3
- Steel structure in good condition
- Control equipment and cables obsolete
- Refurbishment includes
 - New travel motor
 - New cable reel
 - New control panel
 - Radio remote control
 - General mechanical check
 - Re-painting of the structure
