# BEAM INDUCED HEATING

B. Salvant, O. Aberle, G. Arduini, R. Assmann, V. Baglin, M. J. Barnes, P. Baudrenghien, C. Bracco, R. Bruce, A. Bertarelli, F. Carra, G. Cattenoz, F. Caspers, S. Claudet, H. Day, J. Esteban Mueller, L. Gentini, B. Goddard, A. Grudiev, B. Henrist, R. Jones, G. Lanza, L. Lari, T. Mastoridis, E. Métral, N. Mounet, J. L. Nougaret, A. M. Piguiet, S. Redaelli, F. Roncarolo, G. Rumolo, M. Sapinski, E. Shaposhnikova, L. Taviani, M. Timmins, J. Uythoven, A. Vidal, D. Wollmann, (CERN, Geneva, Switzerland).

## Abstract

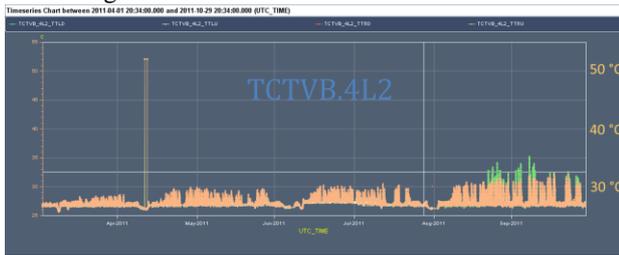
Fig. 6: measured jaw temperatures for the 4 probes of the TCTVB.4L2 during the 2011 proton run (April 1<sup>st</sup> to October 29<sup>th</sup> 2011).

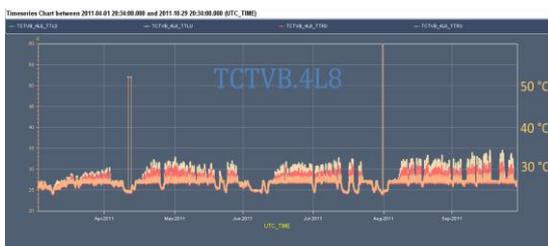
Fig. 8: measured jaw temperatures for the 4 probes of the TCTVB.4L8 during the 2011 proton run (April 1<sup>st</sup> to October 29<sup>th</sup> 2011).
