Status of Activities at CERN

EN/MME et al.

- Bare cavity drawings
- Helium tank
- HOM
 - Design
 - Fabrication
- Tests
- Alignment monitoring system
- EDMS

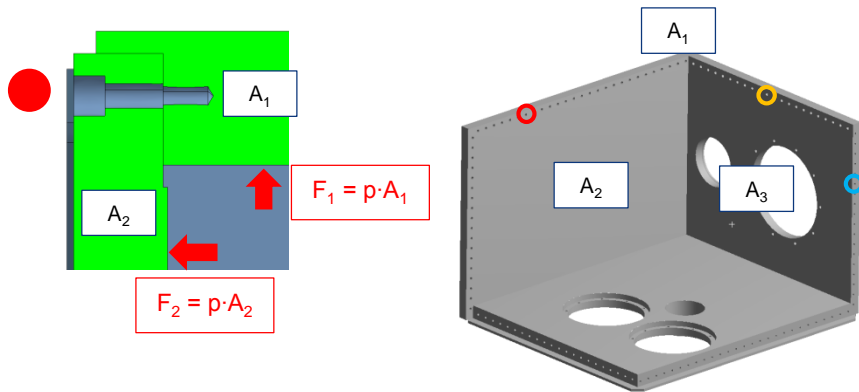
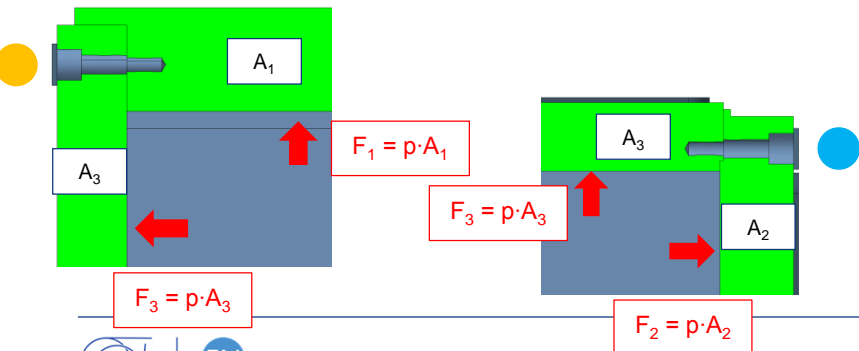
He tank: stress calculation

- Calculation according to VDI 2230
- Both FE and analytical
- 268xM6 Ti gr. 5

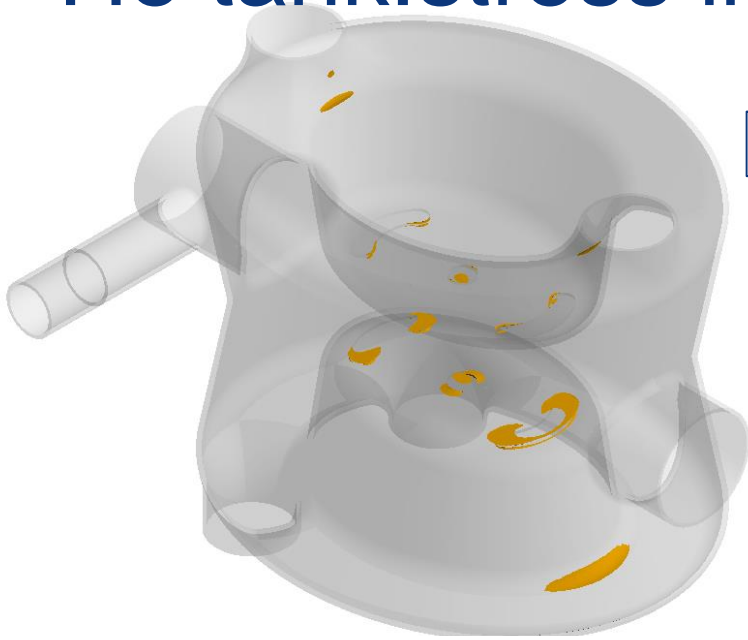
Pressure

He tank: stress in the cavity (load cases)

~105 MPa

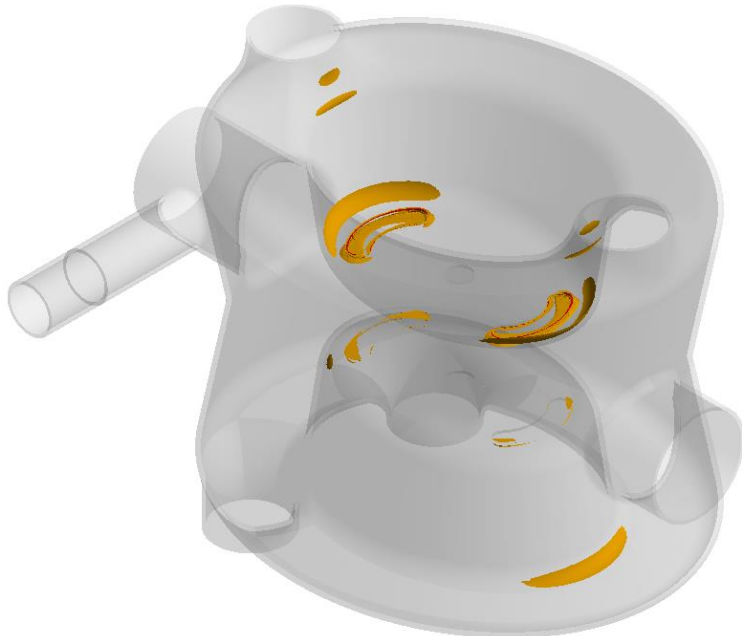
Pretuning

~80 MPa

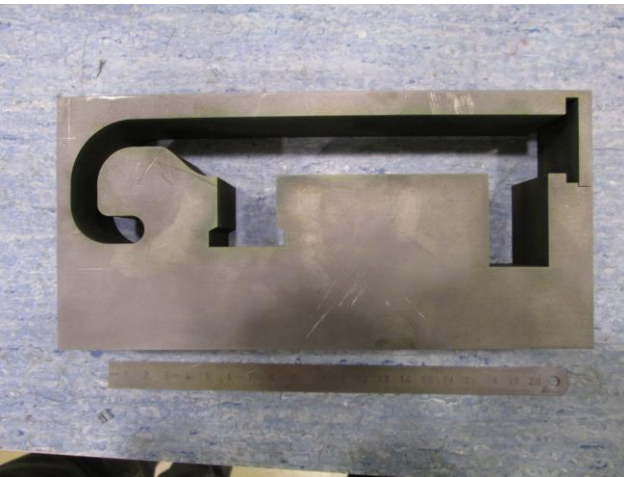
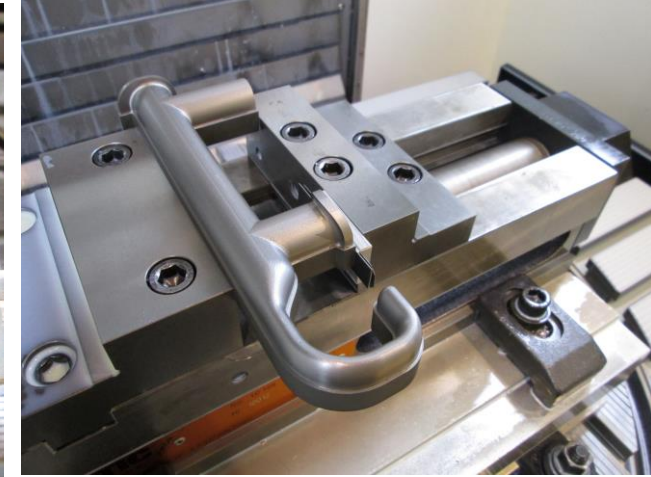
HOM Hook

From bulk Nb...

... to finished part

Encouraging preliminary results in terms of shape accuracy

- Full metrology of prototype
- BCP strategy evaluation:

BCP_{30um} → metr. → BCP_{30um} → metr. → BCP_{10um} → metr. → ...

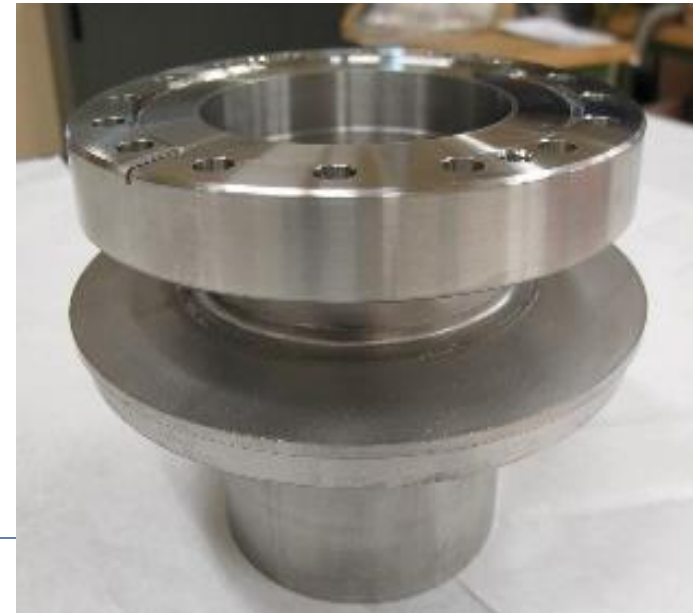
Tests: Beam Tube

- Vacuum Leak Test before and after Thermal Shocks – OK
 - Procedure according to EN 13185
 - 5 Thermal Shocks in liquid nitrogen performed to assess the possible evolution of brazing defects.
- *All welds and brazed joints were **successfully** tested at a background of 1.0×10^{-10} mbar/l/s, there was no evidence of leaks.*
- Ultrasonic by immersion on brazing part – OK
 - Procedure according to ASTM E1001
 - Defects were **NOT** found
