# Investigation of Cherenkov light scattering and refraction on aerogel surface

# Outline

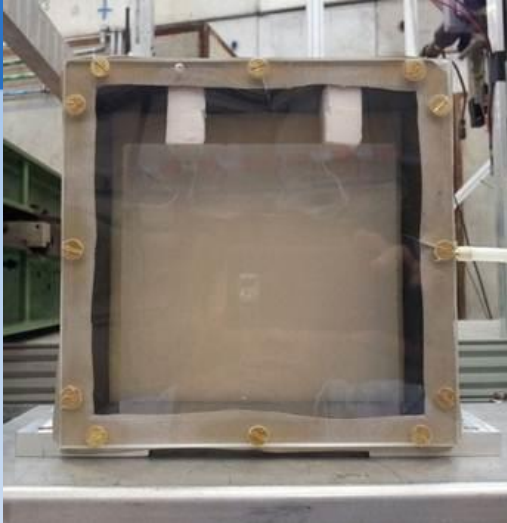
# Beam test with PDPC FARICH prototype at CERN (2012)

- 4-layer aerogel
- $n_{\text{max}} = 1.046$
- thickness 37.5 mm
- focal distance 200 mm
- hermetic box with acrylic glass window was used to prevent moisture condensation on aerogel tile

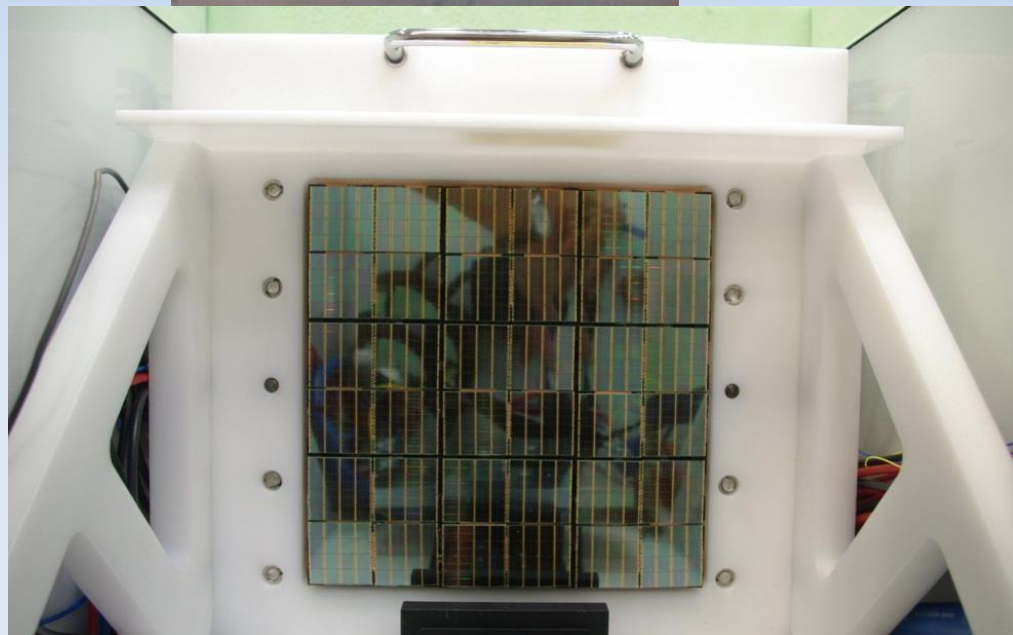
## Photon matrix $20 \times 20 \text{ cm}^2$

- Sensors DPC3200-22
- 3200 micro-cells in pixel,
- 3x3 modules = 6x6 tiles = 24x24 dies = 48x48 pixels
- 576 time channels
- 2304 amplitude (position) channels
- Pixel dimension  $3.2 \times 3.9 \text{ mm}^2$
- to detect single photons detector was cooled to  $-40^\circ \text{ Celsius}$

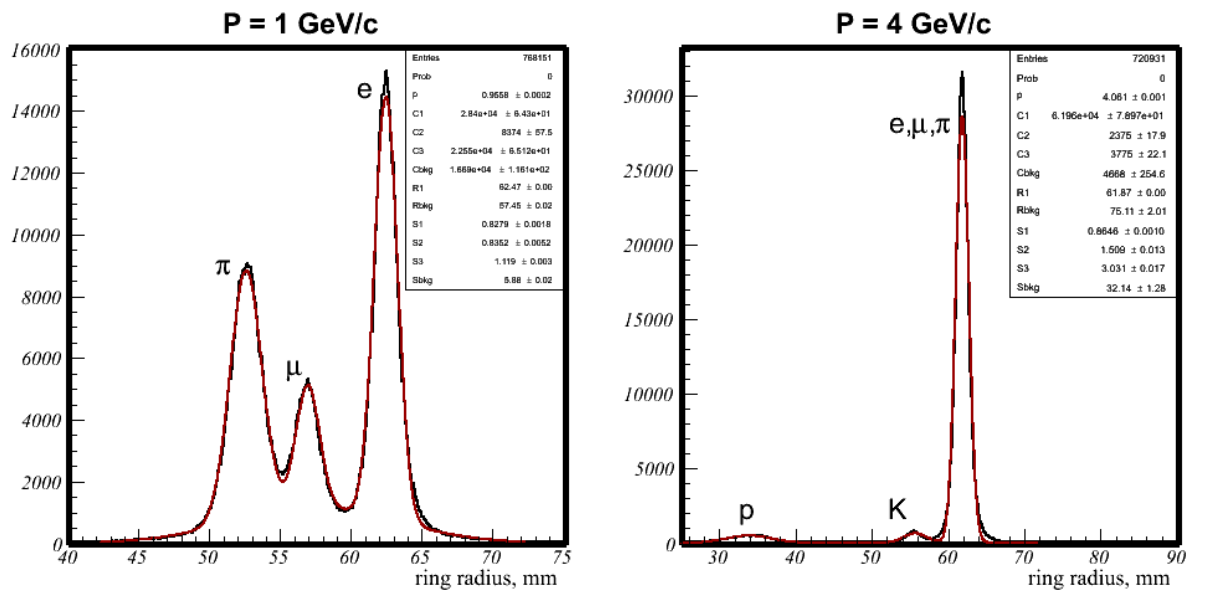
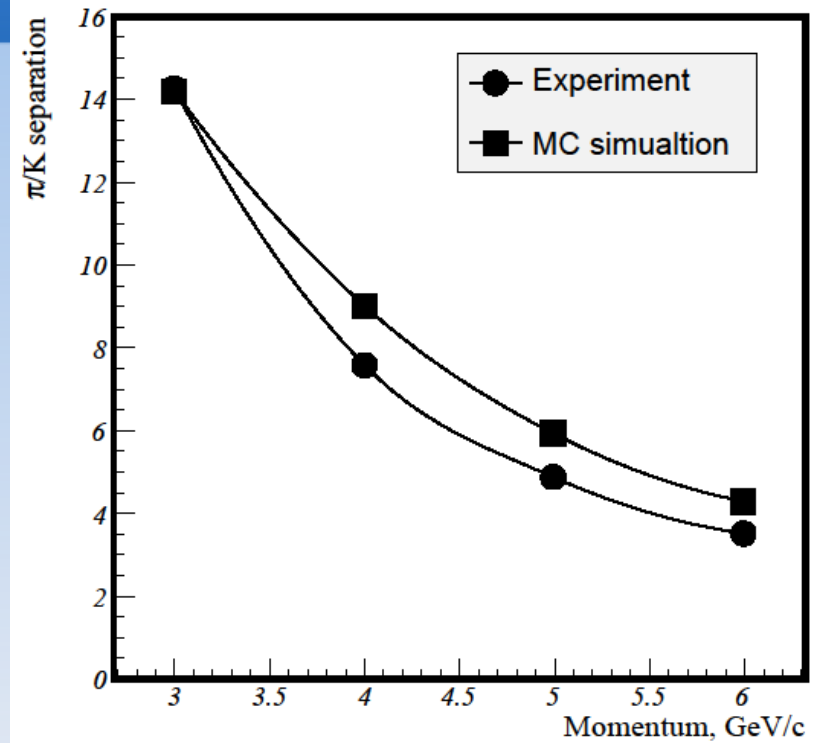
## Cherenkov rings radius distribution

$\mu/\pi$ : **5.3 $\sigma$**  @ 1 GeV/c  
 $\pi/K$ : **7.6 $\sigma$**  @ 4 GeV/c  
 $\pi/K$ : **3.5 $\sigma$**  @ 6 GeV/c

▣ **2.6 times less than in initial MC simulation**

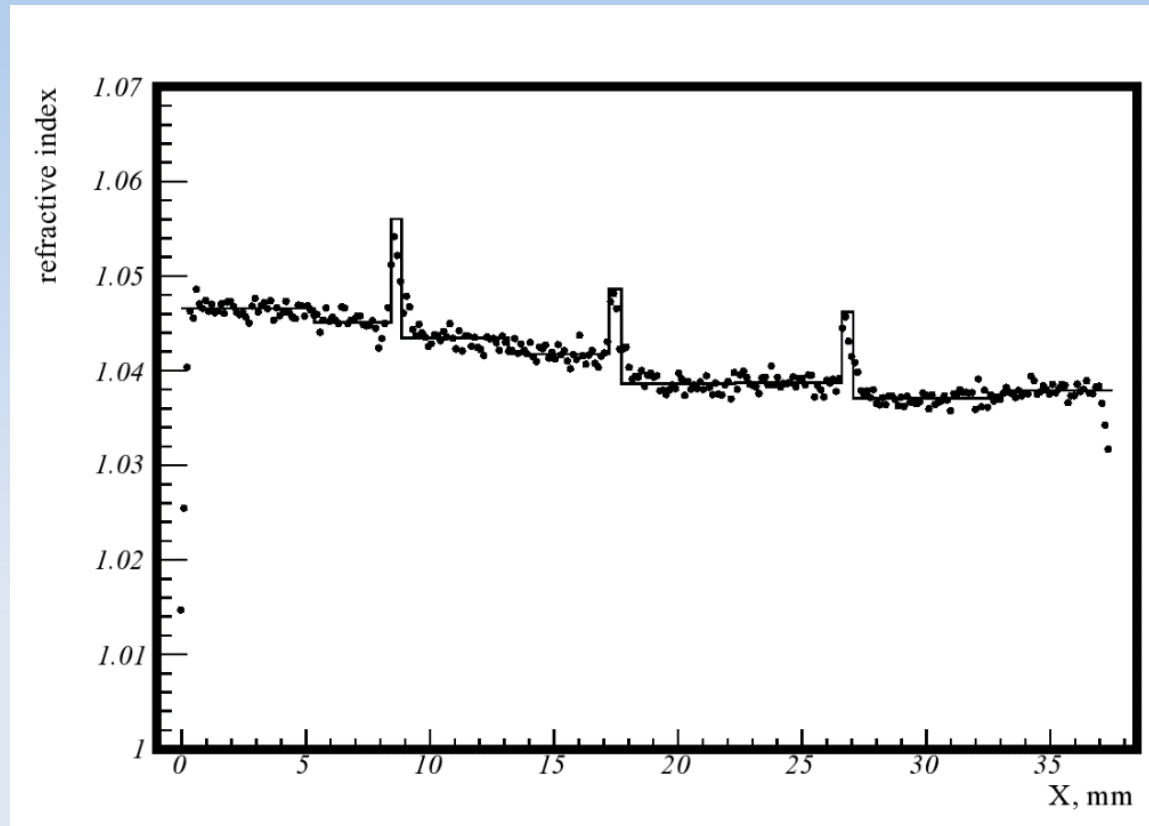
## X-ray scan of the density within thickness of the tile

- $N_{pe}$  was 1.6 times less than expected
- Strong effect of uncontrolled refractive index variations

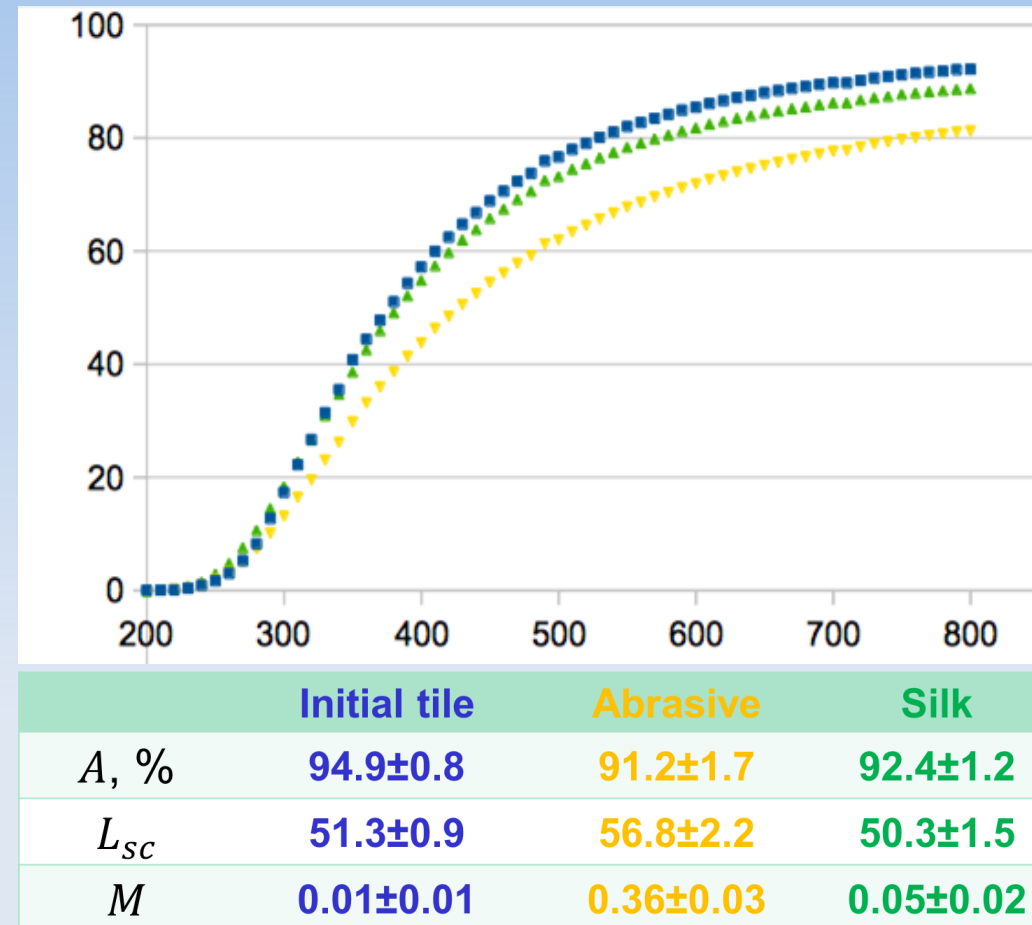
# Light scattering on the polished aerogel surface (2)

- Best result we got using natural silk for polishing
  - Almost optical quality
- Only ~5% loss of light

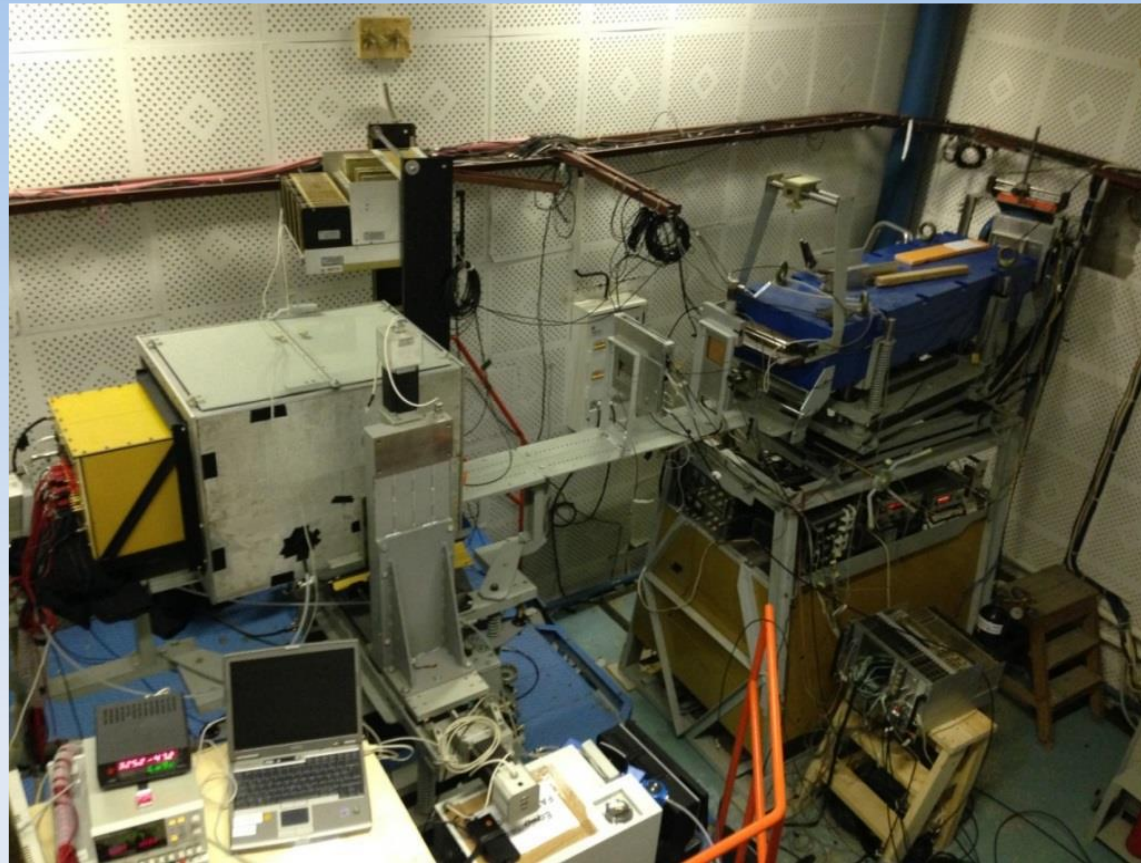
# Test beam measurements with polished tile(1)

- Electron beam with 3 GeV/c momentum at VEPP-4M
- Sensors DPC3200-22
- 3200 micro-cells in pixel,
- 20x20 cm = 3x3 modules = 6x6 tiles = 24x24 dies = 48x48 pixels
  - = 576 time channels
  - = 2304 amplitude (position) channels
  - = Pixel dimension 3.2x3.9 mm<sup>2</sup>
- to detect single photons detector was cooled to -40° Celsius

R,mm	$\sigma R$ ,mm	Npe
clean	69.33±0.05	1.18±0.03	13.3±0.1
silk	69.01±0.05	1.83±0.06 +55%	12.7±0.1
clean	69.78±0.05	1.22±0.03	12.6±0.1
abrasive	68.01±0.05	2.67±0.09 +119%	12.0±0.1
clean	70.95±0.05	1.08±0.04	13.3±0.1
bottom	71.27±0.05	1.39±0.06 +29%	13.3±0.1

We see strong degradation of Cherenkov angle resolution due to small angle scattering at polished surface

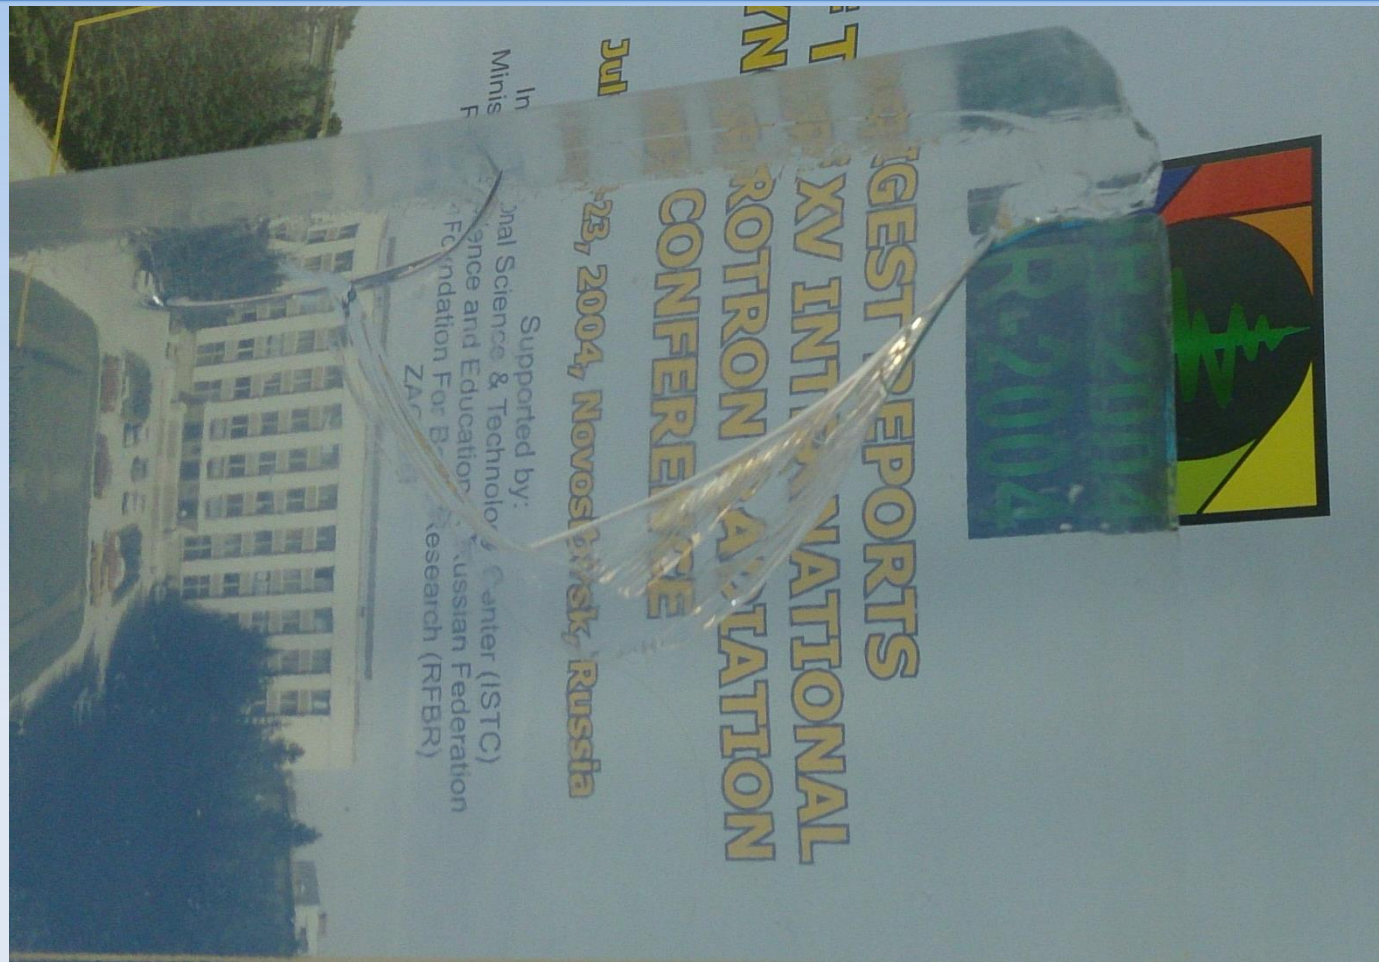
# Impact of cracks in aerogel on the Cherenkov angle resolution(1)

What will happen when a crack appears inside of aerogel tile?

- Crack is a **thin** air gap inside aerogel.
  - Radius of curvature of the crack is much-much larger than gap.
  - We can assume that this is a parallel gap.
- In addition  $\sin(\Theta_{agl}) * 1.05 = \sin(\Theta_{air})$ 
  - Light deviation from the initial direction after the crack should be very small.

- Fresnel reflection at normal incidence is  $(n-1)^2/(n+1)^2 \sim 0.0025/4 \sim 0.0006$ 
  - Loss of photons on the crack is negligible
- The angle of total internal reflection is large.  $\Theta_{tir} = 72^\circ$ 
  - Probability of total internal reflection is small.

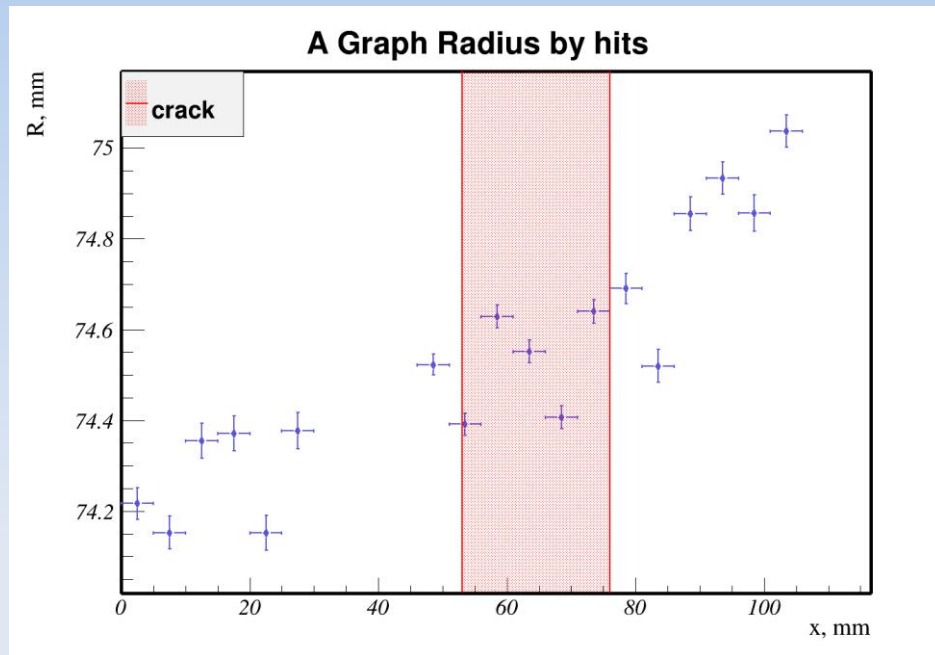
## Preliminary results

**We do not see Cherenkov angle resolution degradation in the crack area of the tile**

- **Previously found method of aerogel polishing with silk can not be used. We see a strong effect of small angle scattering at polished surface.**
- **Non destroying crack in aerogel tile does not influence on the accuracy of Cherenkov angle measurement at that area.**
