PCMAG Status

EUDET Extended SC Meeting JRA1

01-Sep-2008

Detector R&D towards the International Linear Collider

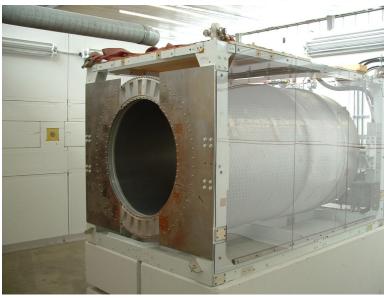
Arrangement PCMAG

Magnet needed to be rotated by 180°
