Progress on p-type isolation technology

M. Lozano, F. Campabadal, C. Fleta, S. Martí*, M. Miñano*, G. Pellegrini, J. M. Rafí and M. Ullán

IMB-CNM (CSIC) Barcelona, Spain

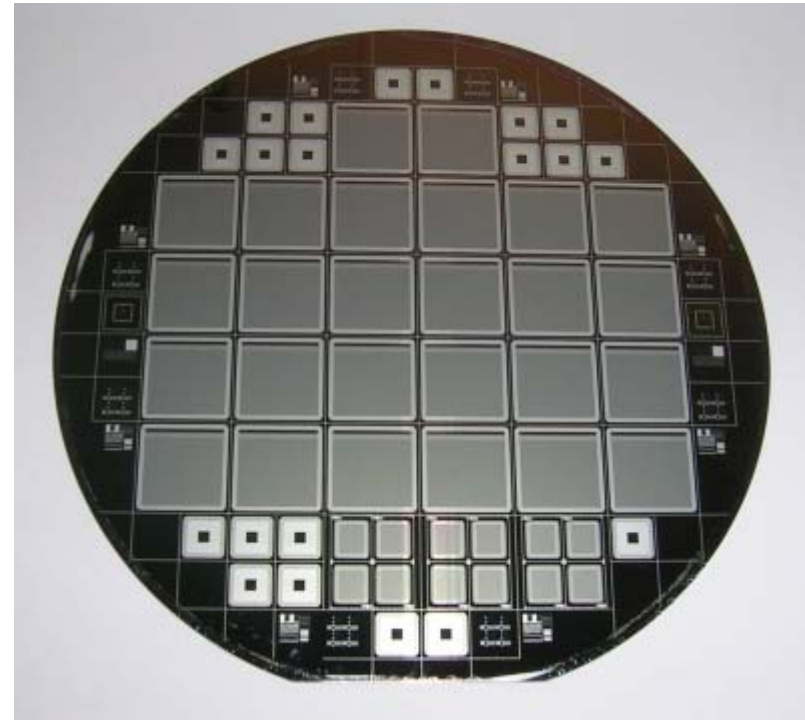
- ❑ Optimize the p-spray parameters before processing the RD50 wafers
 - Complete simulation process (ISE-TCAD)
 - Test runs to check simulation results and adjust p-spray implant parameters (dose, energy, SiO₂ layer thickness)

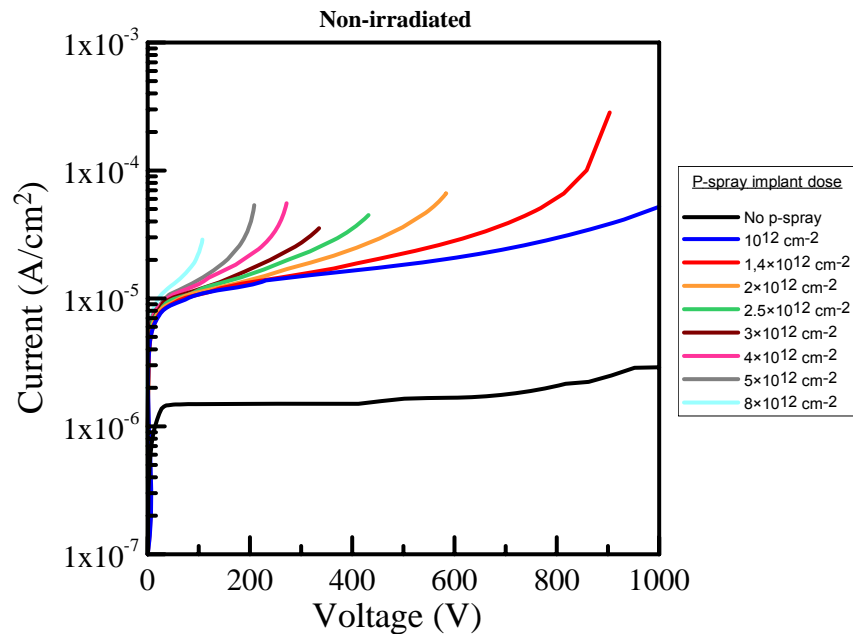
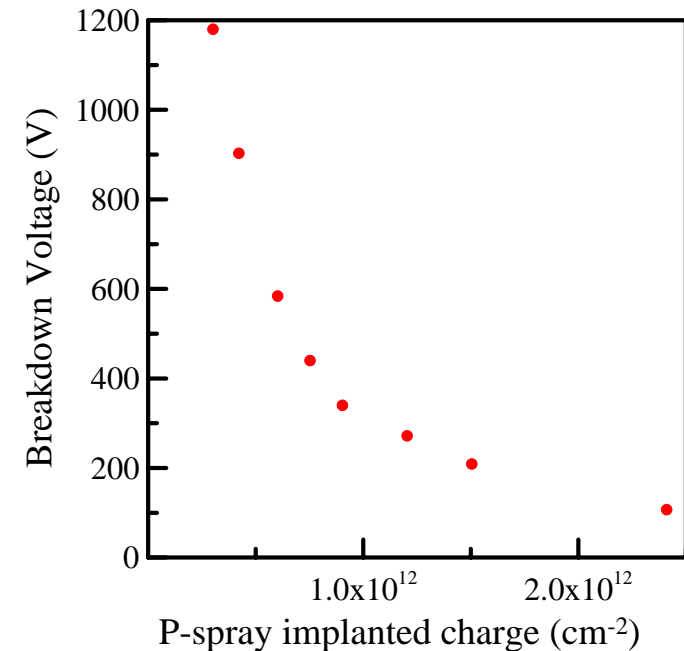
Simulation results

- V_{BD} decreases and leakage current increases as the p-spray implanted charge increases
- Need high p-spray doses to avoid inversion in the silicon surface in irradiated devices
- **Compromise solution** between reasonable V_{BD} and good strip insulation. Can be critical in devices fabricated on Cz silicon
- See presentation at the 6th RD50 workshop for details

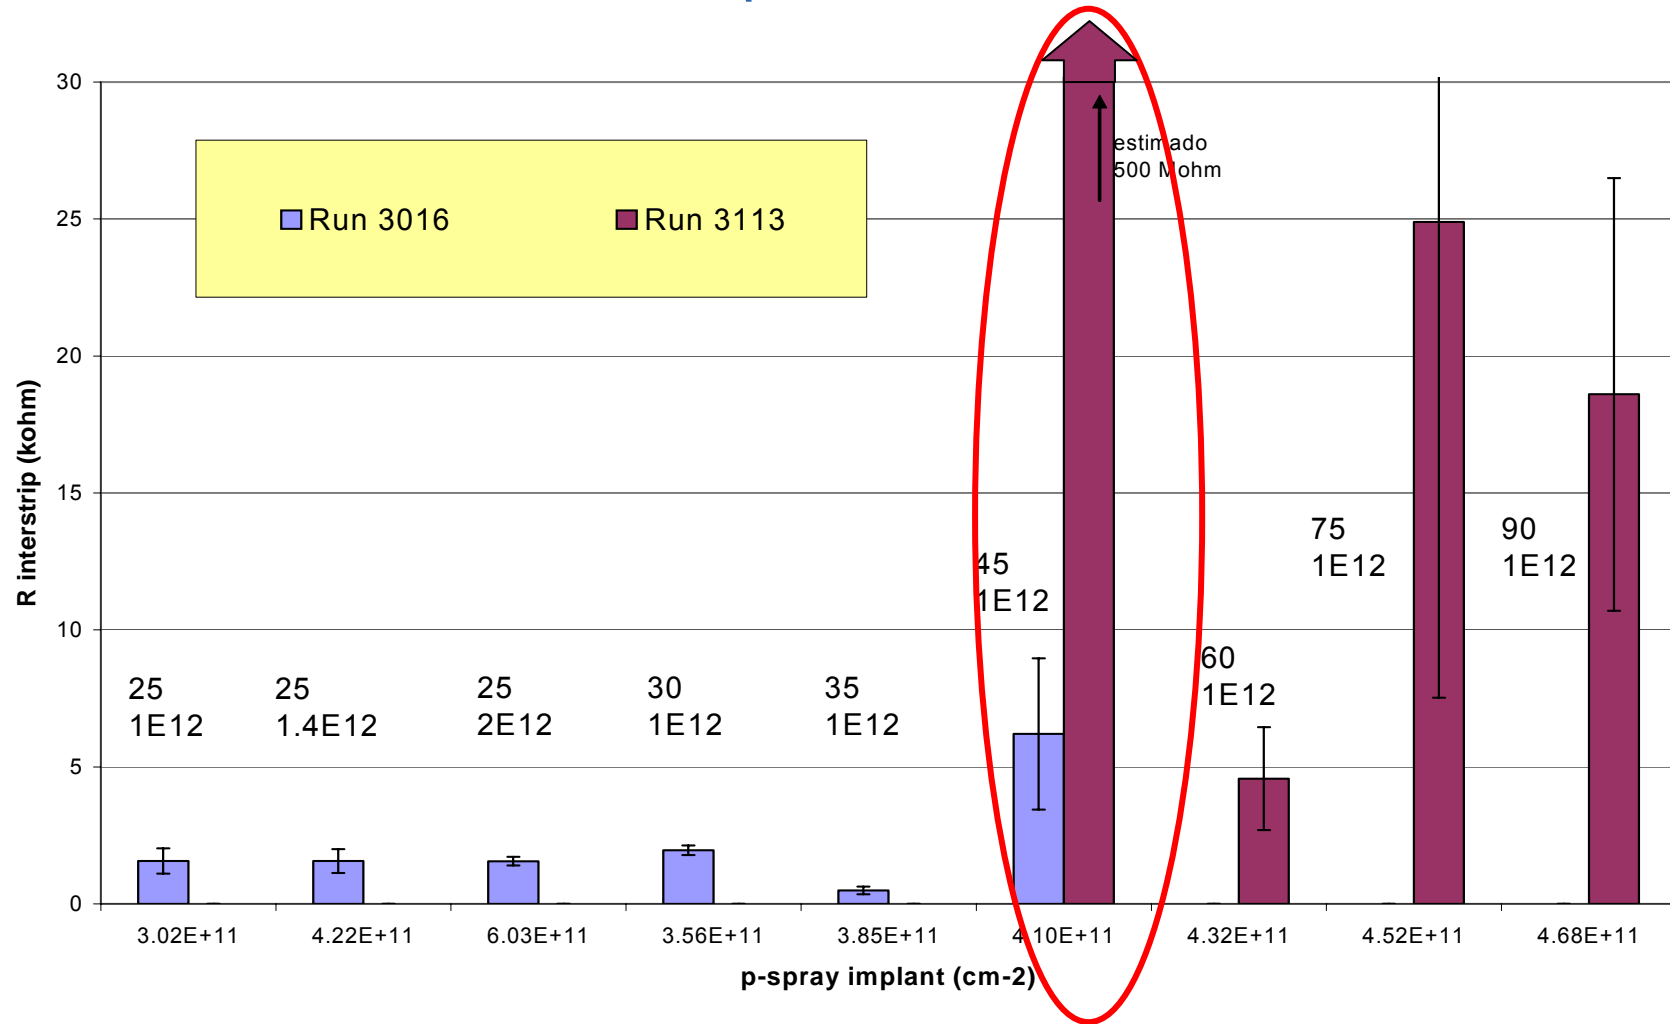
Run 1 and 2 inter-strip resistance

~250 MΩ for n-in-p with P-stops → still some hope

- ❑ Bad results:
 - all devices in most wafers shorted
 - No correlation between results and process parameters
 - No agreement with expected values from simulation
 - Only two wafers with working detectors

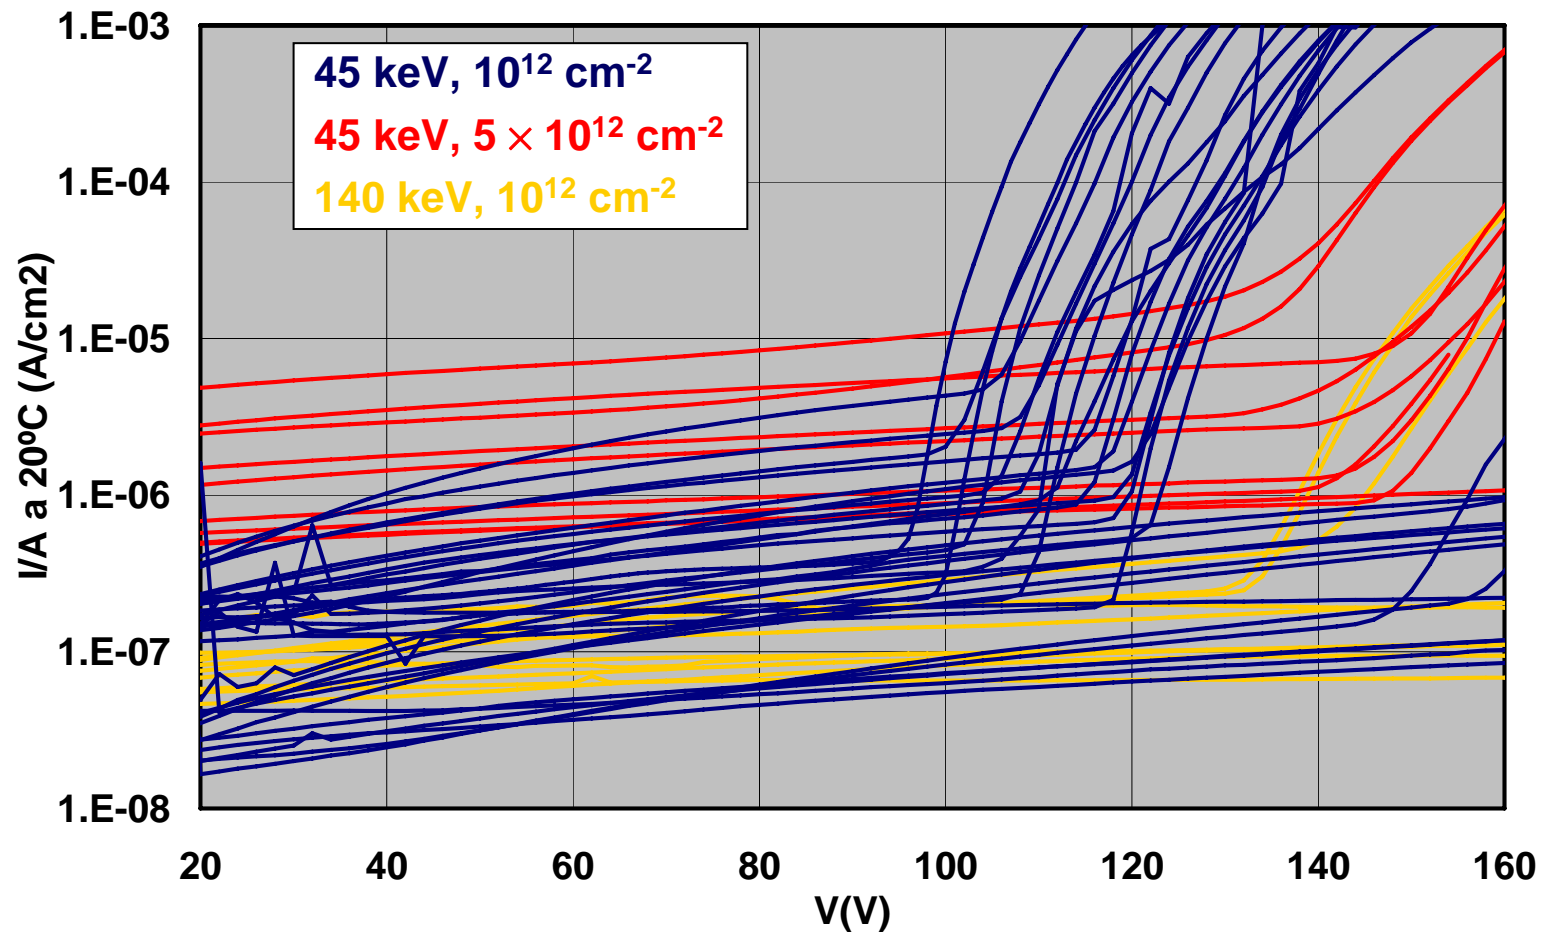
Microstrip detectors: Breakdown voltage

- V_{BD} between 100 and 200 V for all wafers

- ❑ Good results
- ❑ Working devices
- ❑ Simulation agreement for pad detectors
- ❑ Strip detector breakdown voltage not much dependent on p-spray dose, limited by geometry
- ❑ We are ready to start RD50 process
 - We have to check epitaxial backside rim incompatibilities

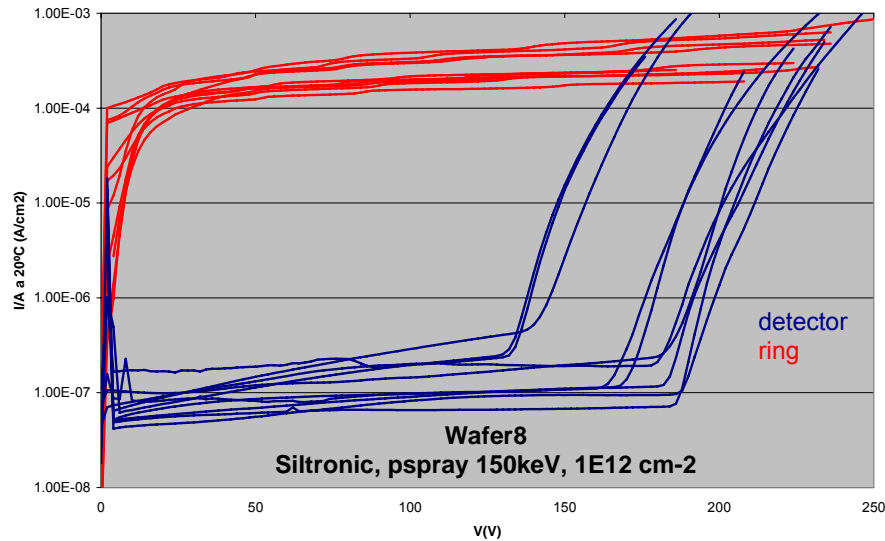
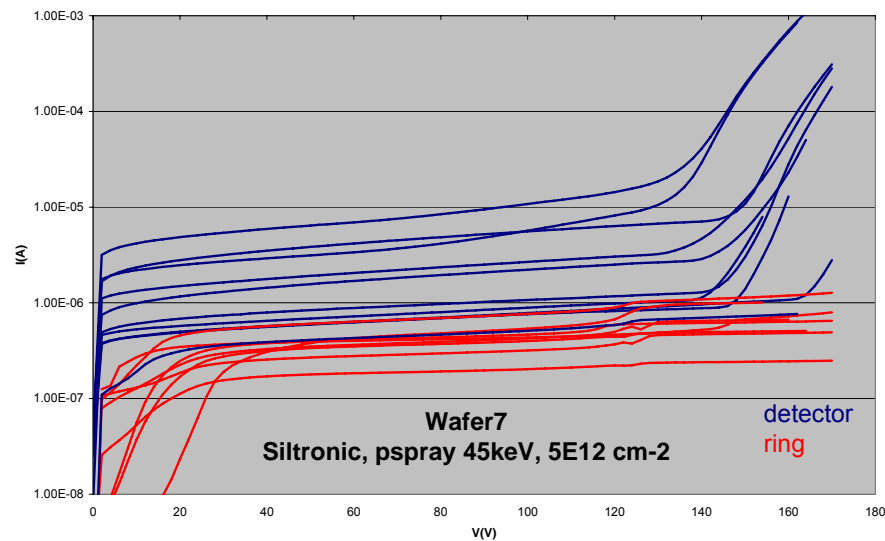
Microstrip detectors: Leakage current

- Microstrips with a p-spray dose of 10^{12} cm⁻² are not fully isolated
- Large leakage currents in guard ring
- Should improve with wafer cutting

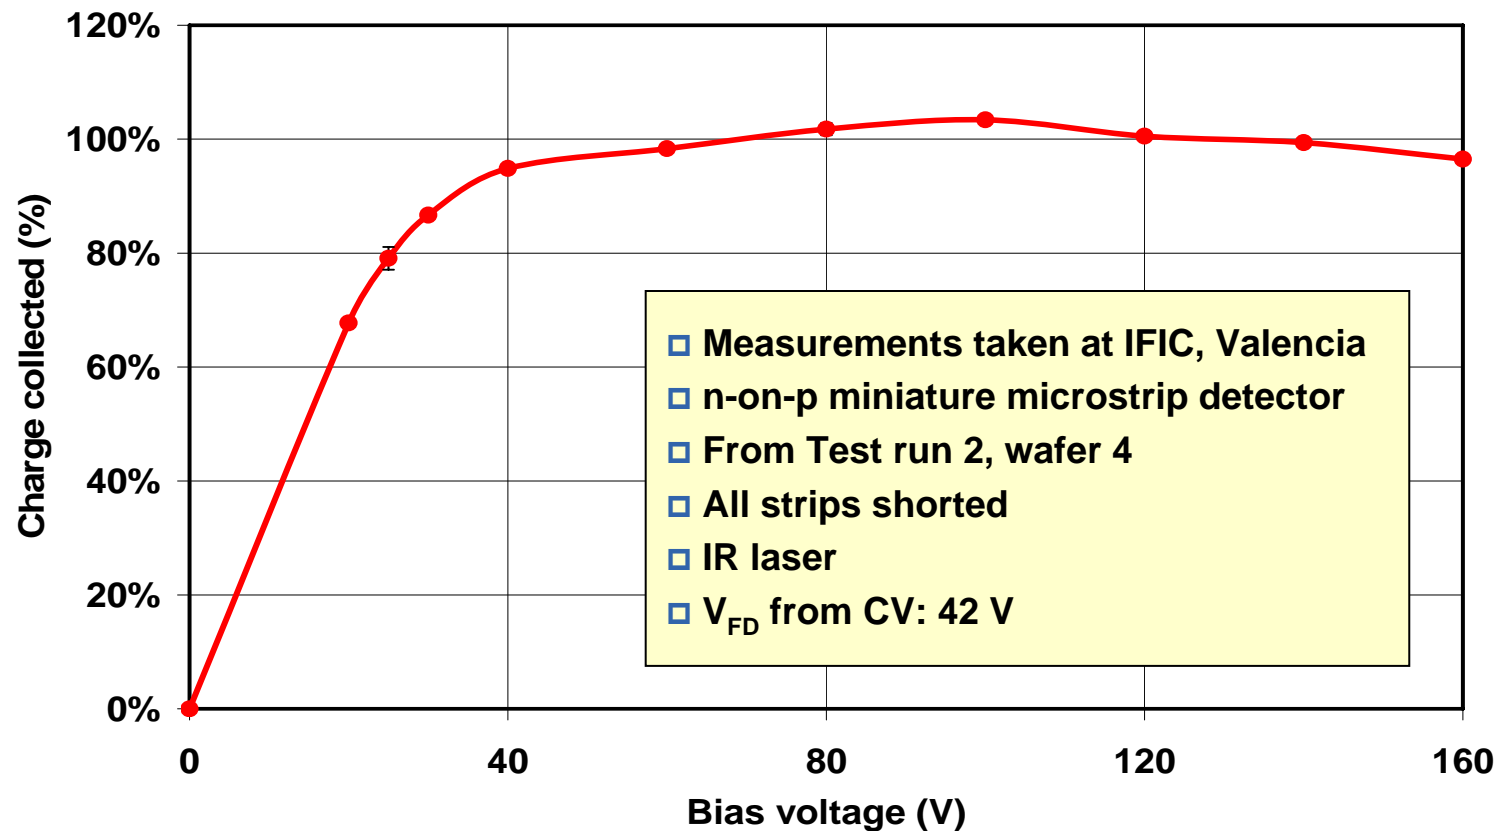
Charge Collection Efficiency results

- ❑ IFIC setup finished and operative with IR laser
- ❑ CNM setup in progress, finished by next month
