Construction and Testing of Large GEM Trackers for Super BigBite Spectrometer at JLAB

Huong Nguyen
University of Virginia
(On the behalf of the SBS collaboration)

- **GEM Back Trackers for Super BigBite Spectrometer (SBS)**
- **Quality Control and Fabricating Procedures of GEM Module for SBS Back Trackers**
- **Characterization of SBS Back Tracker GEM Module**

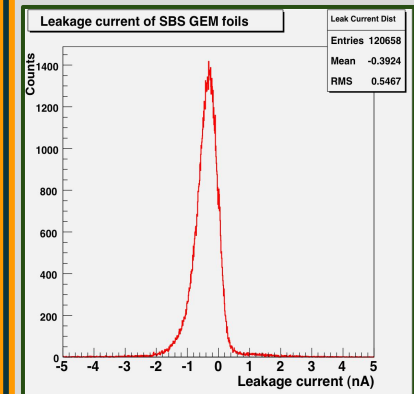
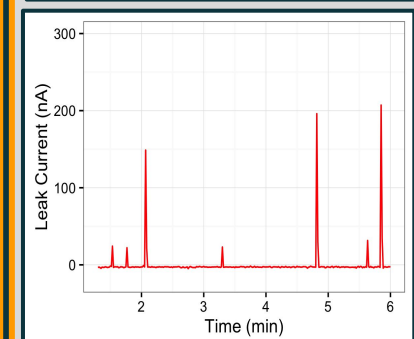
SBS BT GEM Foil

- Design parameters of SBS BT GEM foils
 - 50 μ m kapton foil coated with 5 μ m copper
 - 70 μ m diameter holes at 140 μ m pitch
 - Active area of 60x50 cm²
 - Top side divided in 30 sectors
- Inspection of GEM foils
 - Sampling optical inspection
 - Measure the dimensions of the holes
 - Evaluate the shape of the holes
 - Leak current measurement of each sector:
Applied HV=550V across foil in N₂ gas environment.
Accepted foil has leak current < 5nA
- Common issues with GEM foils
 - Imperfect hole shape and size: 7/150
 - High leak current: 10/150
 - Positive spikes in leak current spectrum: 6/150
- High acceptance rate (90%)

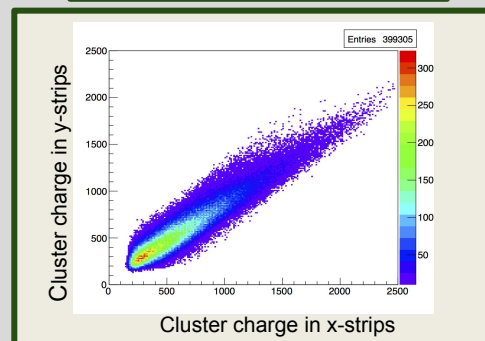
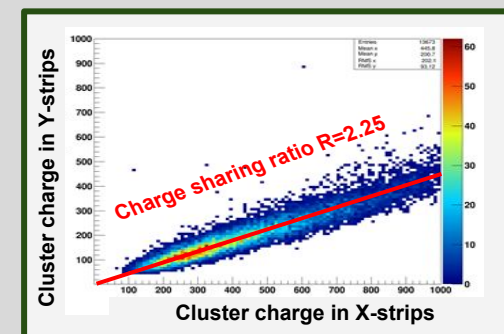
- Most common issue: large spread of the base of the Kapton layer masks part of the bottom strips
- Acceptance rate (95%)

- Causes: Largely exceeding spread of the base of the Kapton
⇒ Reducing exposed area of bottom strips
⇒ Charging of Kapton layer increases shielding of bottom strips
- Solution:
 - Improvement of quality of readout board at CERN
 - Optical inspection of the board and use RO board with kapton spreading less than 10 μm

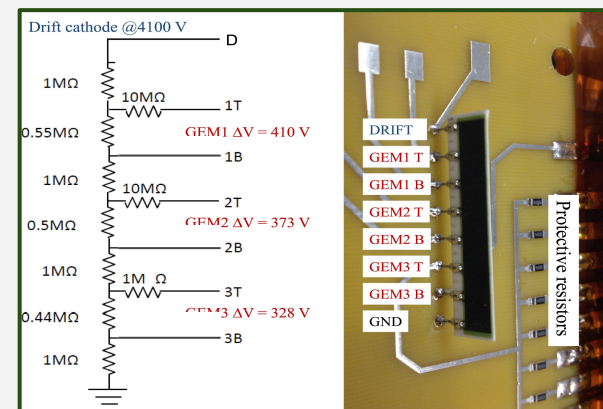
- Seal 4 sides of GEM module with a thin layer of Dow Corning Coating to prevent gas leak
- Flow N_2 gas into GEM module for 3 days to remove residual dust
- Perform the final leak-current test for each sector
- Electrical Connection
 - Each sector of the 1st and 2nd (3rd) GEM foils is connected to HV distribution board through individual $10\text{ M}\Omega$ ($1\text{M}\Omega$) protection resistor
 - Mount the HV divider on GEM module to distribute voltage across 6 GEM electrodes, drift cathode and top gas window
- High Voltage Certification
 - Monitor GEM module with applied HV=4200V with N_2 gas flowing for 3 days
 - Monitor GEM module with applied HV=4100V with Ar/CO_2 (70/30) gas flowing for 3 days
- GEM module is ready for final laboratory testing

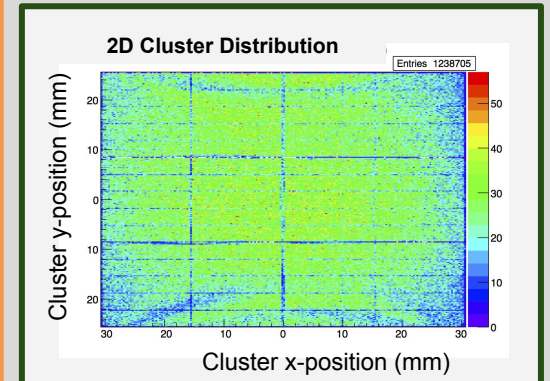
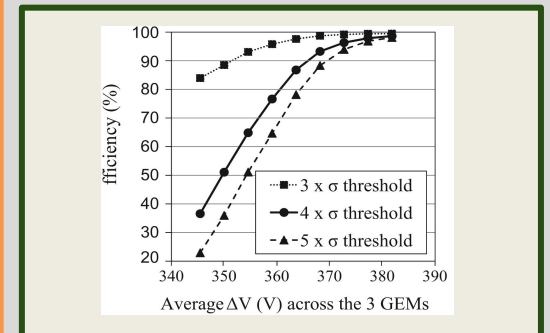
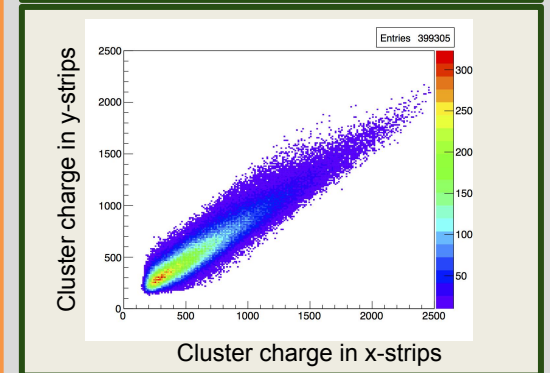
- Continuously flowing Ar/CO₂ gas into the GEM module at a rate of 10 L/h (representing 3 module volume changes per hour)
- Operating GEM module at applied HV in the range of 3.9kV - 4.2 kV and taking cosmic data for two weeks
- Mounting GEM module in front of X-ray generator. Operating GEM module at applied HV 4000 V and taking data with radiation flux of 25 MHz/cm² at the surface of GEM module

- Gain uniformity: evaluating 2D distribution of cluster positions (gain variation less than 15%)
- Efficiency: scan efficiency in HV range of 3.8kV - 4.2kV and evaluate the efficiency plateau (95% at 4.1 kV)
- Charge sharing of 2D readout strips (charge sharing ratio of 1.0)

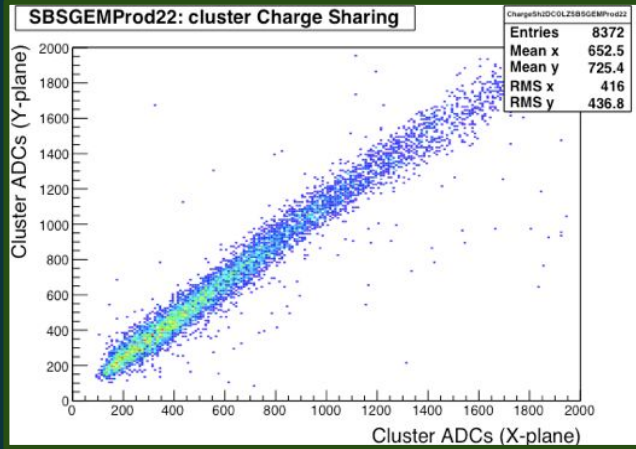
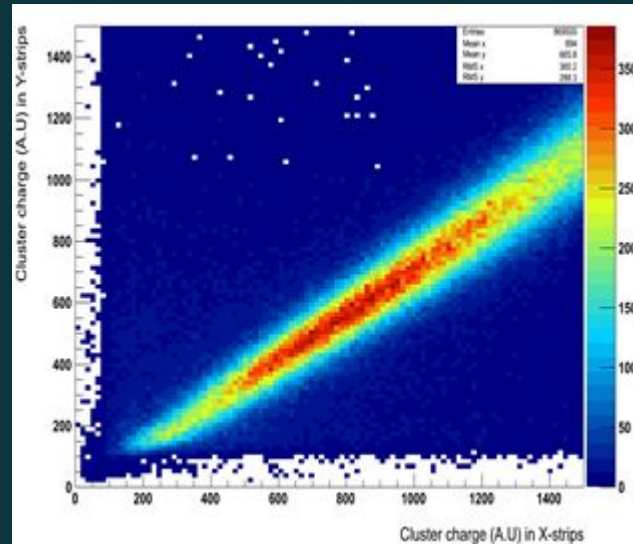
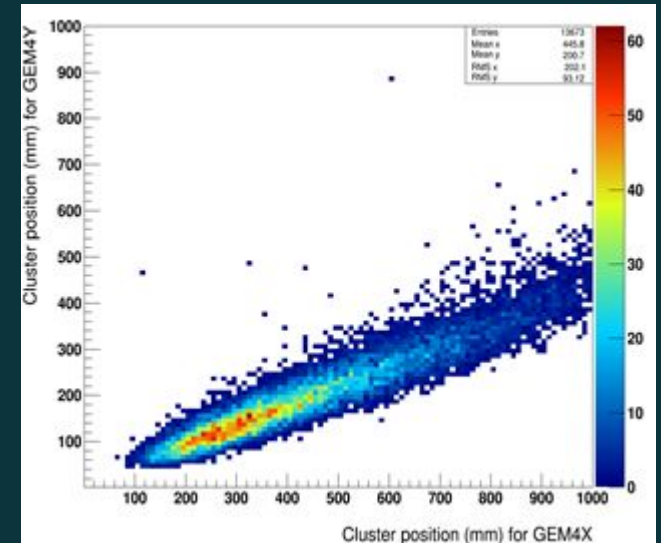
Unequal Charge Sharing vs Particle Rate

- The width of top and bottom strips was designed to obtain almost equal charge sharing between x- and y- coordinates, charge sharing ratio expected to be $R \sim 1.0$)
- Largely unequal charge sharing observed at ratio $R=2.25$
- Charge sharing dependent on particle rate

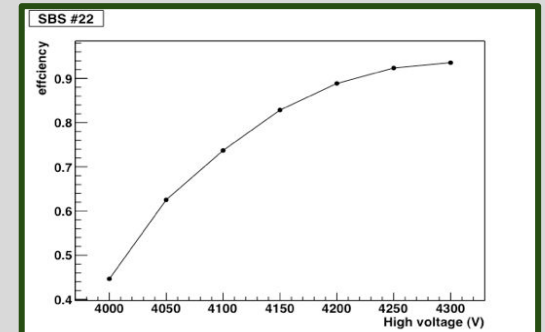
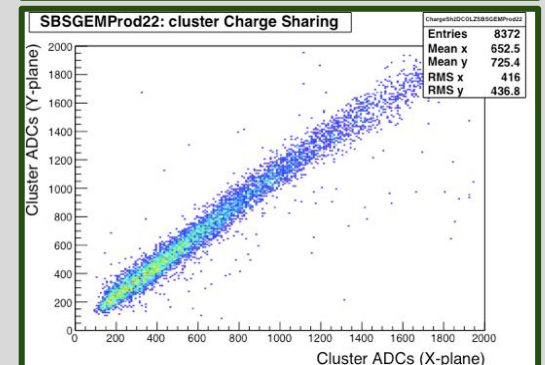
- Continuously flowing Ar/CO₂ gas into the GEM module at the rate of
- Operating GEM module at applied HV in the range of 3.9keV - 4.2 keV and taking cosmic data for two weeks
- Mounting GEM module in front of X-ray generator. Operating GEM module at applied HV 4000 V and taking data with radiation flux of 25 MHz/cm² at the surface of GEM module
- Analyze collected data to study performance of the GEM module

- Gain uniformity: evaluating 2D distribution of cluster positions (gain variation less than 15%)
- Efficiency: scan efficiency in HV range of 3.8kV - 4.2kV and evaluate the efficiency plateau (95% at 4.1 kV)
- Charge sharing of 2D readout strips (charge sharing ratio of 1.0)
