Overview of SESAME Diagnostics and Recent Work

Hussein Al-Mohammad

DEELS 2018, Diamond Light Source, Didcot, UK

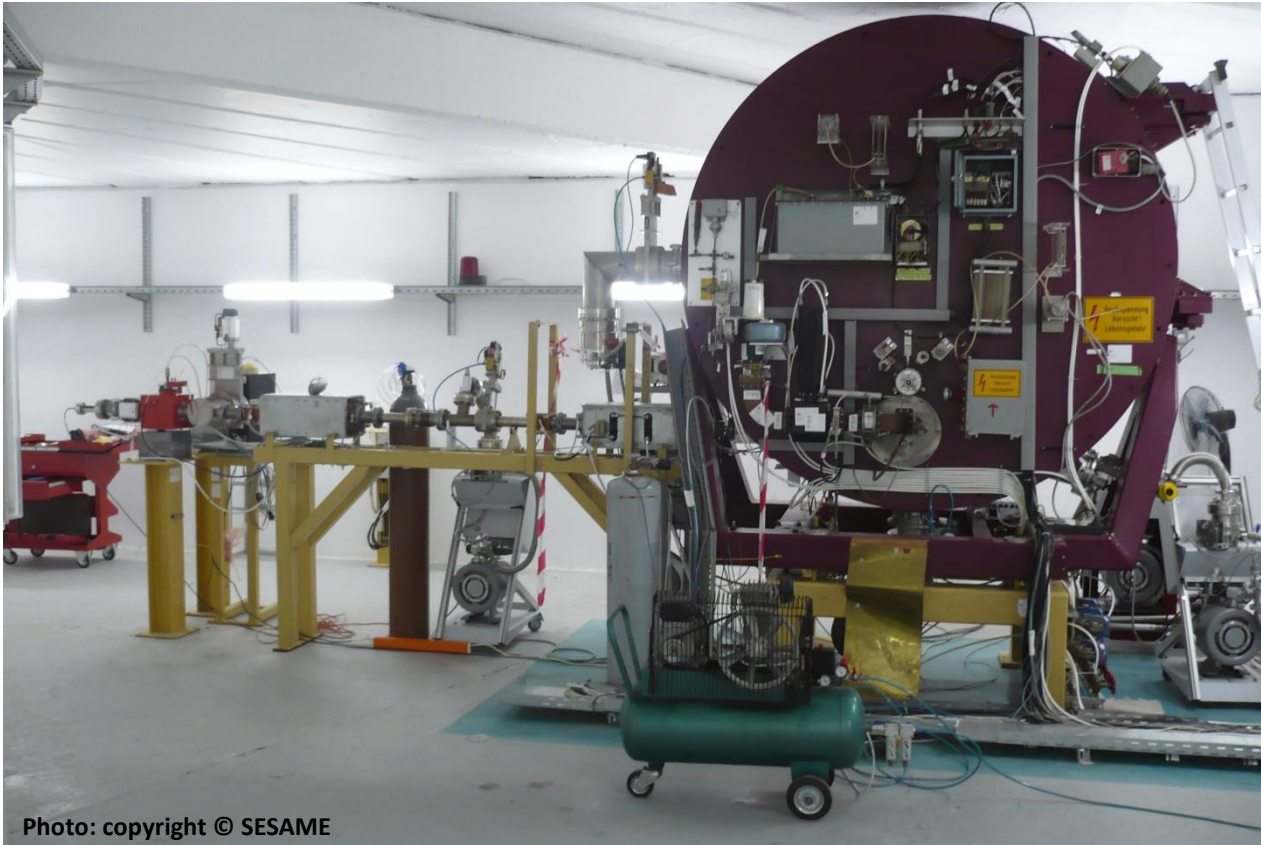
Microtron and Transfer Line 1 (2011)

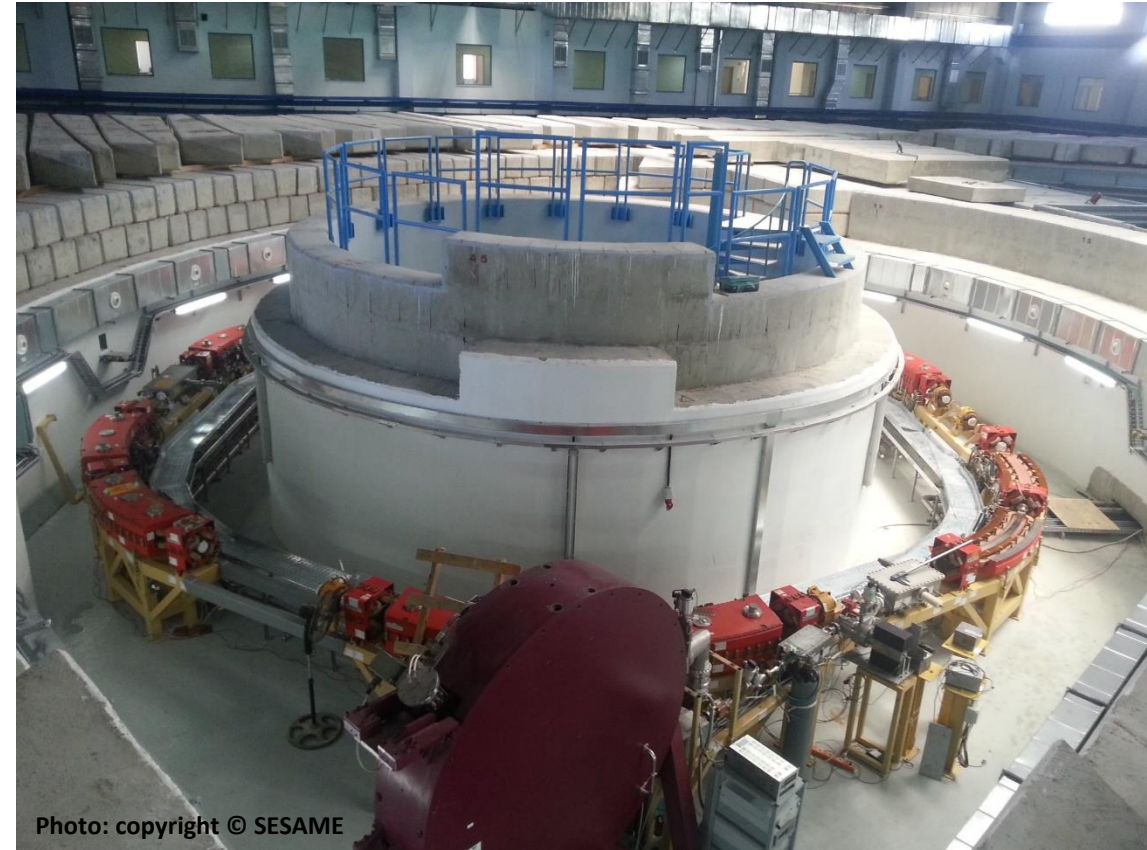
Microtron, TL1 and 800 MeV Booster (2014)

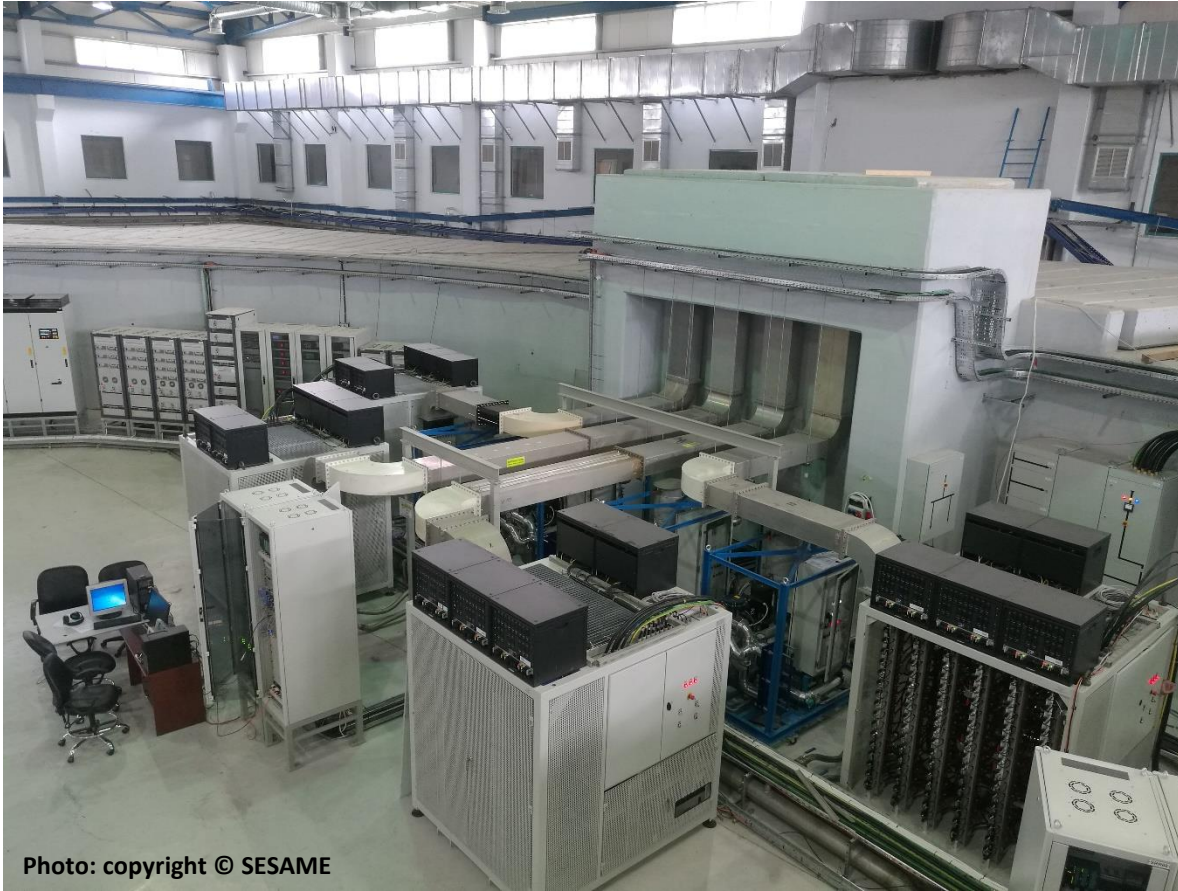
RF Plant (4*80KW SSA)

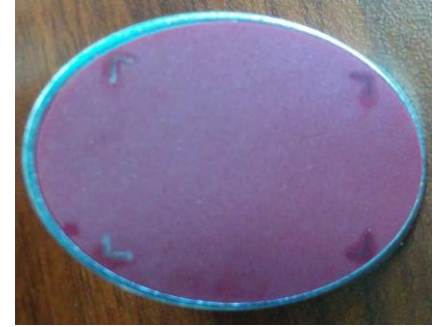
- All the FS are in-air, mounted horizontally.
- Pneumatic type and 1 stepper motor.
- Aluminum Oxide screens with calibration marks >> cost effective.
- Basler 1300-30gm CCD PoE triggered camera (1/3" sensor 3.75x3.75um pixel size)
- Kowa lens, zoom lens type, $f = 50\sim 82\text{mm}$

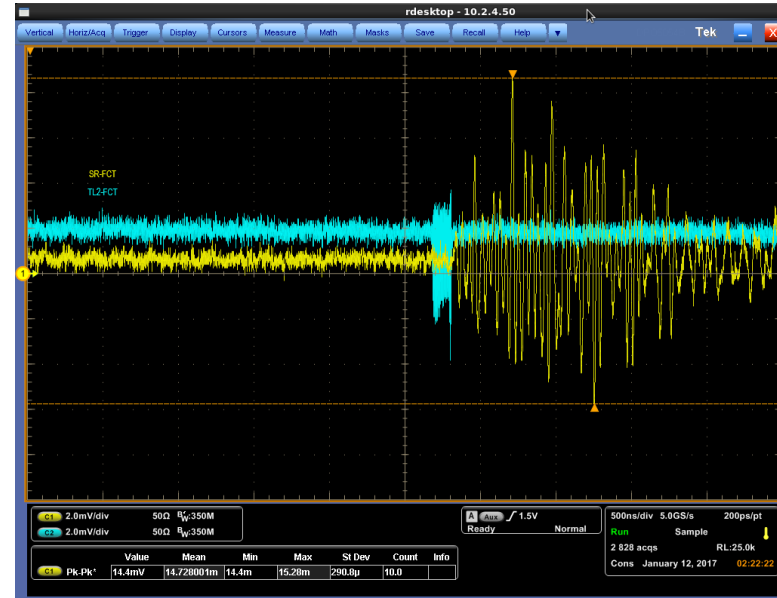
- The sheets improve noise reduction but unfortunately the noise still there.
- The system needs more time to be improved and to solve noise problem.
- → So we made a simple math on the scope !!
- → Turn on all PE with no injection to the ring → take this signal as a reference → subtract the FCT signal from the reference one ! → we got the beam ☺until we will solve the problem !!
- BUT the TL2 FCT not affected ! And this not far from SR FCT.

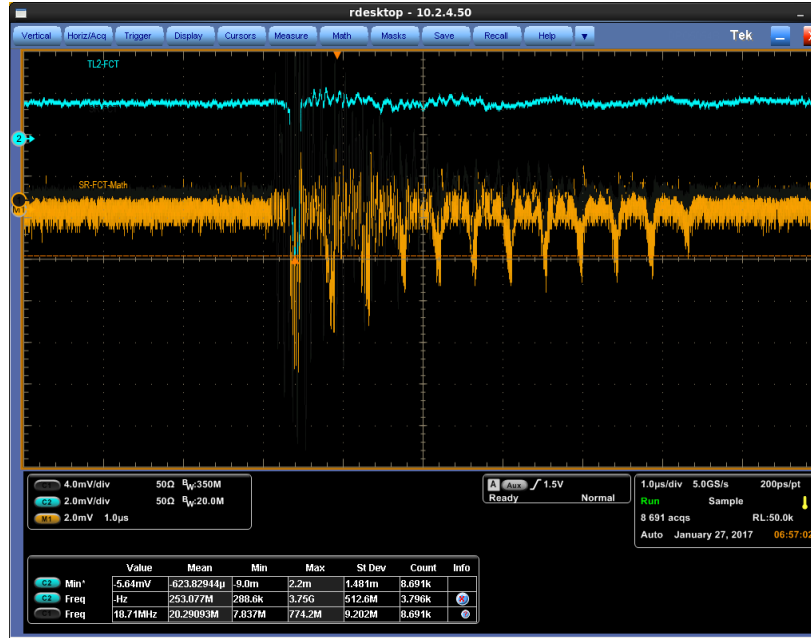
Few turns in SR

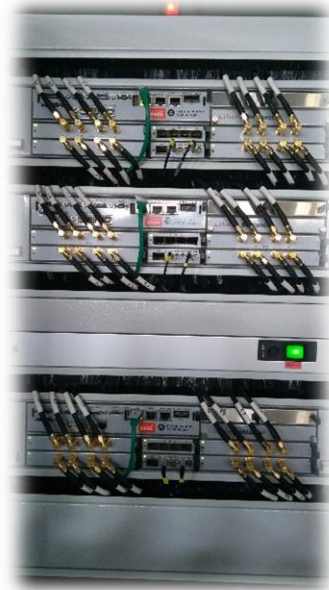
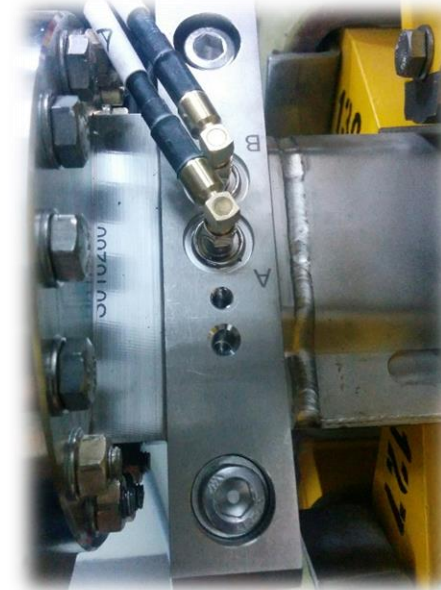
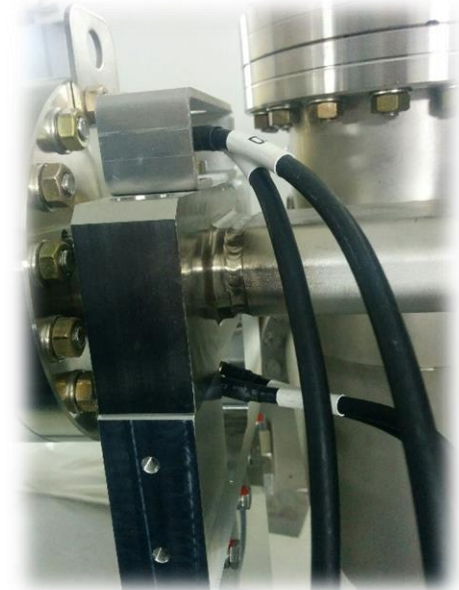
- 64 Button type BPM, 4 BPMs/Cell.
- 12 Libera Brilliance +, 8 are equipped with 8 GDX modules, 4 of them are donated from Instrumentation Technologies.
- 48/64 BPM are connected to the Libera.
- 32 BPM will be used for FOFB.
- Low Loss TWS240-FR Coaxial Cables.

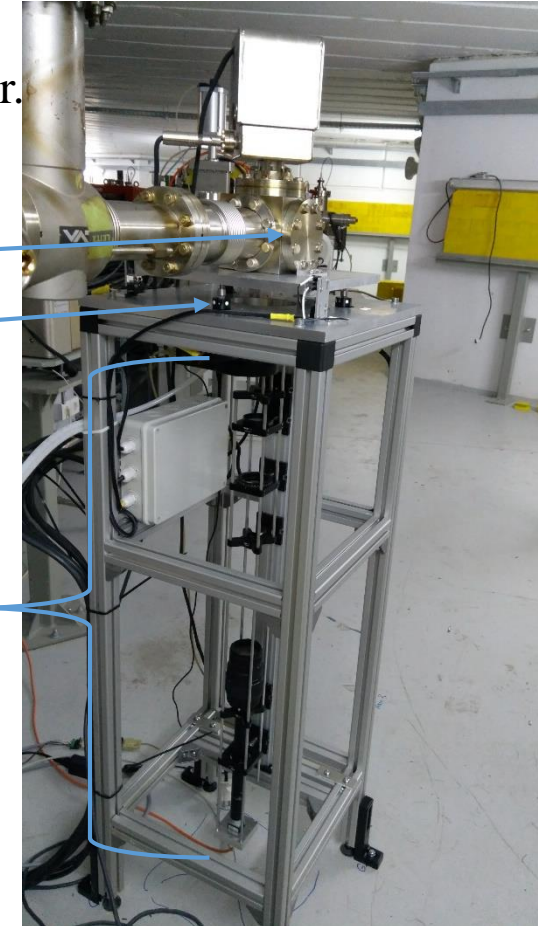
- The in-vacuum mirror design is borrowed from ANKA.
- In the phase one of SESAME the SRM will be inside the tunnel.
- So a motion system was designed to control and to do fine alignment for the in-vacuum mirror.
- The motors are mounted in vertical and triangle shape to move the mirror with $1\mu\text{m}$ step.

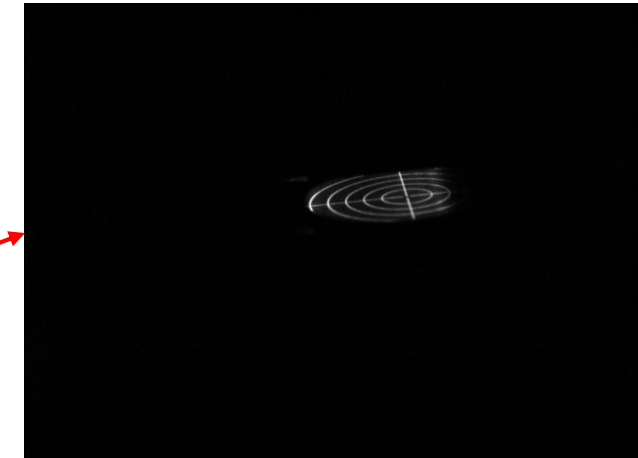
1st Synchrotron Light (2.5GeV) in SESAME The target were put on the intermediate image plane On August 16th ,2017

1st Synchrotron Light (2.5GeV) in SESAME The target were put directly after the in-vacuum mirror On August 16th ,2017

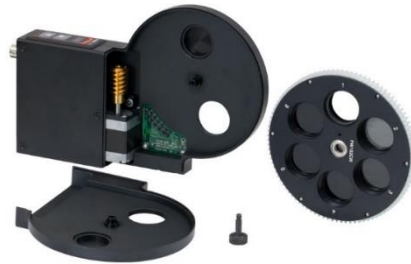
- We put a weight temporary in the upper plate to compensate the vacuum force.
- We repeat again the same testing when we test it the 1st time.
- We saw the beam passing 1st mirror and then 2nd mirror and we adjusted the motors .
- But still the system need alignment and mechanical optimization.
- Slit Scan:
 - ❑ To do slit scan remotely we use motorized filter wheel from Thorlabs, we replaced 5 filters with a slits and left one for direct imaging.
 - ❑ The problem is the alignment of the slits !! → but we can know the best slit.
 - ❑ The measurement still not verified → need alignment and improvement.

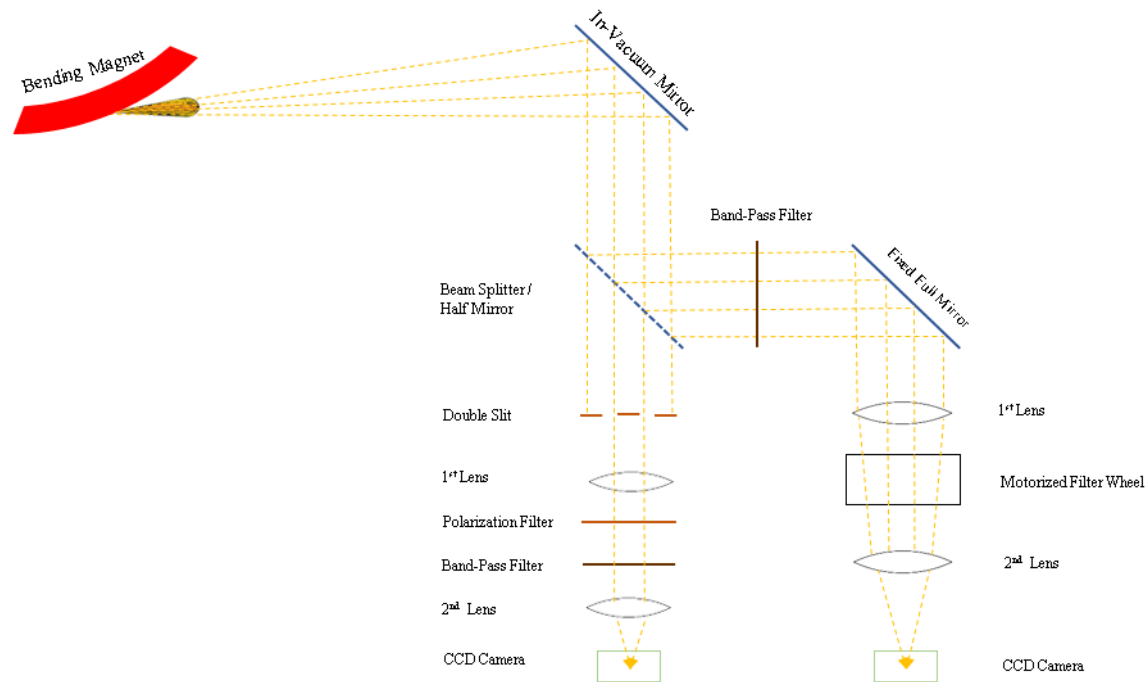
- A new beam splitter will be added to the system to have two options : Direct Imaging and Interferometry at the same time.
- Replace the 1st lens (singlet monochromatic 400mm) with (doublet achromatic 400mm).
- Realign and recalibrate the whole beamline.
- Put a springs or change the mounting mechanism for the mounting plate.

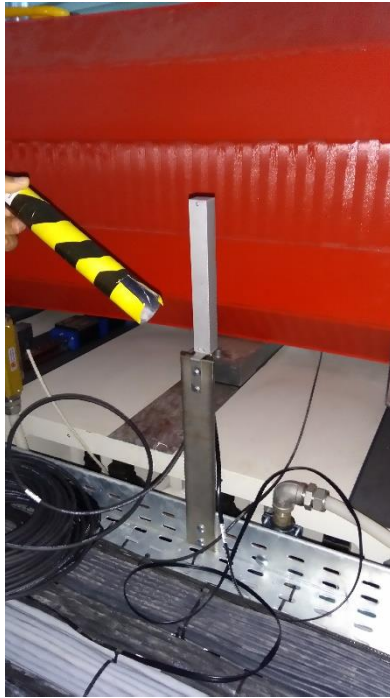
- Four Beam Loss Detectors (BLD) were installed in the machine and connected to one Beam Loss Monitor (BLM).
- One BLD and BLM are donated from I-Tech as a support to SESAME project.
- The BLDs are installed in 4 cells in the machine, their cables are long ~50m so we can turn them around to see the losses in all the ring.

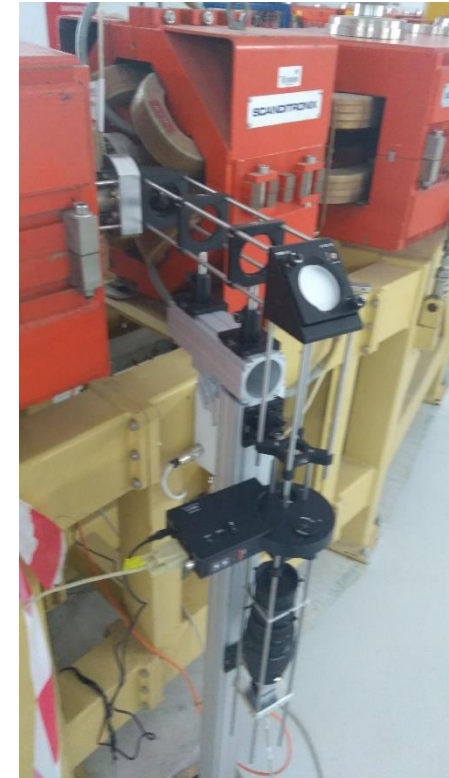
- New Booster SRM installed and replaced with the old BESSY I SRM.
- Position interlock and post mortem functions are implemented and will be tested on next operation.
- New system to send a hardware signal from SR-FCT/DCCT to PSS system for current indication .
- Upgrade beam shaker controller and scheme system for SR and BO.

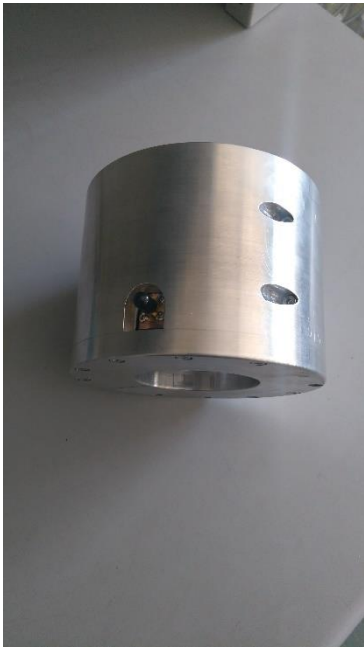
- New FCT (2.5V/A, 82mm) will be installed in TL2
- Will be installed after extraction septum
- Simple bypass shield.
