MQXFS1-d Welding Results

CM Status Meeting

01 March 2018

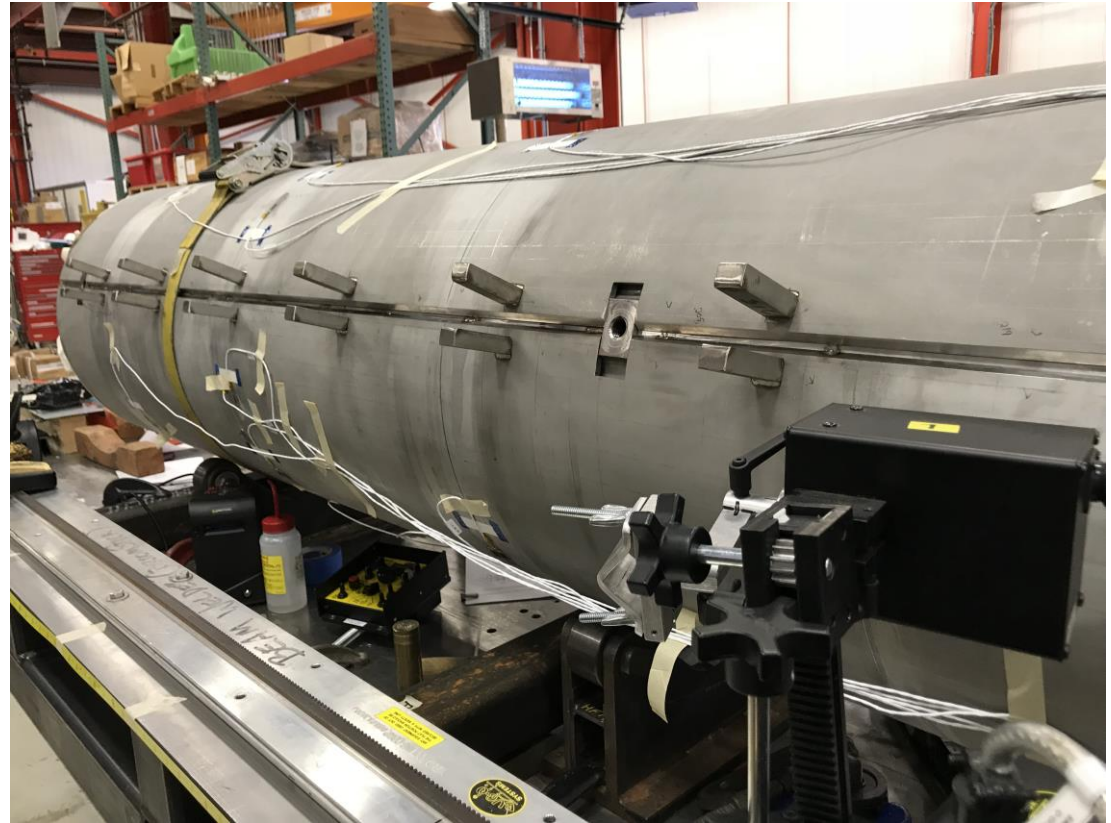
Fit-Up

Fit Up:

Root Gap required - .094"

Actual – Side A: 0.103" - 0.121"
(2.6mm – 3mm)

Actual – Side B: 0.096" – 0.105"
(2.4mm – 2.7mm)

- Inconsistent root gap
- Root gap width larger than anticipated
- Welder #2 (Side B) not as familiar with controls - delayed adjustments on the fly

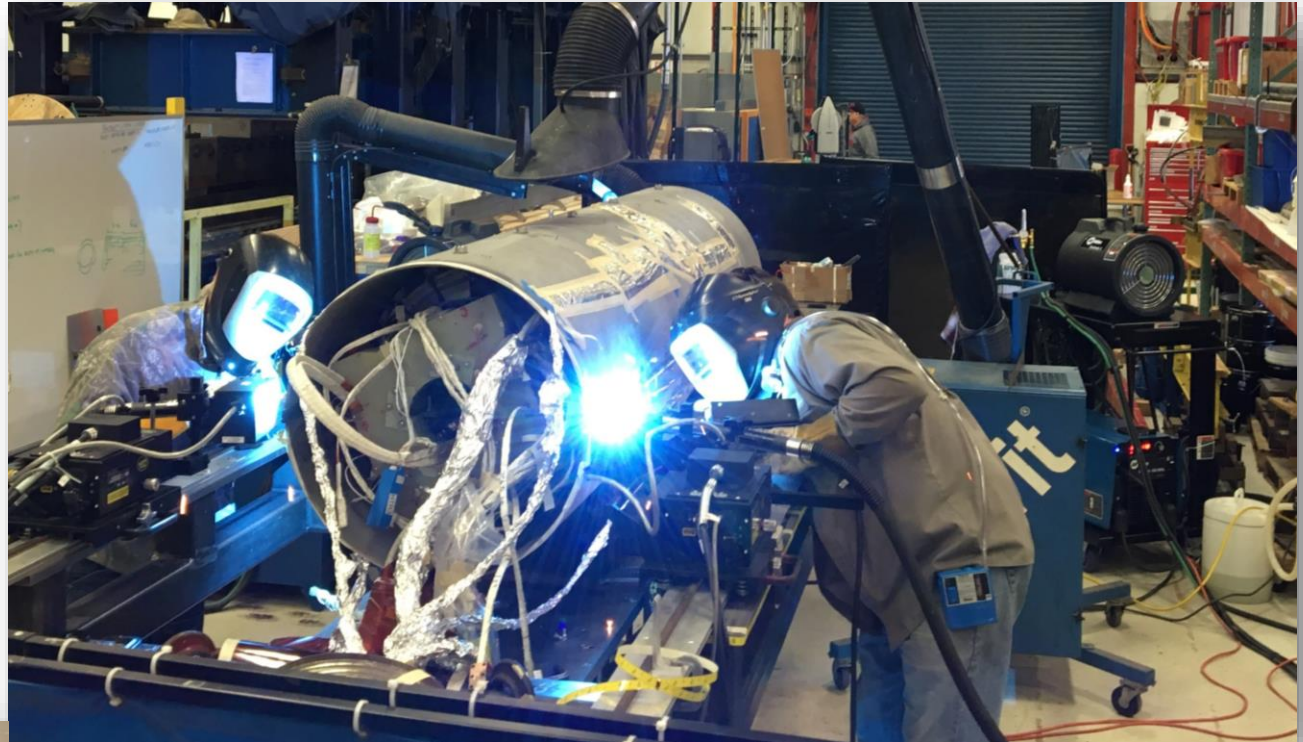
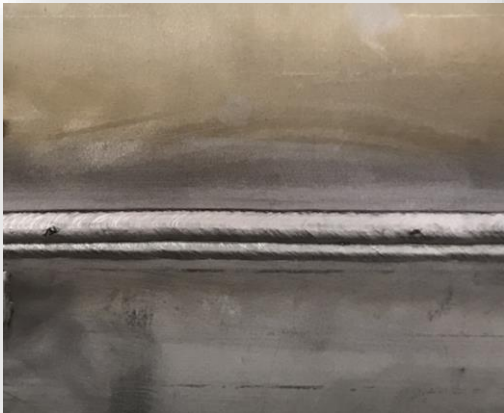
Welding

Temperature:

Start

1st Pass – 2° C

2nd Pass - 2° C

3rd Pass – 1.5° C

Total 5 - 6° C Rise

**Returned to Room
Temperature in 48 hours.
