MQXFAP1b TEST RESULTS

Joseph F Muratore – Brookhaven National Laboratory

9th HL-LHC Collaboration Meeting Fermilab 14-16 October 2019

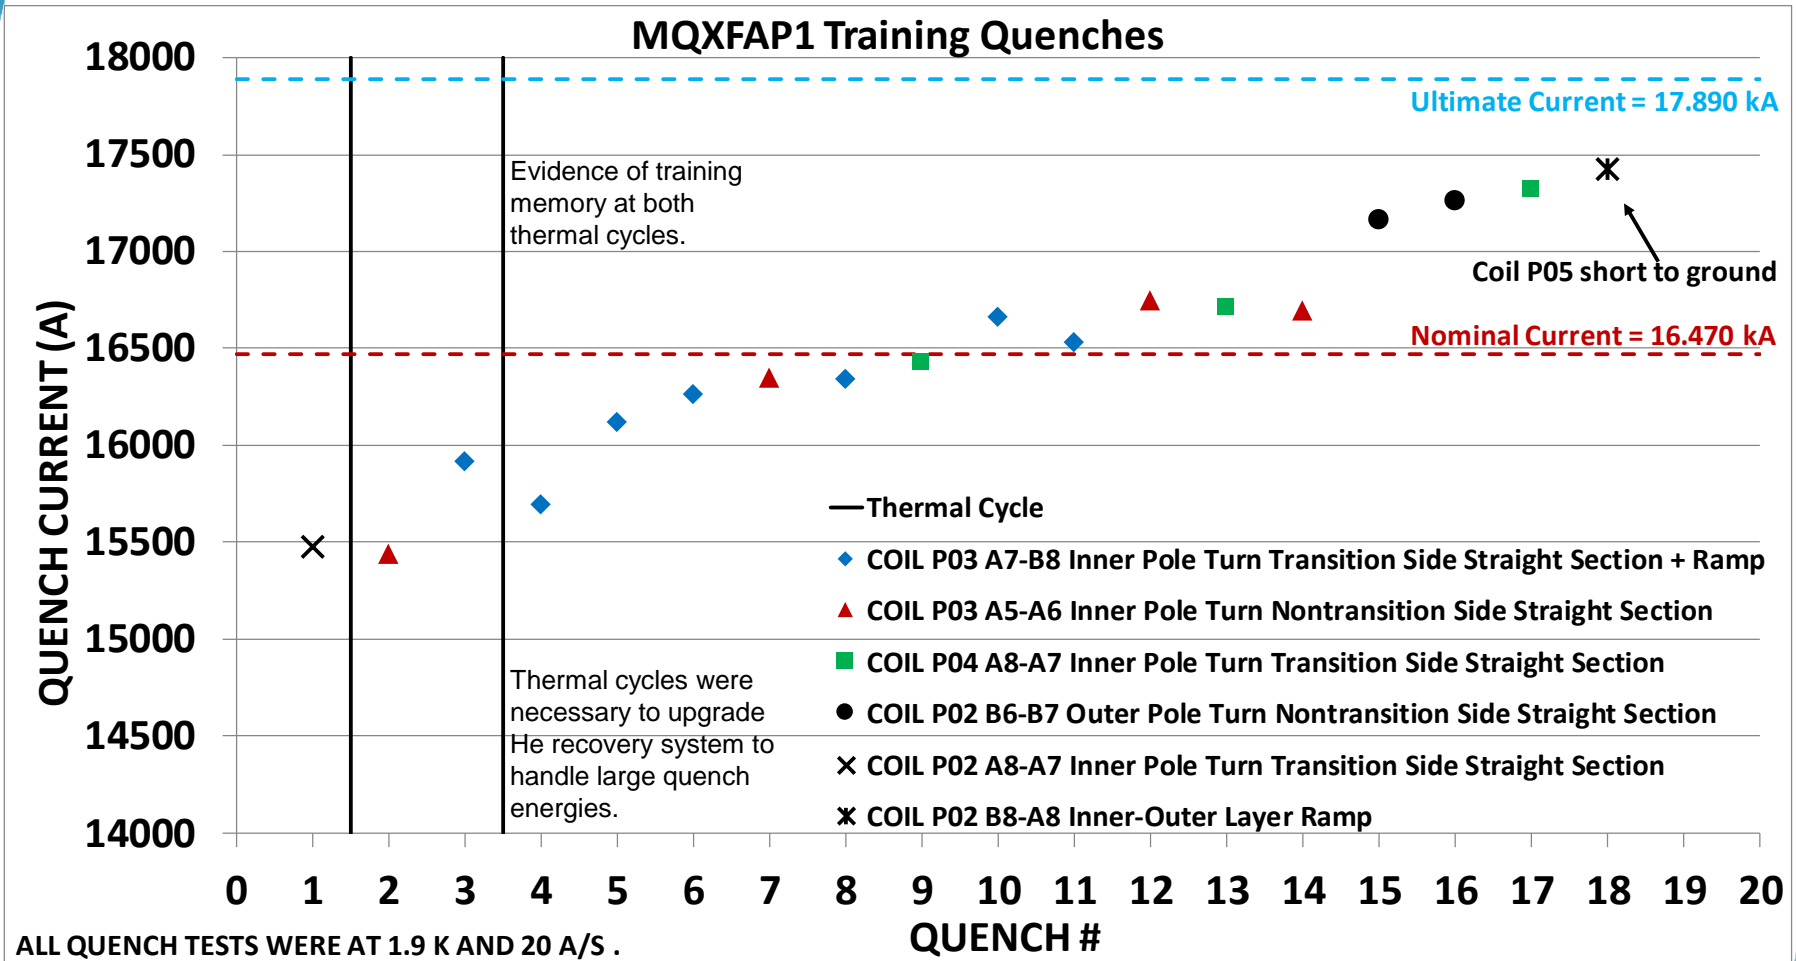
MQXFAP1 QUENCH RESULTS

Last five quenches included CLIQ and last four did not use inner strip heaters. Testing ended after 18 training quenches due to development of short to ground.

- Last 5 quenches done with CLIQ added: MIIts decreased from ~29 (~270 K) to ~25 MIIts (220 K), as expected. This was first CLIQ operation with full-length MQXF magnet.
- Last 4 quenches were done without inner layer heaters; MIIts values were not affected. Inner layer heaters are no longer to be used in MQXF magnets.
- Testing ended with Quench 18 when Coil P05 developed a short to ground
 - Hipot tests had been problematic starting with the first cooldown, and at first warmup, where the Coil P05 outer layer - low field strip heater started exhibiting shorts to the coil.
- Coil P05 issue is attributed to a combination of the following causes:
 - Non-conforming impregnation of Coil P05;
 - Hipots done at room temperature after first test at 1.9 K – trapped He gas.
- Coil P05 was subsequently replaced with new 4.0 m coil (P06) for re-test later as MQXFAP1b.

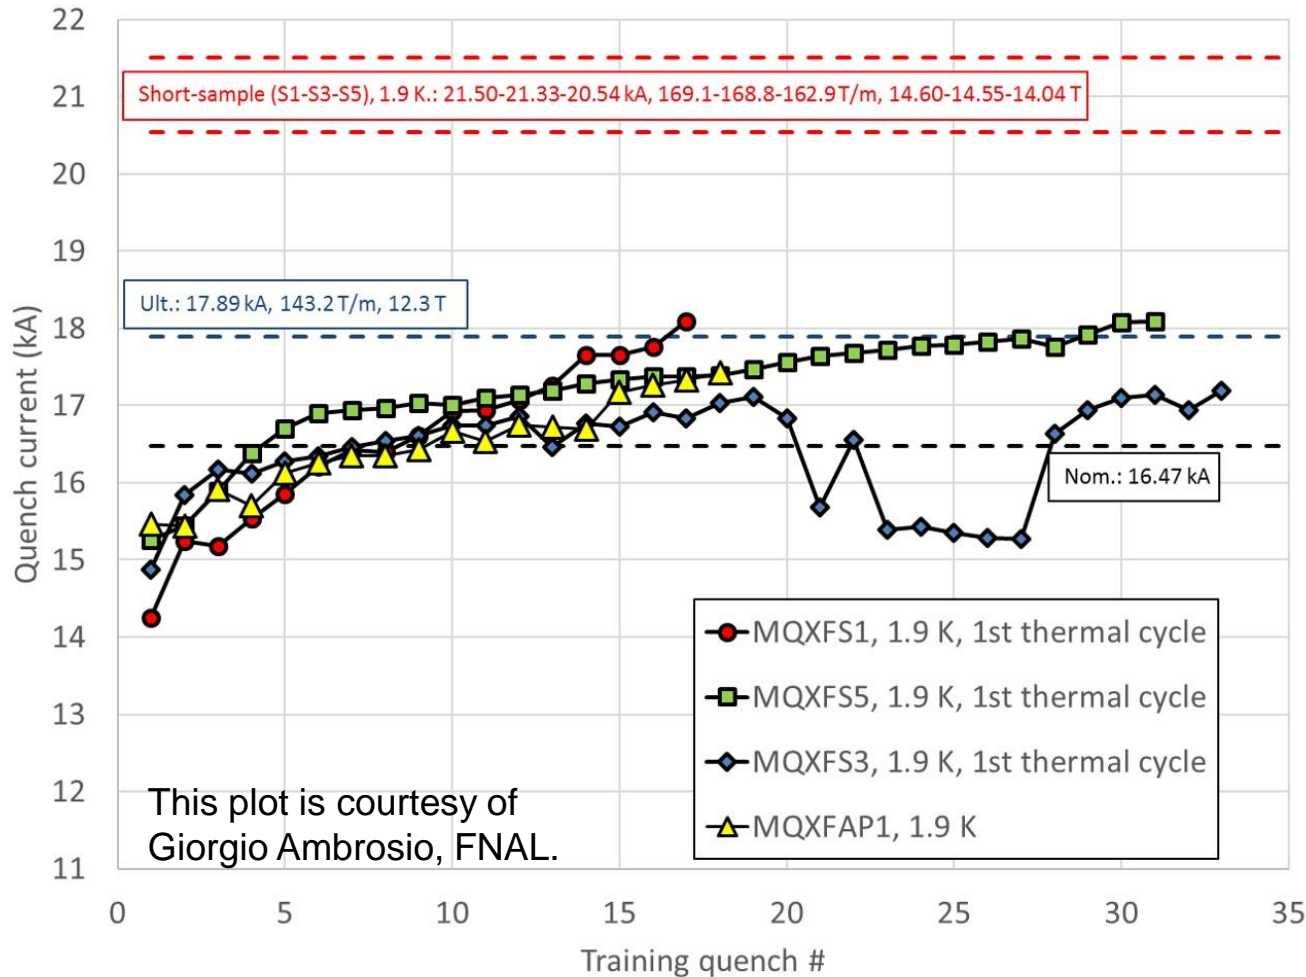
MQXFAP1 QUENCH RESULTS COMPARED

First full-length MQXFA magnet training was similar to short models.

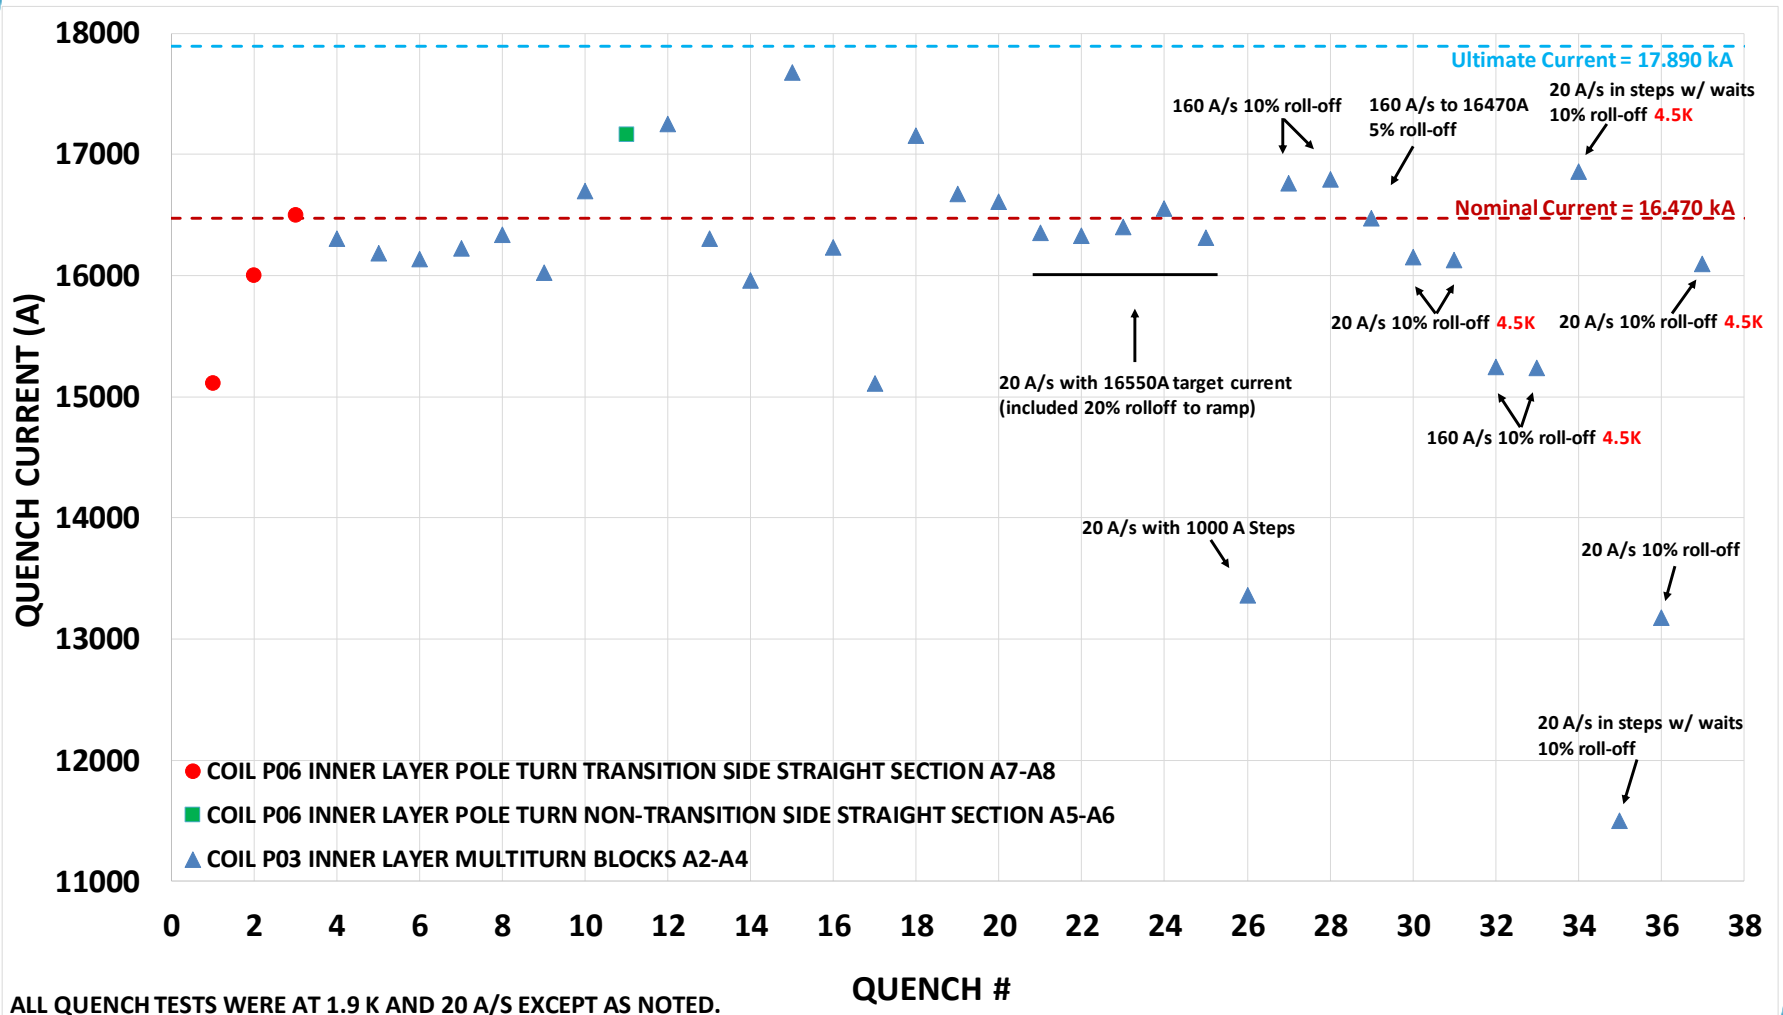
MQXFAP1b QUENCH RESULTS

- First 3 quenches were in the new Coil P06 and trained normally to nominal operating current, and were in the inner layer pole turn. This was as expected for virgin coil.
- Other than one more quench in Coil P06, the rest of the quenches were in Coil P03 inner layer, somewhere in the two multiturn blocks; the tap A3 in P03 was open so the resulting section comprised all the turns other than the pole turn.
- Quench currents 8-18 were highly erratic, implying mechanical issue.
- Starting with Quench 19, quench currents were stable but low, and were affected by both ramp rate and temperature, implying conductor damage.
- MQXFAP1b will be disassembled and Coil P03 will be inspected.
- Epoxy failure is suspected.
- Also, pre-loading sequence (100% Az, 100% Ax) may have contributed to limited performance, and has been changed for future magnets.

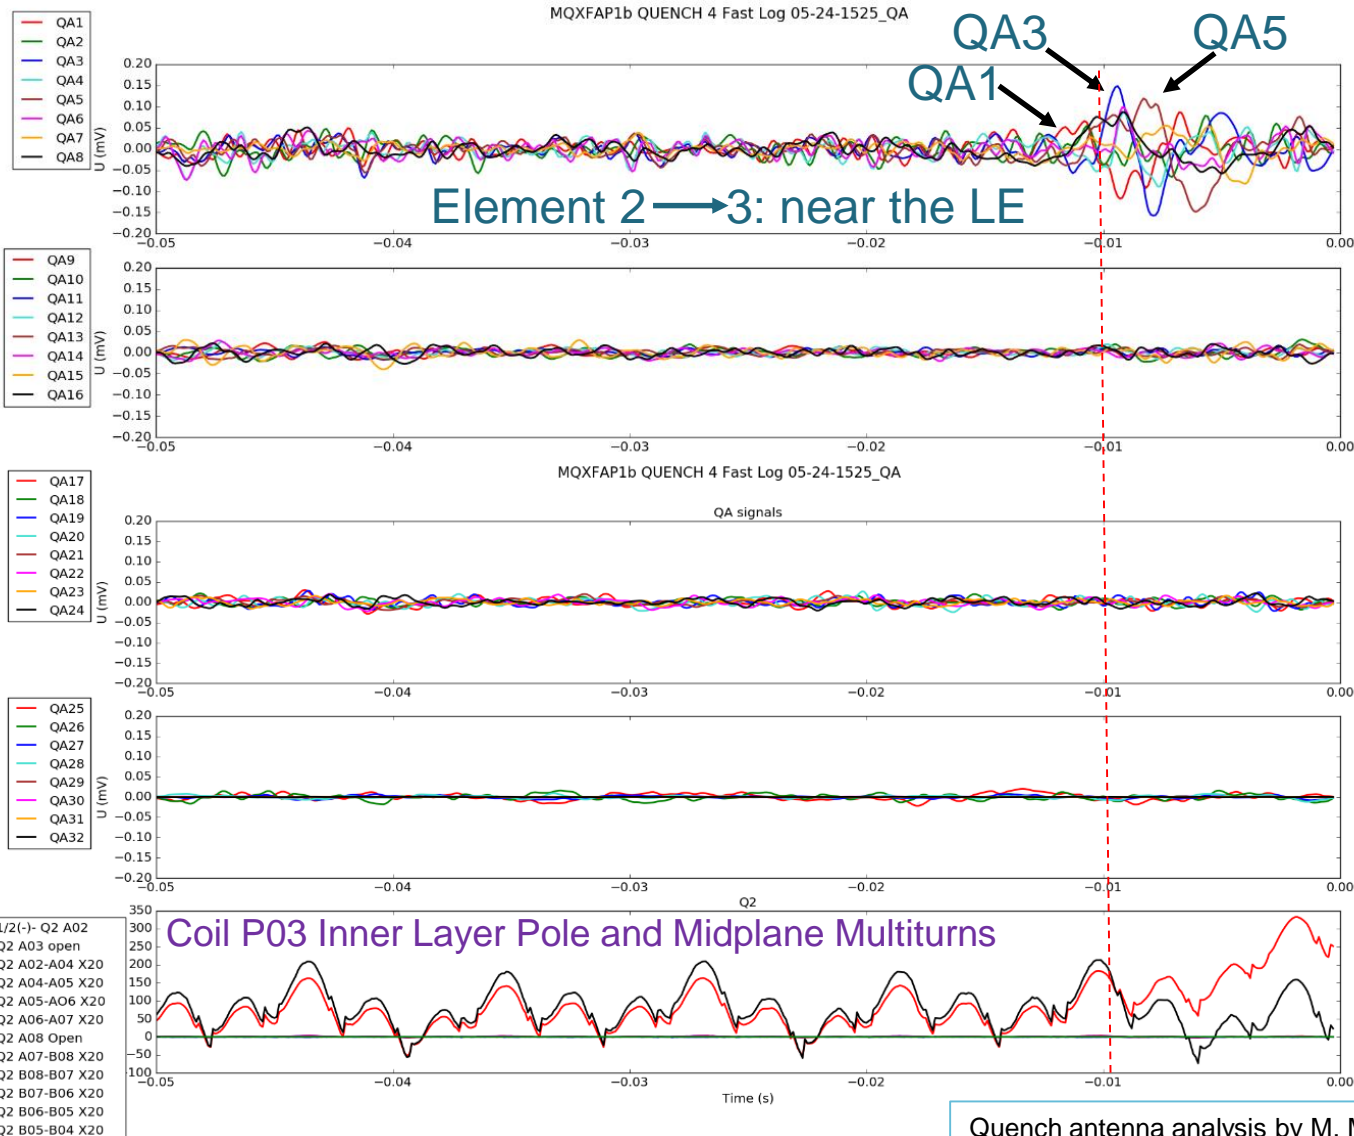
MQXFAP1b QUENCH ANTENNA

Quench antenna analysis by M. Marchevsky, LBNL.

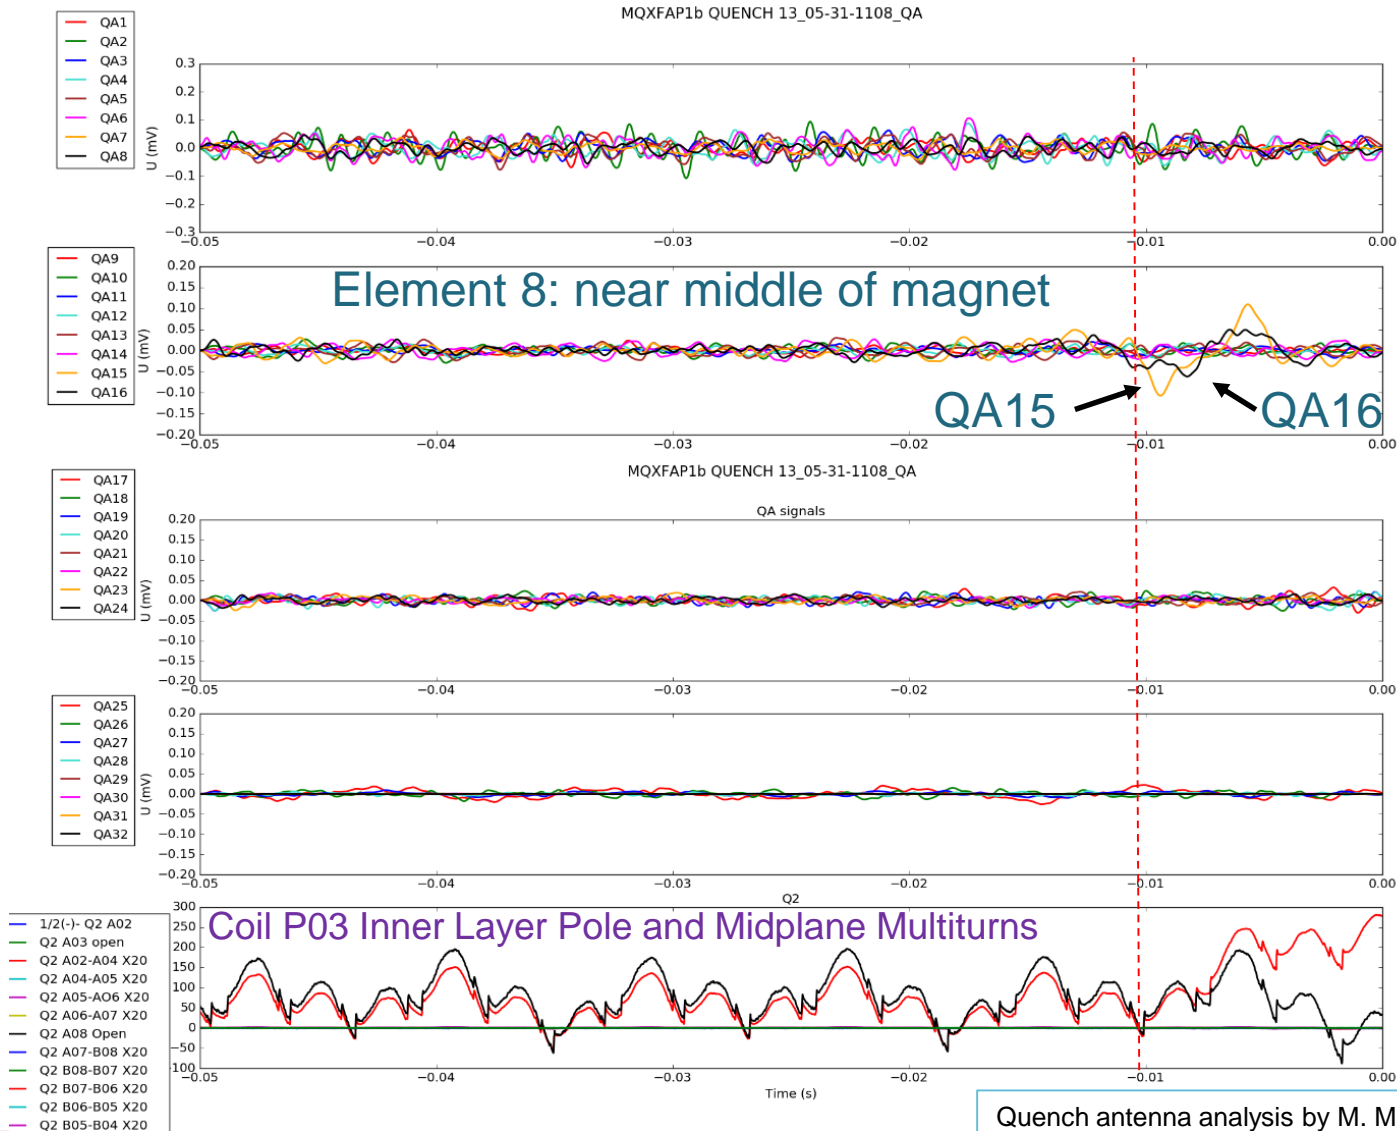
MQXFAP1b QUENCH ANTENNA

Quench antenna analysis by M. Marchevsky, LBNL.
